Cedre Information Day

Operational Response at Cedre

Past incidents

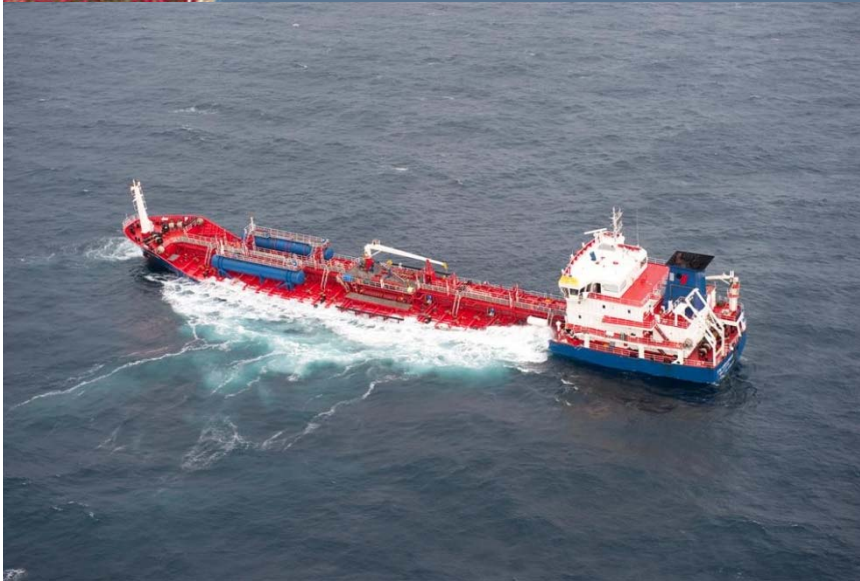
YM Uranus
Date: 05/10/10
France

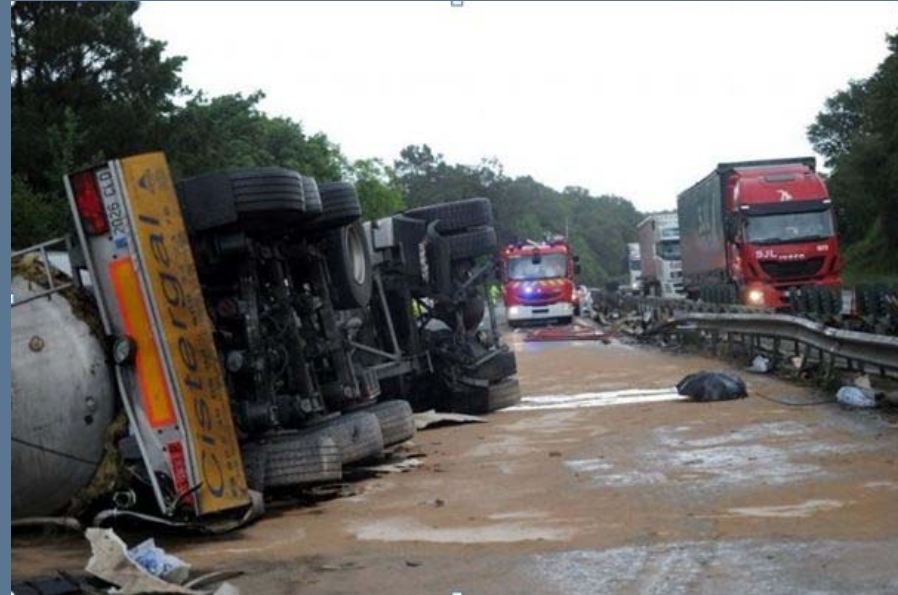
May 2013 Accident on A63. photo SDIS 40

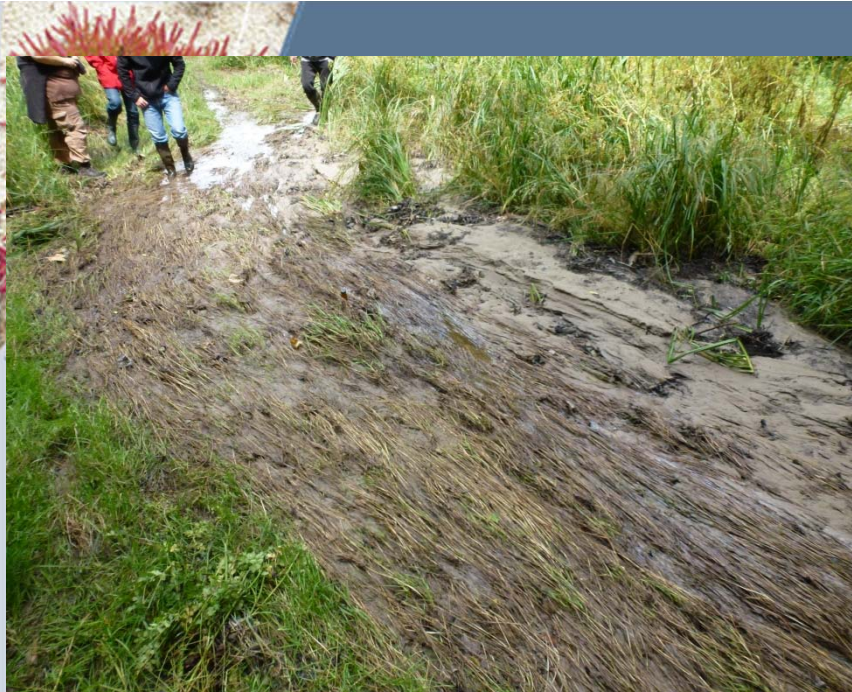
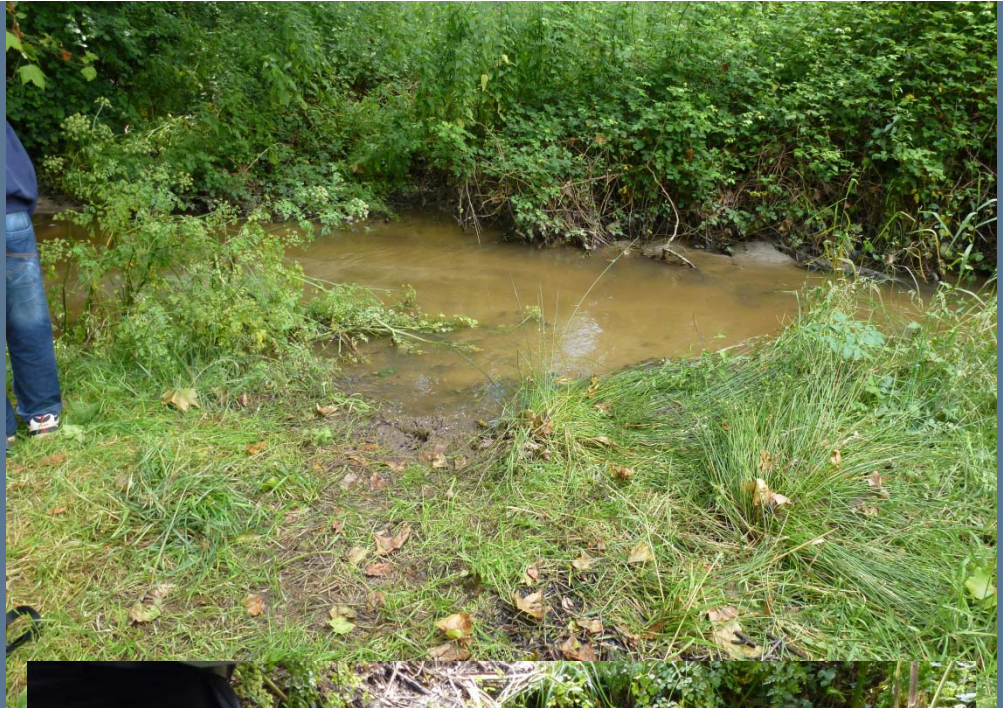
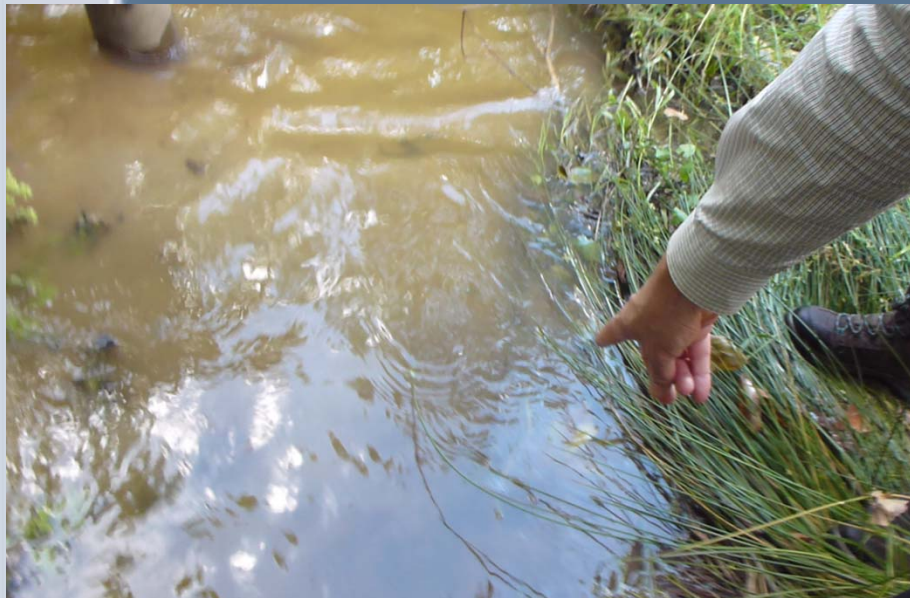
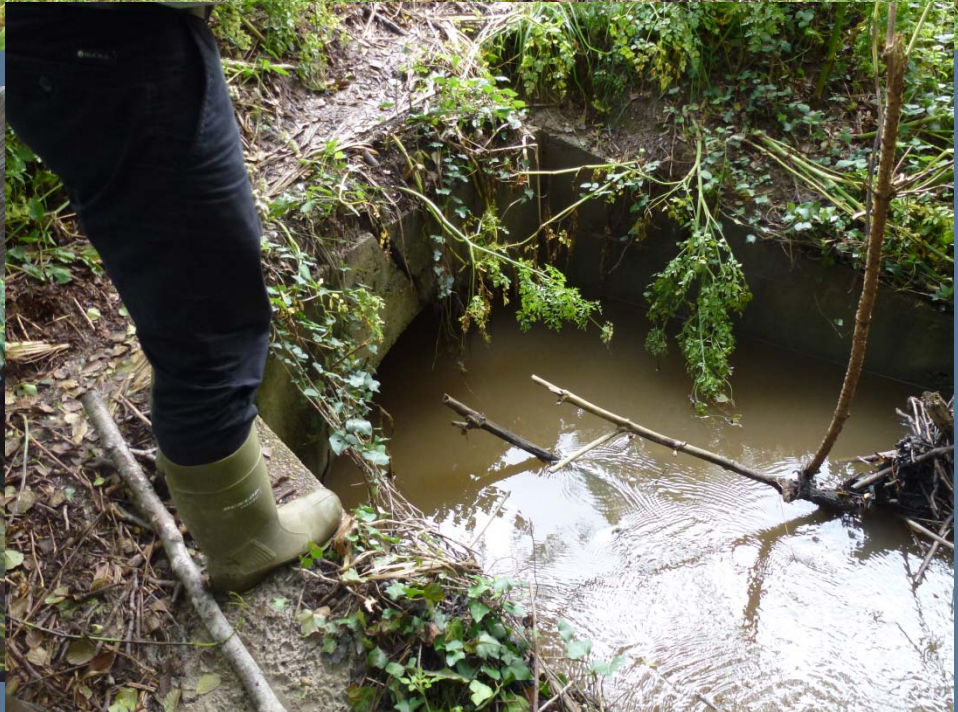
5 weeks after the incident, strong smell from sediment, sheen when sediment mixed.

Once weather drier, remove sediment and vegetation between ASF pipe and main stream, store and treat. Area around 150 m long and 10 m wide

Contact ASF, who have begun clean-up, in order to coordinate work and form a united front before the polluter.
