# AMBES OIL DEPOT

INFORMATION DAY OF CEDRE

22 MARCH 2007

**Friday 12 January 2007 – 8am**  
**Rupture of tank 1602**  
**Loss of 13,500 m<sup>3</sup> of crude oil**

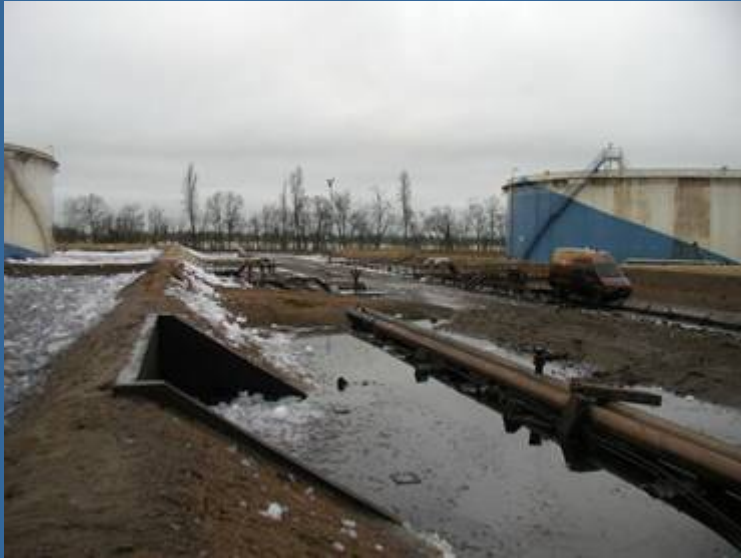
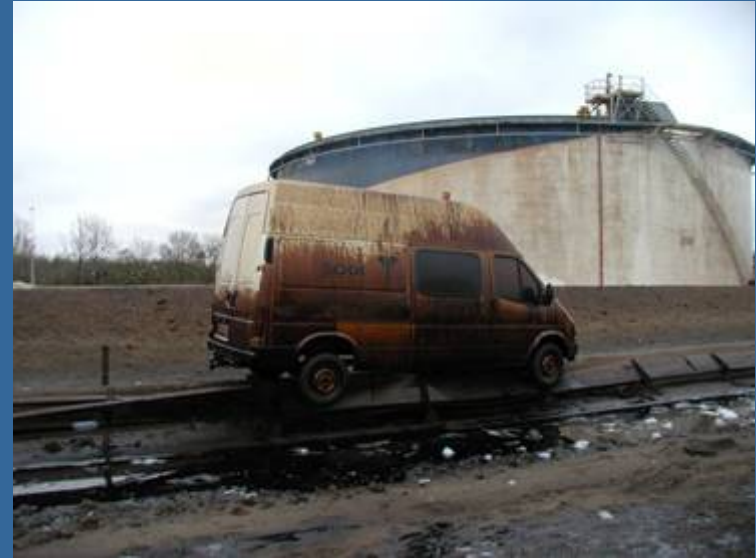
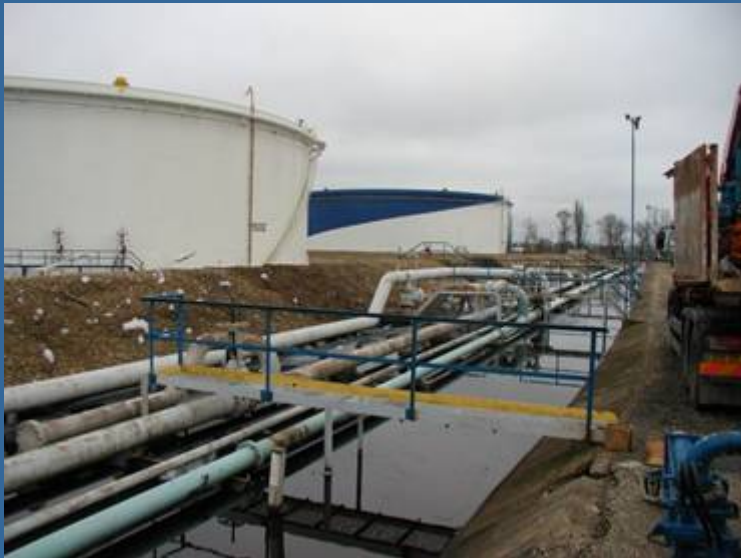
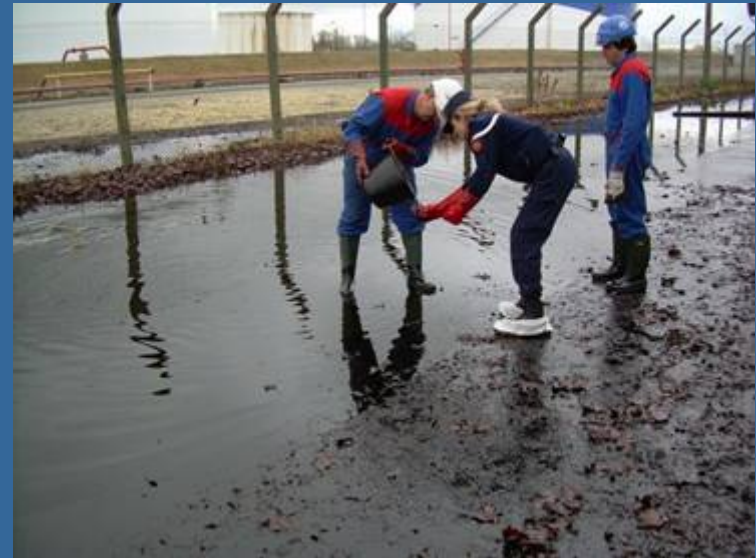
# Resistance of tank but wave effect

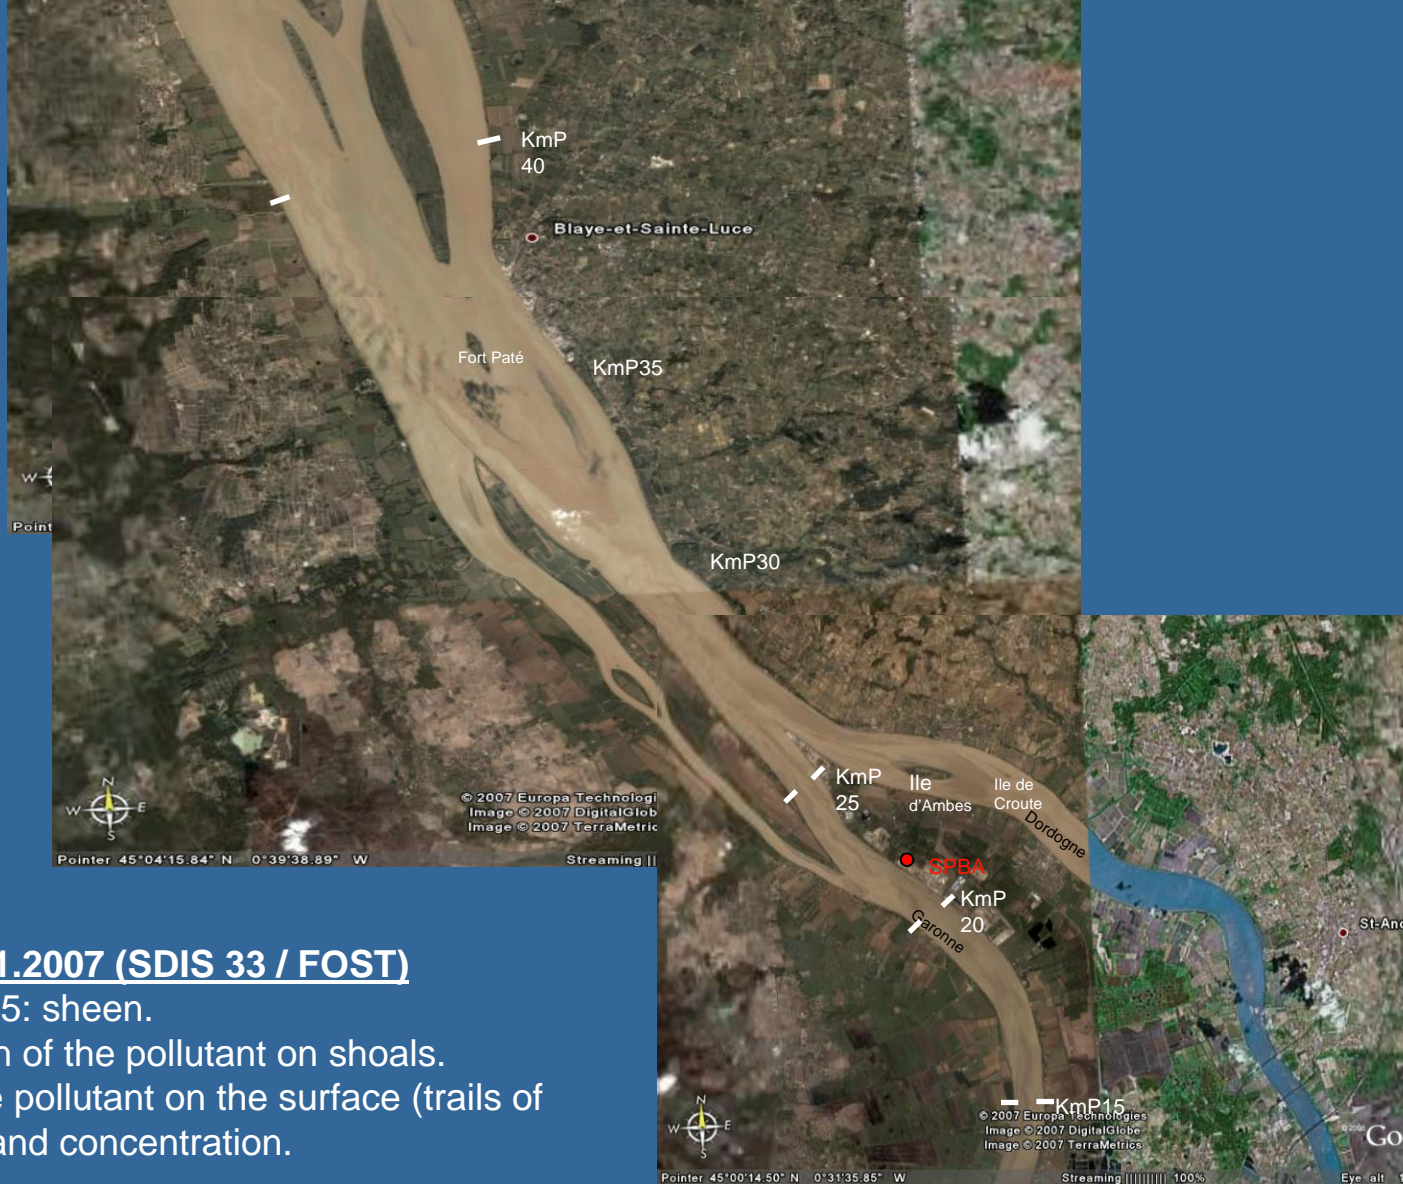
12 January 2007: 50 m<sup>3</sup> of crude oil on the right bank of the Garonne, as the tide began to rise.

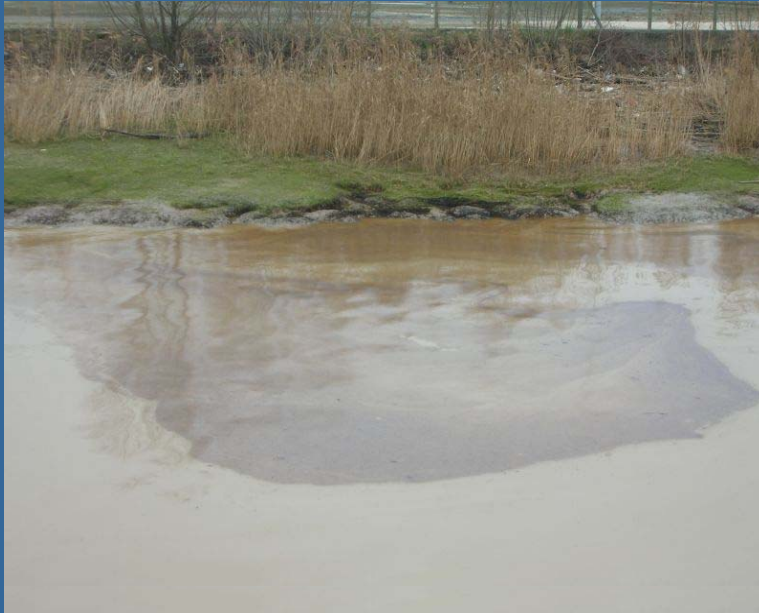
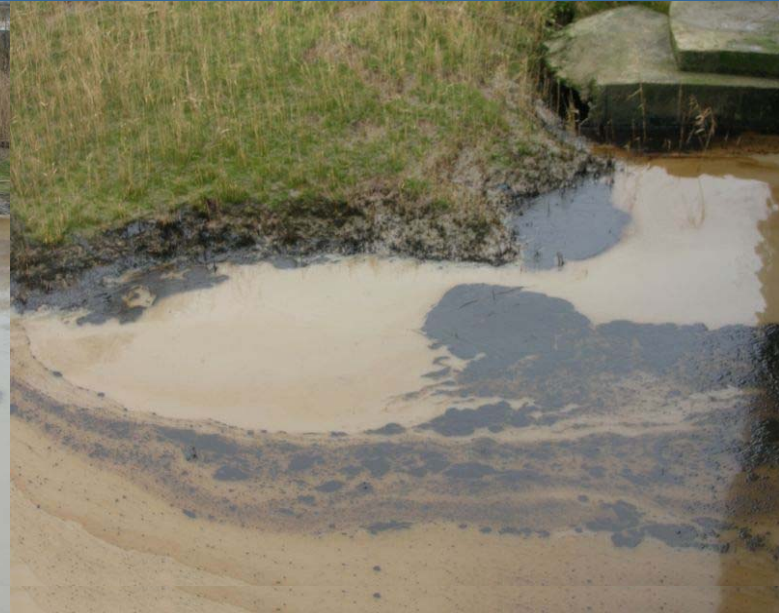
# Observations of 13 January 2007 to the right of the site

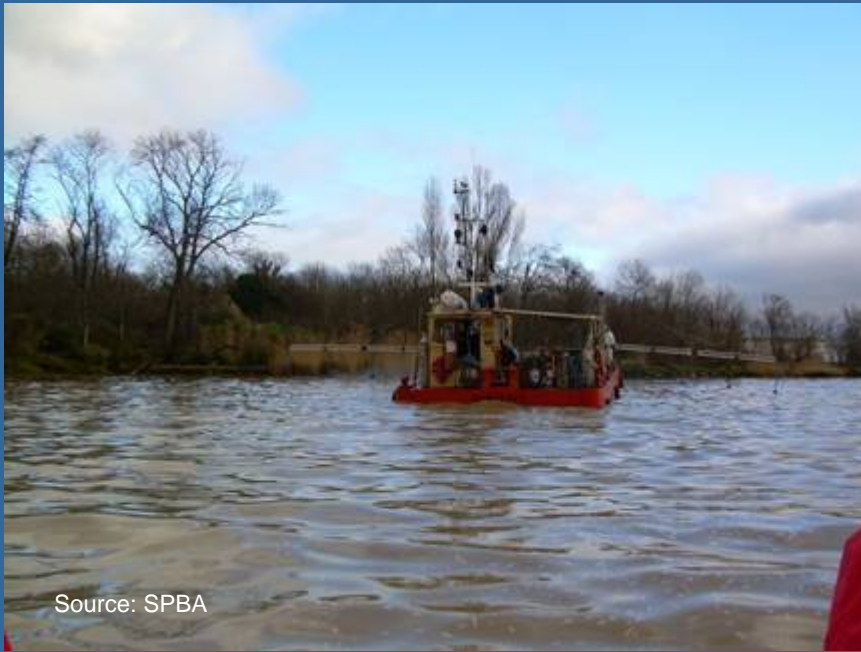
Application of dispersant by coastal pilots (12/01/2007) +  
intervention of the buoy tender the Gascogne on 13/01/2007

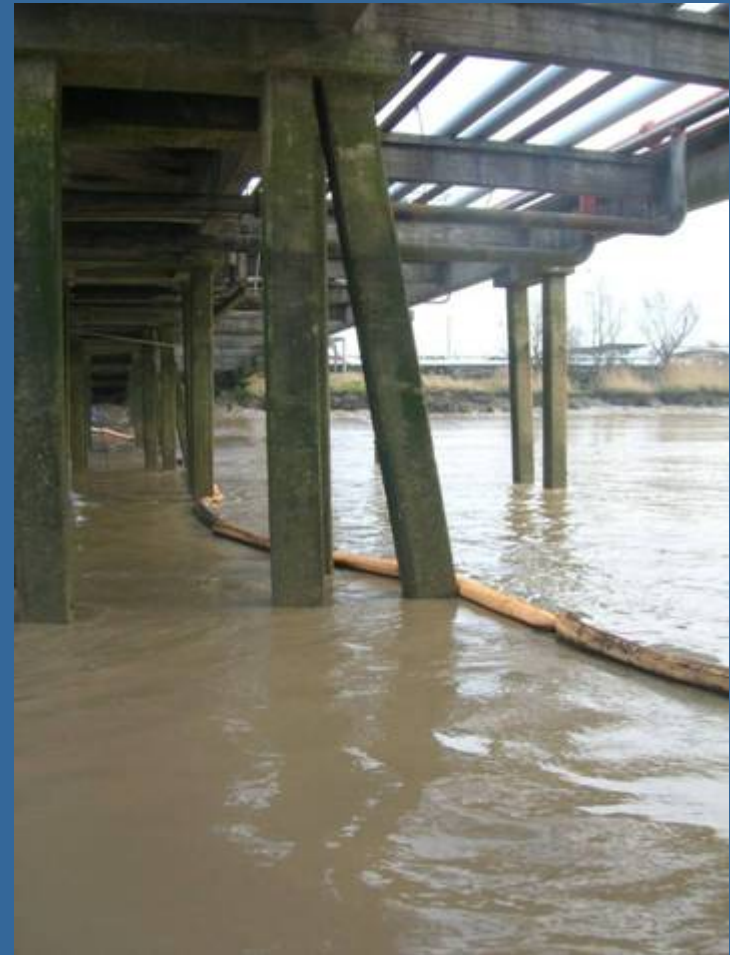
Sorbent boom deployment under wharfs to catch  
floating pollutant in both directions of the tidal current  
(began 14/01/2007)

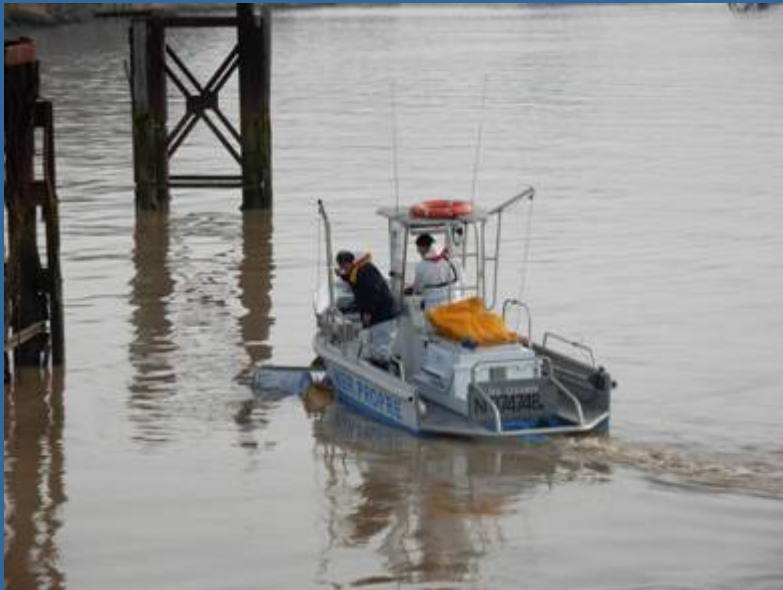
Dynamic then manual recovery  
of floating pollutant (began  
15/01/2007)

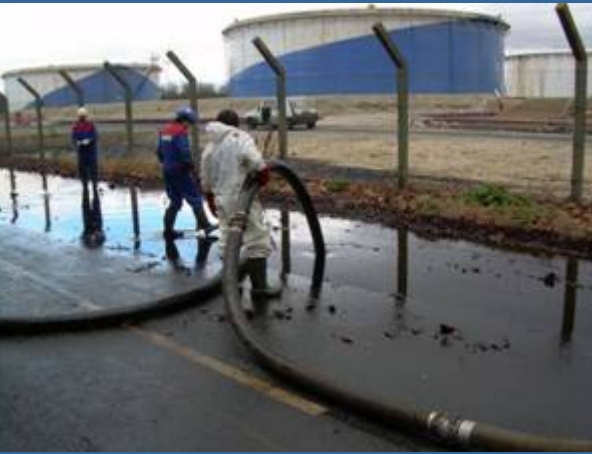
Pumping off accumulations of pollutant by the banks (began 12/01/2007)

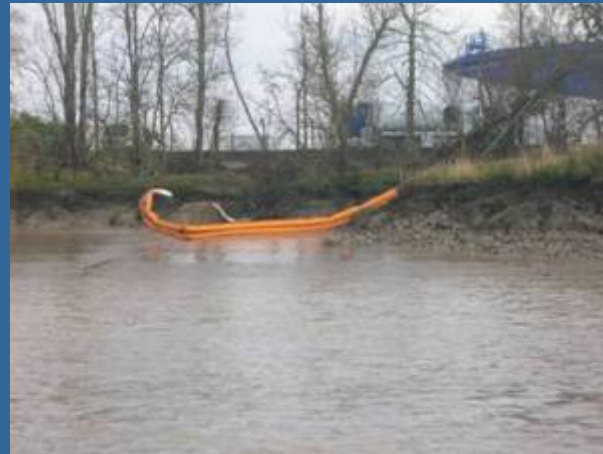
Installation of a shore-sealing boom in front of the largest source of run-off (15/01/2007)

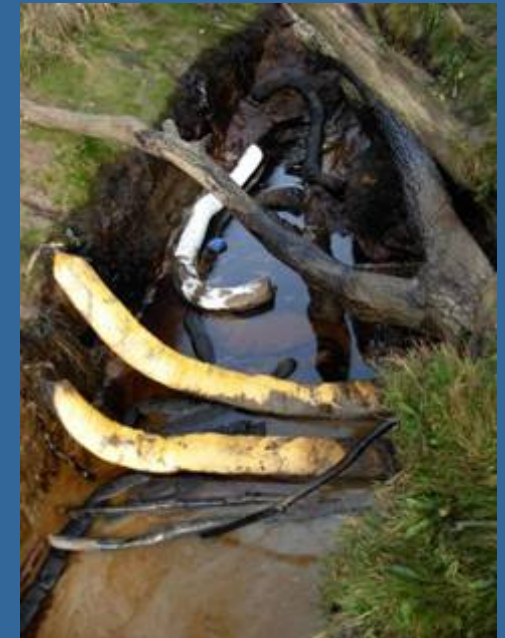
Sorbent boom deployment in front of pollutant run-off (began 14/01/2007)

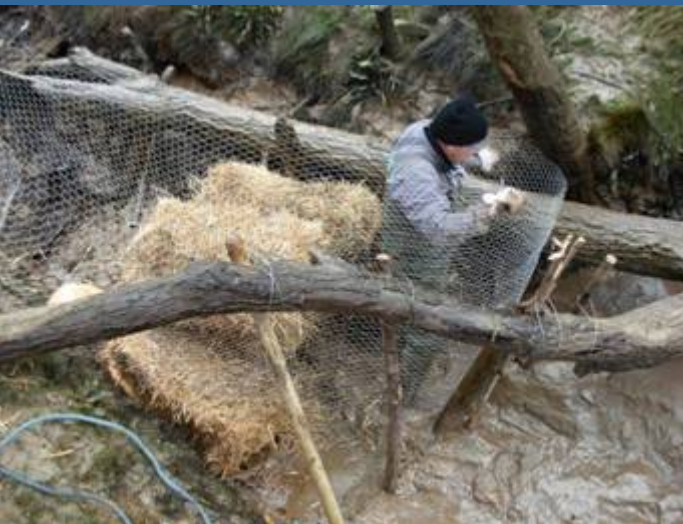
Implementation of makeshift booms (straw + wire + geotextile) to reinforce the system (began 18/01/2007)

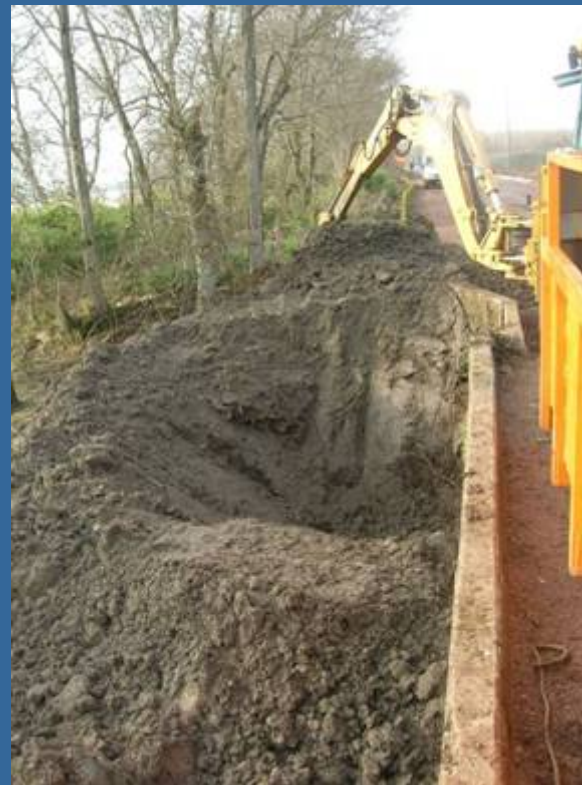
Creation of cofferdams to contain and recover the pollutant on the bank in areas where pollutant is released into the river (began 19/01/2007)

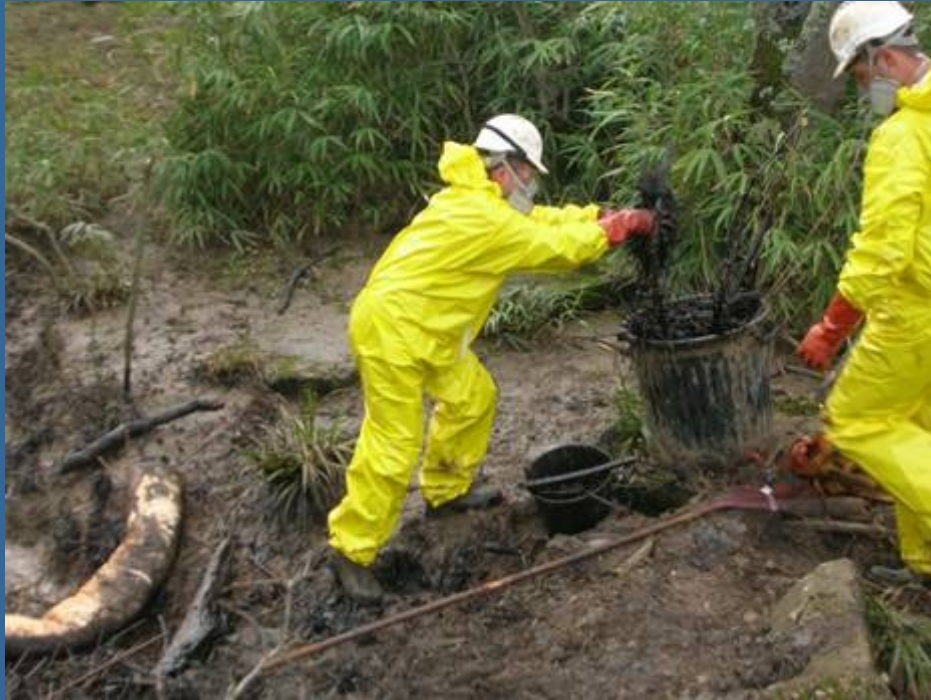
Manual collection of solid waste to prevent it from being remobilised by the tide (began 20/01/2007)

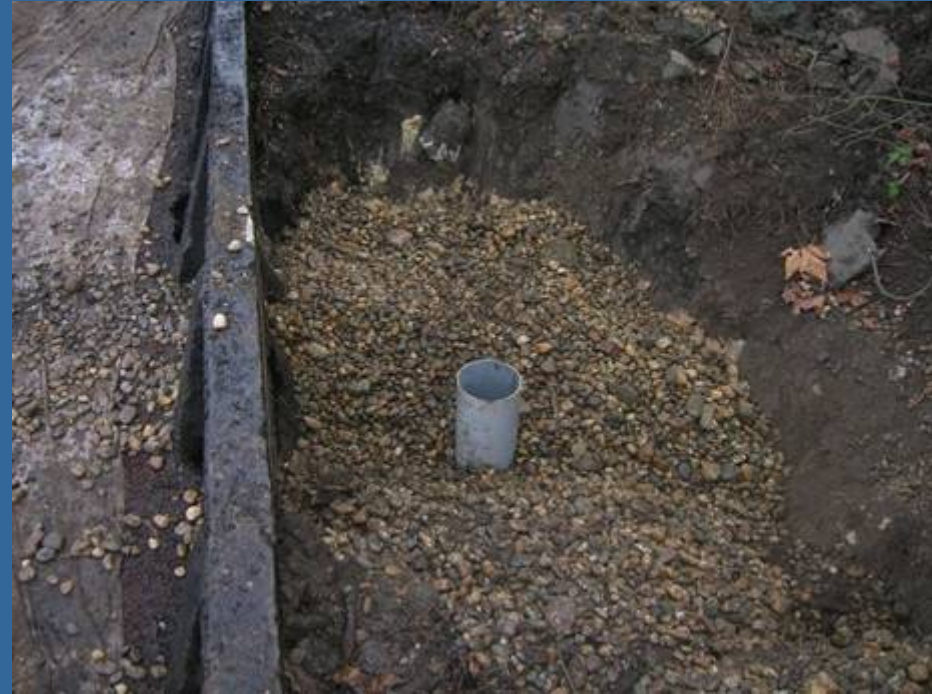
Creation of a vertical drain to conduct a spot test for pollutant soaked into the banks (began 20/01/2007)

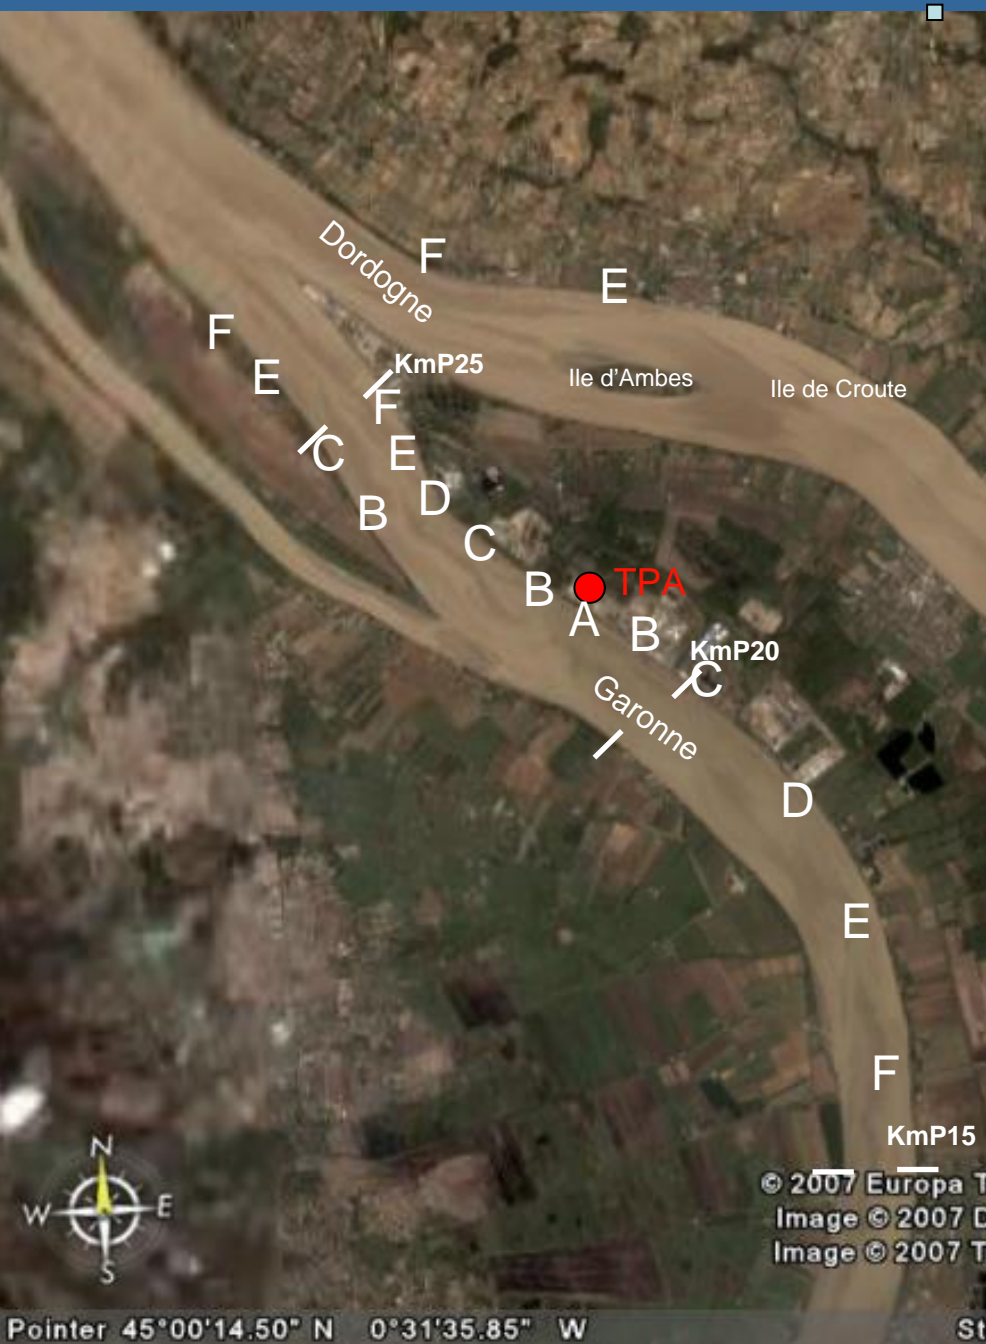
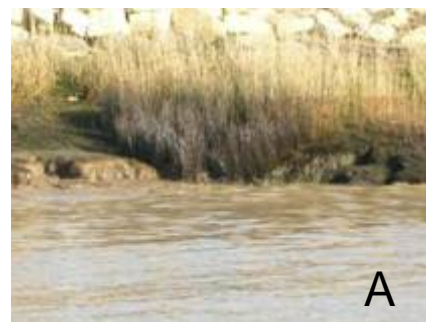
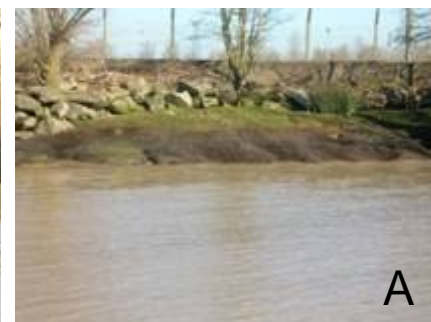
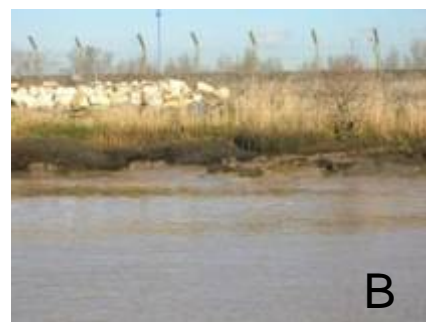
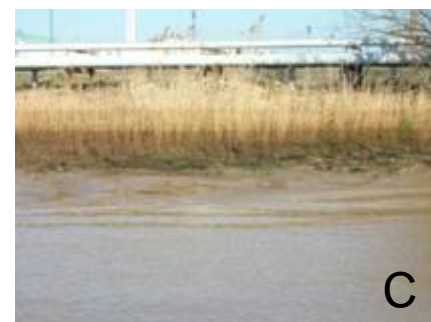
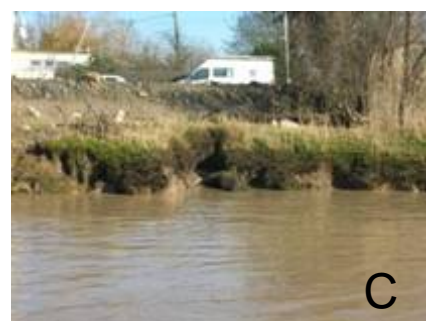
# MONITORING SELF-CLEANING: Nautical survey 13/01, 24/01, 01/02 and 06/03

40 km initially affected
-

30 km affected on 24/01 (yellow sections cleaned naturally)
-

12 km affected 01/02 on the Garonne / Dordogne not surveyed (orange sections cleaned naturally since 24/01)
-

10 km affected on 06/03 (red sections cleaned naturally since 01/02)

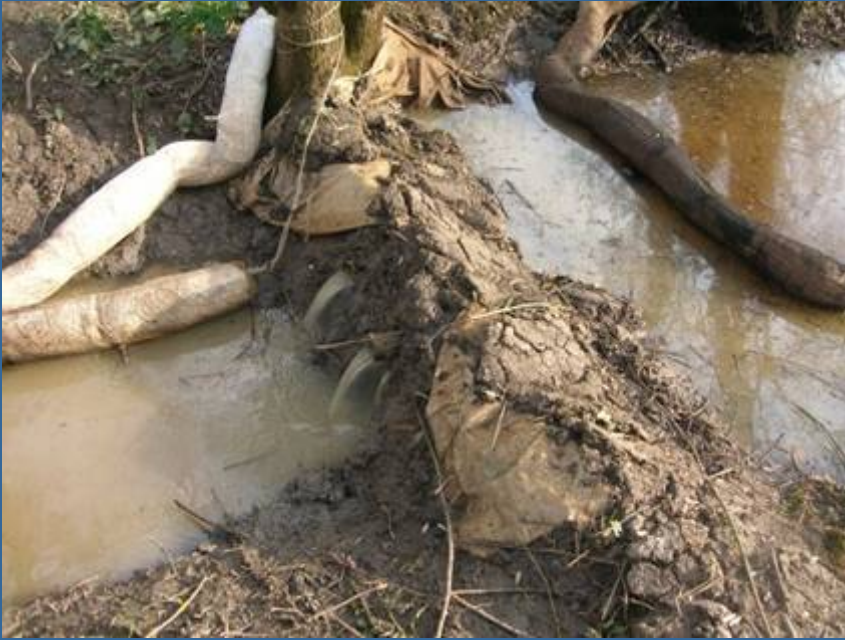
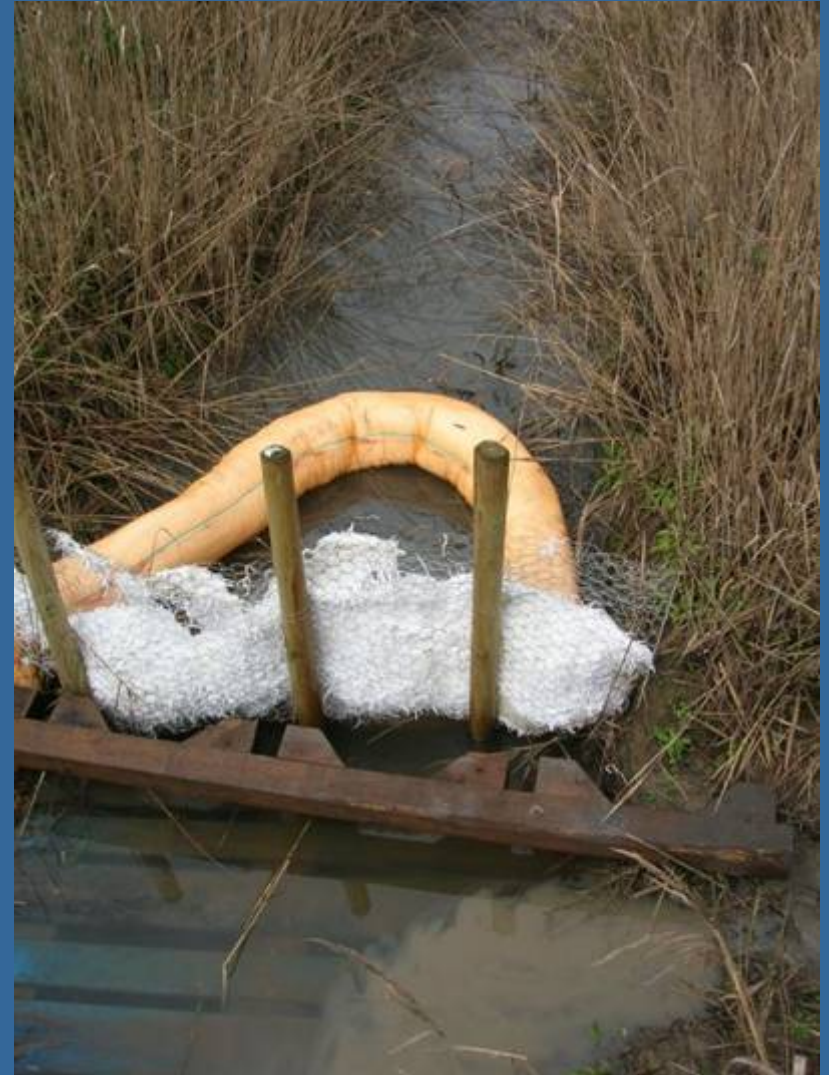
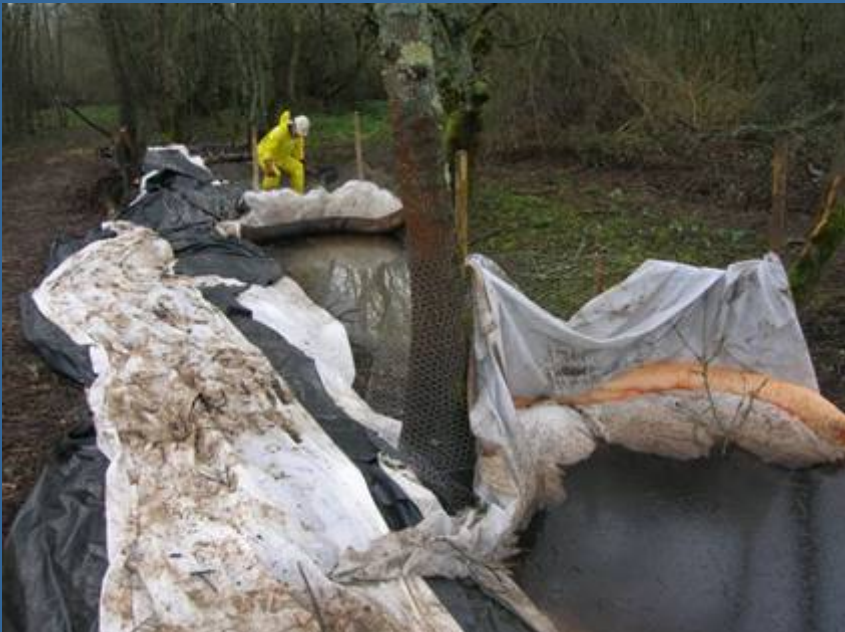
# STOPPING THE POLLUTION FROM SPREADING USING MAKESHIFT BOOMS

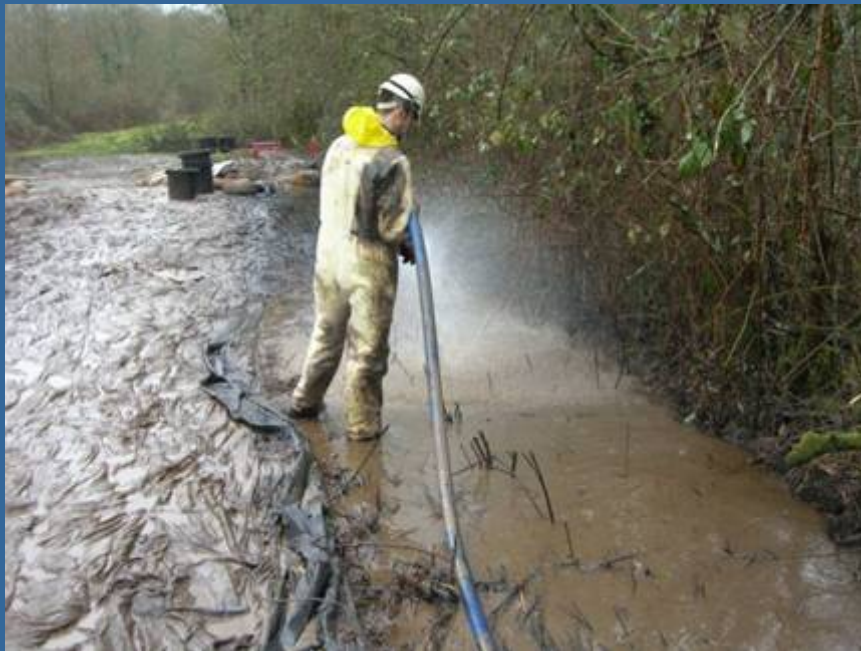
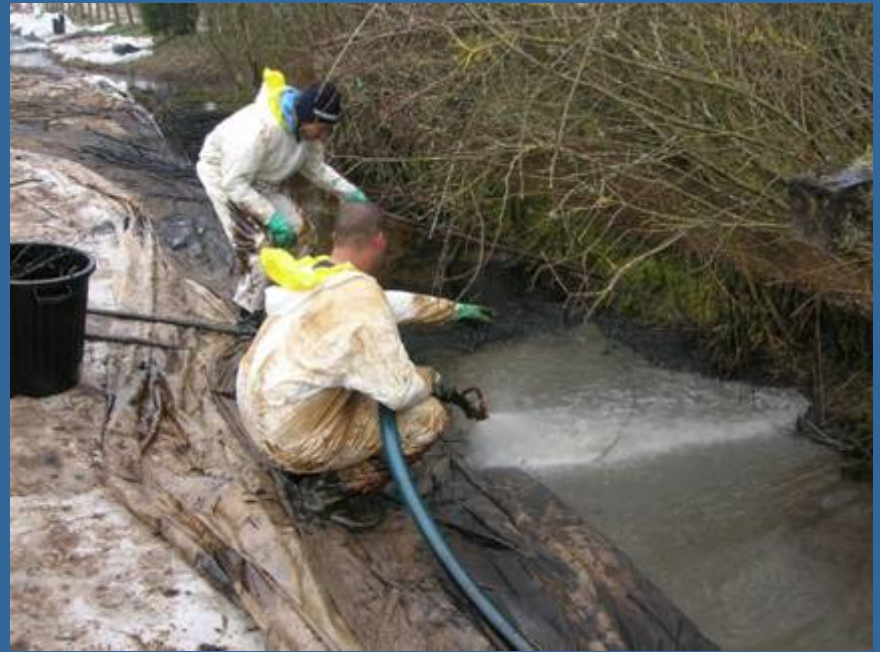
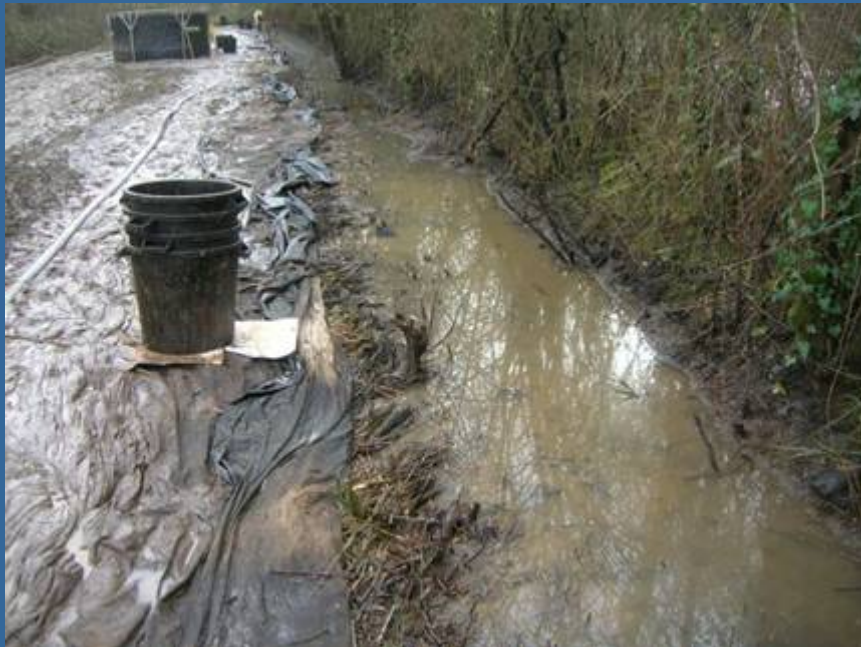
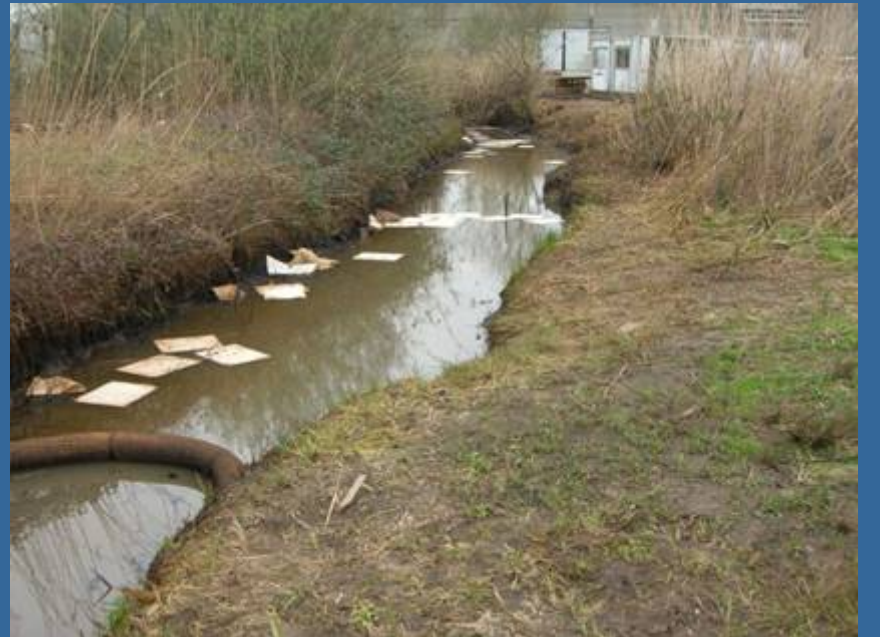
# SCRAPING AND RINSING BANKS, WITH USE OF SORBENTS
