THE PRESTIGE AND INTERNATIONAL CO-OPERATION

Response onshore and site restoration

Xoán Nóvoa Rodríguez

PARIS, 09-03-06

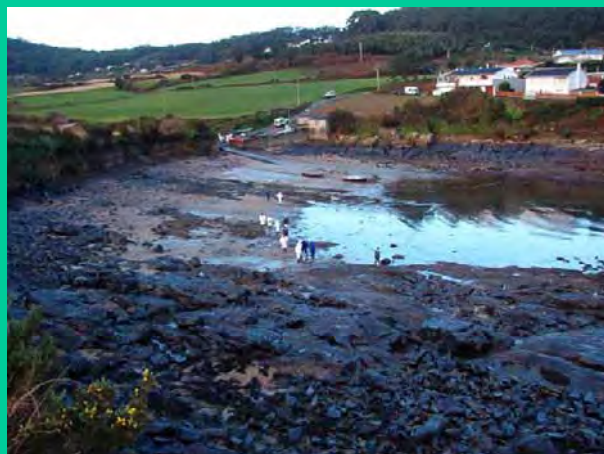
EXAMPLE 2: PORTOCHAS (ARTEIXO)

03-01-2003

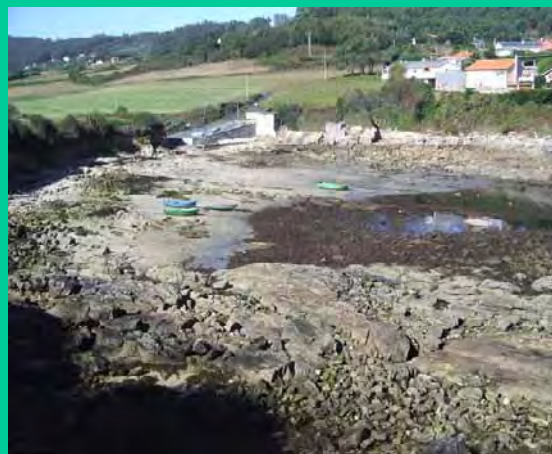
20-09-2005

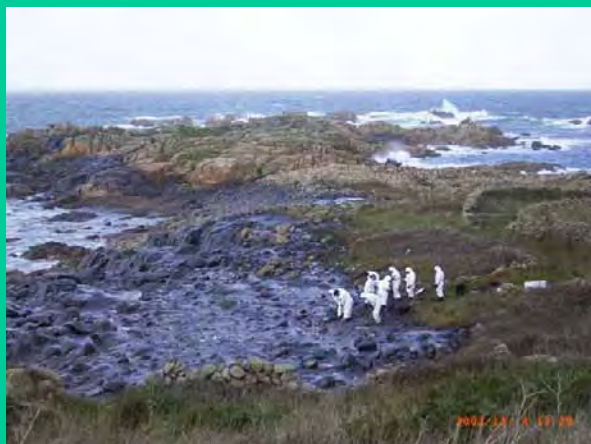
EXAMPLE 3: CARROFEITO (CAMARIÑAS)

04-12-2002

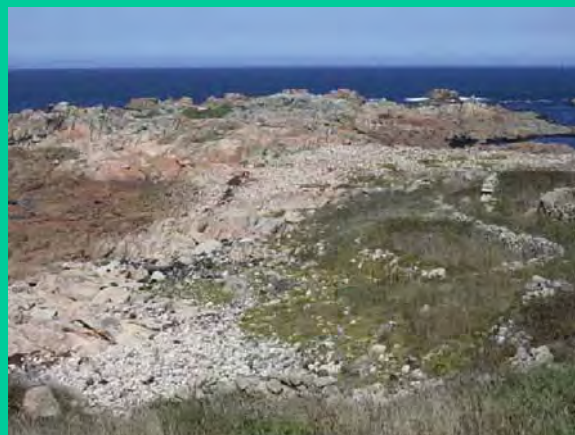
20-09-2005

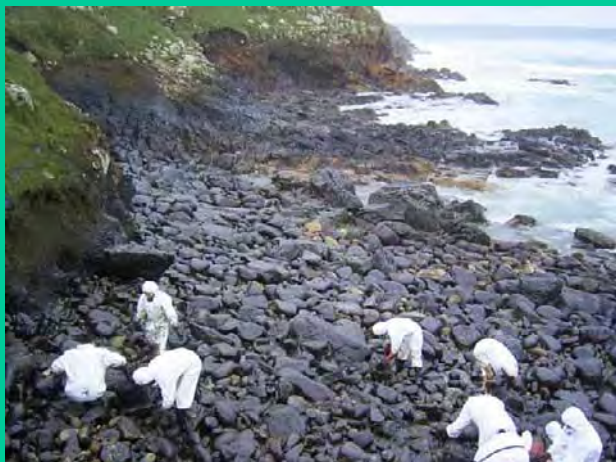
EXAMPLE 1 MÓRDOMO (LAXE)

1.- Difficult access area. Manual
clean-up and moving of boulders
06-12-2002

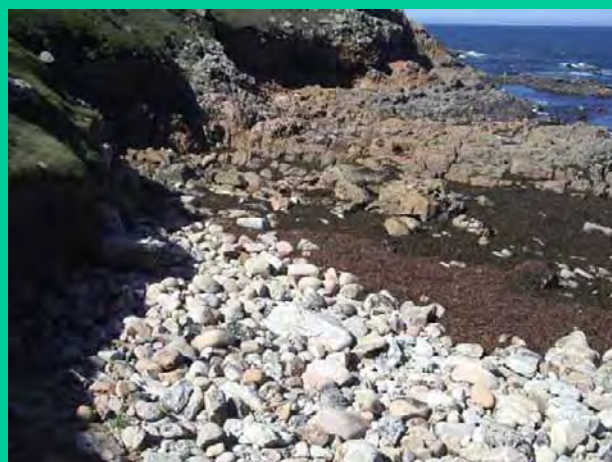
2.- After action of wave energy
20-09-2005

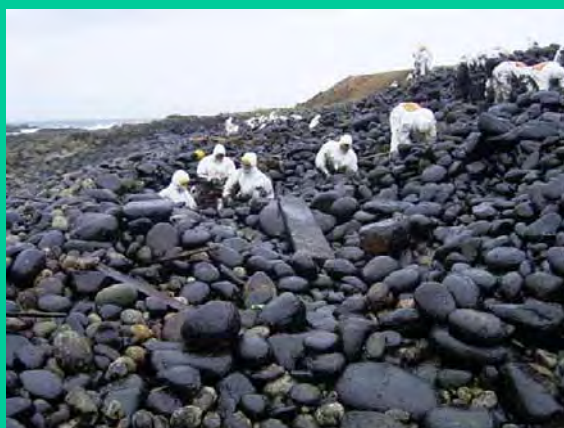
EXEMPLE 2 COENDAS (CAMARIÑAS)

1.- Manual clean-up and moving of boulders
to the surf zone using heavy machinery
06-12-2002

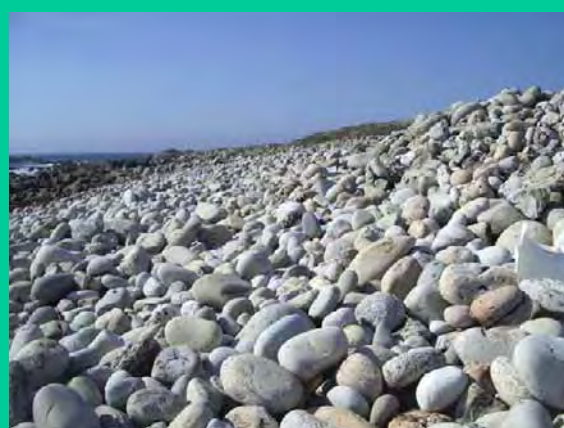
2.- Natural rebuilding of the beach slope
after action of wave energy
20-09-2005

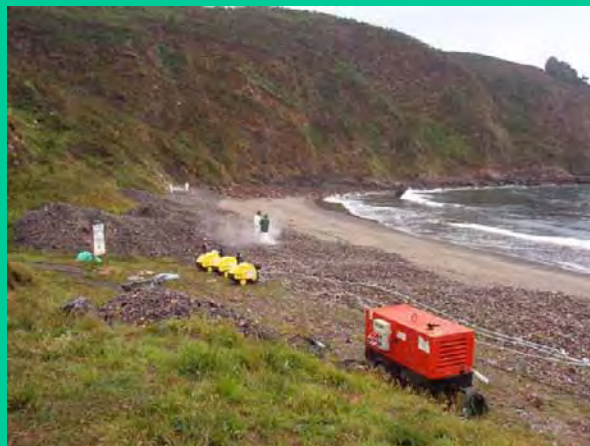
EXAMPLE 5 BAHINAS (CASTRILLÓN)

1.- Pebble beach soaked with fuel

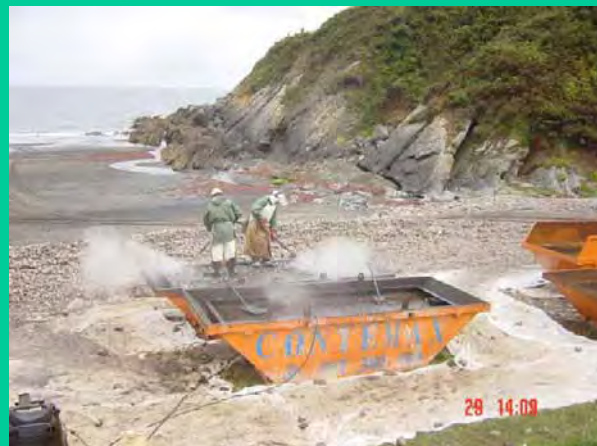
2.- After a few weeks' immersion in water
in a skip, high pressure clean-up of the
softened oil

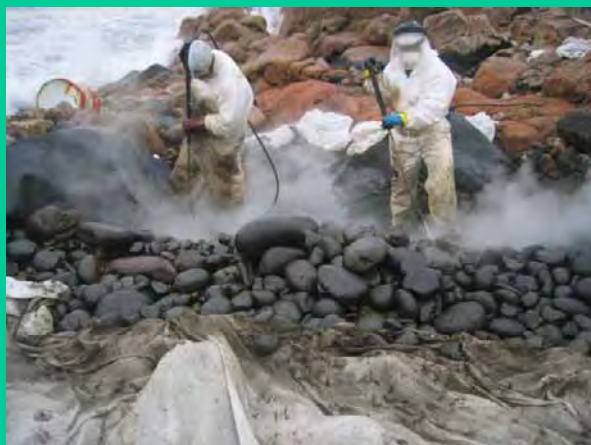
EXAMPLE 6 REIRA (CAMARIÑAS)

5.- After a few weeks, pressure clean-up of softened fuel on the surface of pebbles

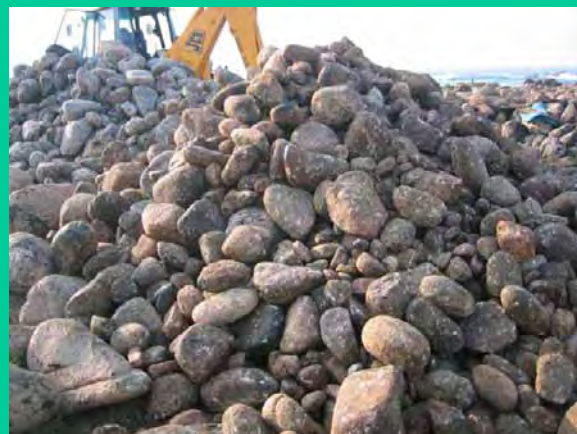
6.- Cleaned pebbles are put back into place and the beach slope rebuilt

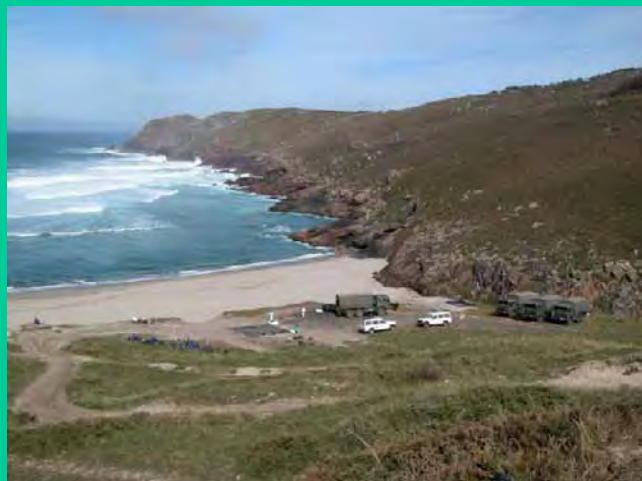
EXAMPLE 3: ARNELA (FISTERRA)

1.-Clean-up works damaging sand dunes
and building of an access road

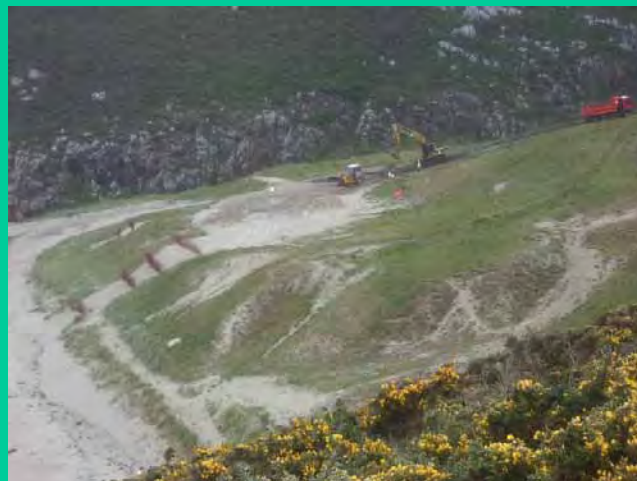
2.-Restoration of sand dunes and
elimination of the provisional access road
