**CENTRE OF DOCUMENTATION, RESEARCH AND EXPERIMENTATION ON  
ACCIDENTAL WATER POLLUTION**

**Inland Waters Technical Newsletter n°18**

**LTEI 2012 - 1**

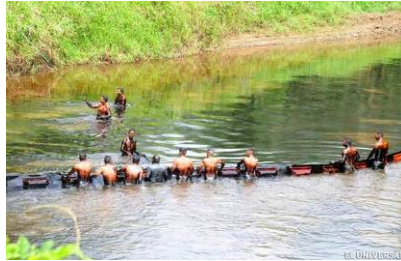
Volunteers deploying a permanent boom (source: El Universal)

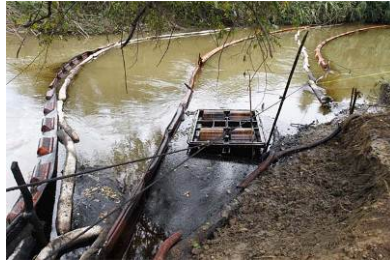
Containment (floating and sorbent booms) and recovery (oleophilic drum skimmer) (source: Agencia Venezolana de Noticias)

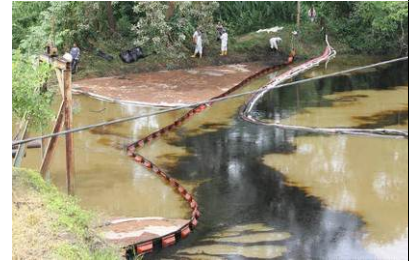
Containment and spreading of loose sorbent (peat) prior to manual recovery (source: El Universal)

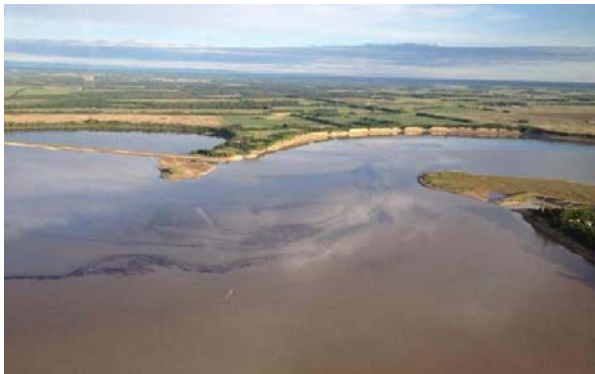
*Aerial view of the spill the day after the release  
(source: Plains Midstream Canada)*

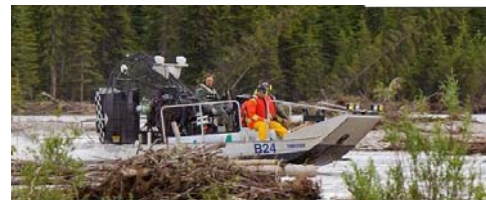
*Surveying the banks from hovercraft (source:  
Plains Midstream)*

The river in spate (melting snow and heavy rainfall) was liable to cause the oil to spread rapidly, and the inaccessibility of certain banks required surveys to be conducted from craft with low draught (flat-bottomed boats or hovercraft).

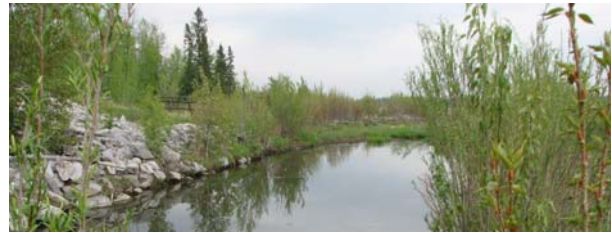
2013: vegetation regrowth in inspected segments  
(source: Plains Midstream)

A control visit to cleaned sites was conducted at the end of summer 2012 and a few additional clean-up actions were recommended, to be finalised in October, i.e. before operations were suspended over the winter. The following spring and summer, inspection of the affected sites (conducted jointly by the official agencies and PMC) concluded that no significant pollution remained and vegetation regrowth was satisfactory: the clean-up sites were therefore shut down.

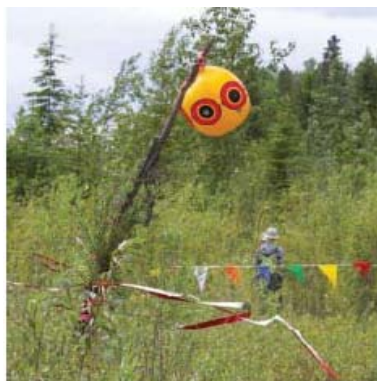
Wildlife deterrents (source: Plains Midstream)

To help mitigate impact, wildlife deterrent devices (flags, scarecrows...) were installed in oiled areas during response activities.

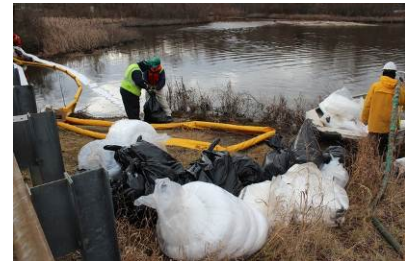
*Containment and recovery of diesel fuel (source: gloucestertownship.patch.com)*

A specialised firm, Clean Venture LLC, was contracted to implement the response, which included containing the diesel – spread widely across the water surface – using containment booms together with sorbent booms. The fuel was partly recovered manually, using sorbents, but mainly pumped using vacuum trucks.

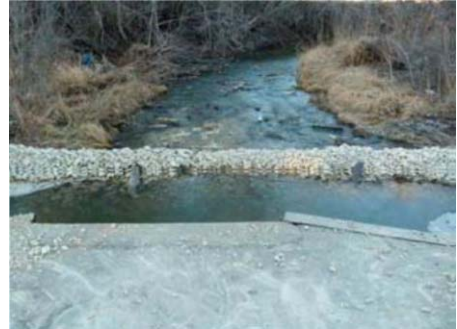
*A limestone filter dam across Lime Creek downstream of the spill point. (source: KDHE)*

The pollutant remaining in the drainage ditch was pumped out, while in the creek the focus was on neutralising the water and containing the corrosive and sinking substance (density of 1.5). Given these characteristics, 3 successive filter dams, made of limestone aggregate (to neutralise the acid in the water and restrict its spread), were built downstream of the spill.

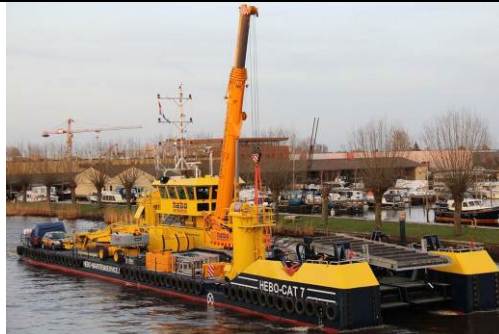
*View of the spill response vessel Hebo-Cat 7 (source: Hebo Maritiemservice)*

In 2012, the oil removal vessel *Hebo-Cat 7* was delivered to the service provider *Hebo Maritiemservice*, whose activities include spill response in the ports of Rotterdam and Dordrecht (Netherlands). This specialised vessel is over 50 metres long and 12 metres wide and is built to Lloyd's Register standards (Class: +100A1 [+] LMC UMS Oil Recovery vessel).

Designed to operate in inland waters, and more specifically in the Rhine-Meuse Delta, it has a high storage capacity of 199 m<sup>3</sup> fluid waste and 60 m<sup>3</sup> (4 x 15 m<sup>3</sup>) of solid waste. The bow of the vessel is fitted with a conveyor belt to recover floating waste.

In terms of oil recovery, the *Hebo-Cat 7* is equipped with a detachable rigid sweeping arm (12 m; built by Koseq) fitted with a pump with a nominal flow rate of 300 m<sup>3</sup>.h<sup>-1</sup>.

Finally, the vessel is equipped with a Consilium Selesmar (X-band radar) oil detection system and a Consilium Salwico system for gas detection in the atmosphere.
