**CENTRE OF DOCUMENTATION, RESEARCH AND EXPERIMENTATION ON  
ACCIDENTAL WATER POLLUTION**

**Inland Waters Technical Newsletter n°16**

**LTEI 2011 - 1**

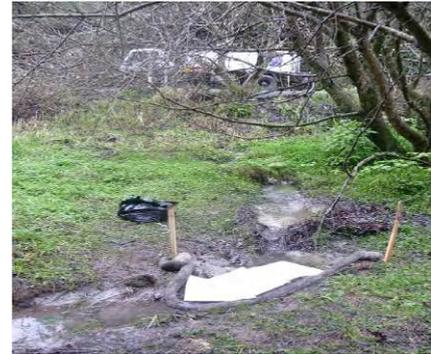
*Laying sorbents at the incident site  
(source: Waikato Regional Council)*

Two RRT teams conducted a survey of the incident site the morning after the spill and noted that almost all the contents of the tanker had already reached Awakino River, making it difficult to implement control measures at the source. The teams (i) recommended a certain number of clean-up techniques (excavation, pumping, laying sorbents) around the overturned tanker (resulting in the recovery of 3 m<sup>3</sup> of oil) and (ii) laid sorbent booms along the banks to contain any further leaching.

In the river, the remaining pollution appeared in the form of floating sheen and oiled vegetation on the banks within 3 km. Recovery operations on the water were initiated two days after the spill at the estuary outlet by deploying booms (floating and shore-sealing) and by pumping using vacuum trucks positioned on the slipways. They were carried out sporadically, due to the remobilisation by the tides of oil trapped in vegetation on the banks. Vacuum trucks took turns to conduct pumping on site, with in situ release of settled water.

The day after the spill, it was decided that the containment systems on the banks would be reinforced, with a view to remobilising accumulations of oil by (i) mechanical mixing (using propellers) in calm, shallow waters and (ii) low pressure rinsing of the oiled vegetation (using fire hoses from boats).

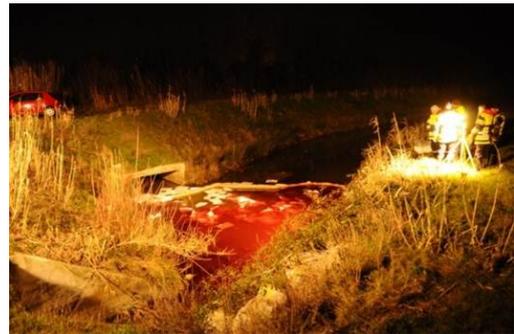
*Containment using sorbents on Canon Canal  
(source: SDIS13)*

Joined by back-up staff from response units specialised in technological risks, the firemen contained the oil on the ground (using straw) and on the water.

Operations on the water aimed to deploy sorbent booms and pads in the canal, both up and downstream of the spill area. Contained oil was recovered by a private contractor equipped with an ADR/ATEX sewer cleaning truck together with pumping and transport equipment suitable for hazardous substances. On land, the oil remaining in a second tank was removed before uprighting the truck and finalising rescue and response operations.

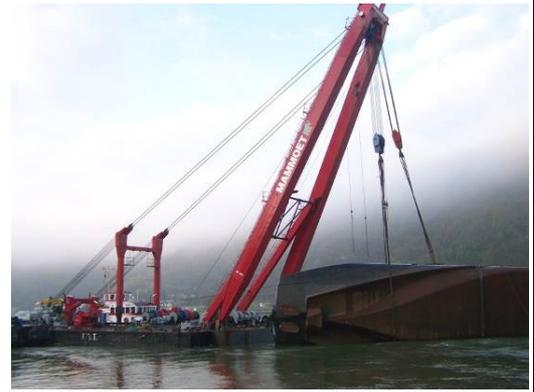
*Stabilising the barge Waldhof using sheerlegs during salvage operations (source: Mammoet Salvage)*

Steel cables were passed under the wreck and held by 2 sheerlegs (*Amsterdam* and *Grizzly*), stabilising the *Waldhof*. The contents of the 7 tanks could then be analysed by piercing several holes in the hull. This examination resulted in the conclusion that (i) part of the cargo (estimated at around 900 tonnes) had leaked out, due to the barge's position and (ii) hydrogen had formed, due to corrosive action of the acid on the wreck's structure. Potentially flammable when mixed with air, this release of gas immediately required the explosion risk to be taken into consideration during operations.

After flushing the tanks with nitrogen to displace the hydrogen, followed by mixing of the acid to ensure a uniform concentration (the ingress of water having caused layers of diluted and concentrated acid to form), around 570 tonnes of the cargo were unloaded to a storage tank on the pontoon. Due to the hull's deformation and risk of rupture, the whole of the cargo was not unloaded and, with the authorities' agreement and under their supervision, the remaining 800 tonnes of acid were released in a controlled manner, at a rate which allowed gradual dilution to minimise the risk of environment impact (continuous monitoring of acidity levels in the waters of the Rhine was conducted around the wreck throughout the process).
