Inland Waters Technical Newsletter n°17

LTEI 2011 - 2

Crude oil leak from a pipeline into Yellowstone River (Silvertip Pipeline, Montana, US)

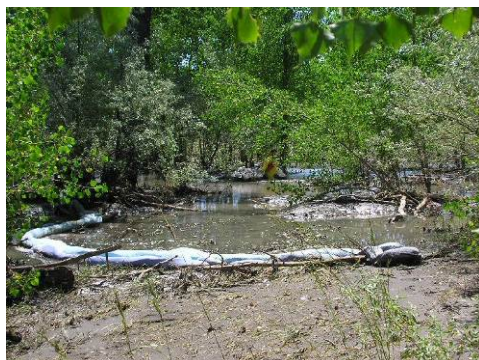
Polluted site (division A): difficult access and sensitivity to response (low load-bearing capacity of ground + vegetation) (Source: EPA)

Implementation of the response was rapidly confronted with difficulties related to the inaccessibility and sensitivity of many oiled areas which, in the meanders and islets of the Yellowstone River (the longest free-flowing river in the United States), were characterised by heavily vegetated banks and a low load-bearing capacity.

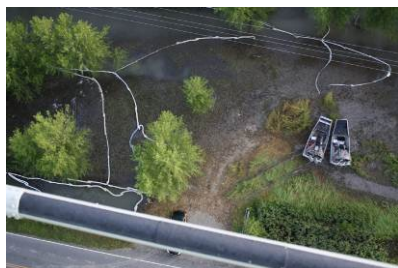
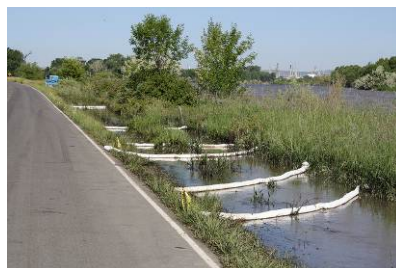
Containment using sorbent booms along flooded banks (left) and in trenches along the south bank (right) (Source: USFWS)

Nevertheless, daily aerial surveys by helicopter helped to locate the main accumulations of free oil, general found in calm areas with low hydrodynamics, along banks or in adjacent trenches.

This floating pollution was contained using sorbent booms, deployed from light, shallow-draught

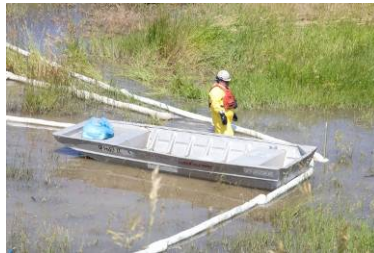
*Maintaining sorbent booms
using a jonboat (Source: USFWS)*

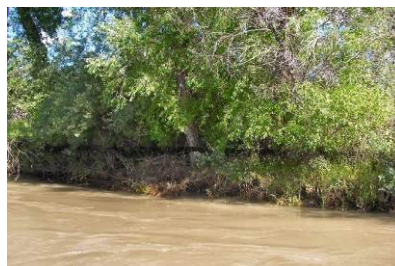
*Lightly oiled vegetation
(trunks/stalks at the flood level)
in division A (Source: EPA)*

- in the case of heavily oiled plants and shrubs, clean-up was carried out using sorbent pads or by scything and collecting the most affected vegetation,
- in the case of dead vegetation and mobile debris, removal was prioritised, except for very large elements (e.g. thick trunks). These elements were cleaned by low pressure rinsing, manual scraping and/or using sorbents, and left on site,
- in the case of levels of oiling below the standards requiring response actions, the vegetation was left to be self-cleaned (as with residual pollution).

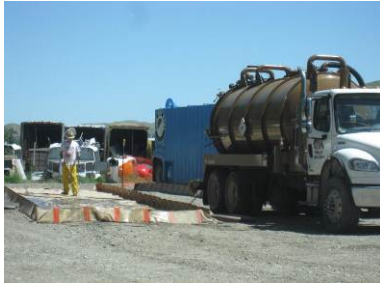
*Equipment decontamination area
(Source: EPA)*

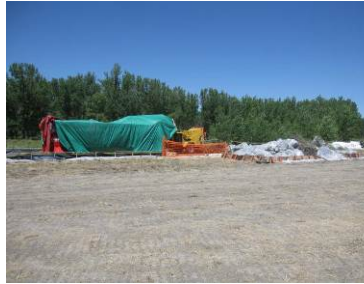
*Temporary storage of solid
waste (Source: EPA).*

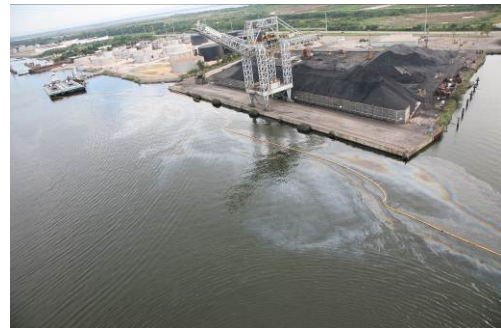
Site overview (Source: USCG)

A safety zone was set up on each side of the spill point (and maintained for 1 week), and the area where response operations were being carried out on the water (from McDuffie Coal Terminal to Cochran Bridge) was closed to traffic on the first day of the response. The response involved containing the oil (with floating and sorbent booms) and pumping it using vacuum trucks and skimmers.

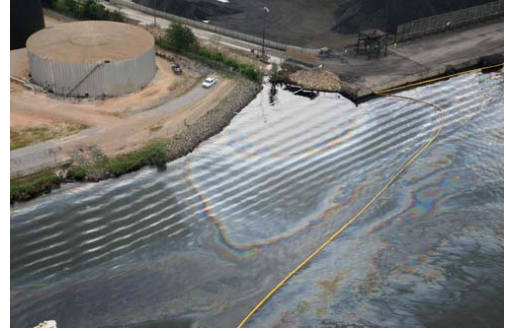
Containing the fuel oil on the water in front of the spill point using floating and sorbent booms (Source: USCG)

By 7th September, almost 10 km of booms had been deployed, as well as 13 drum skimmers, 1 barge fitted with a Marco Filterbelt system, and no less than 15 vacuum trucks and 68 vessels. On 22nd September, the USCG announced that a total of 600 m³ of an oil/water mixture had been recovered.

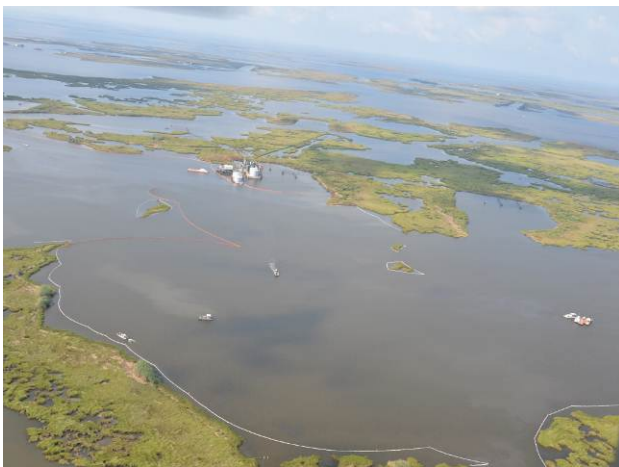
15th September 2011: Containing the oil and protecting the banks with booms (Source: USCG)

The emergency measures consisted, for Wild Well Control Inc., contracted by the owner, of plugging the leaks (3 in total, including the 2 initially discovered) and rinsing the leaking pipes, before securing the 10 ageing wells associated with the facility. Recovery on the water involved a total of around 40 USCG staff and 80 responders from specialised contractors (in particular OMI Environmental Solutions Inc.). Almost 4,000 metres of boom – floating and sorbent – were deployed on the water, as well as a few skimmers and no less than 7 oil spill response vessels.

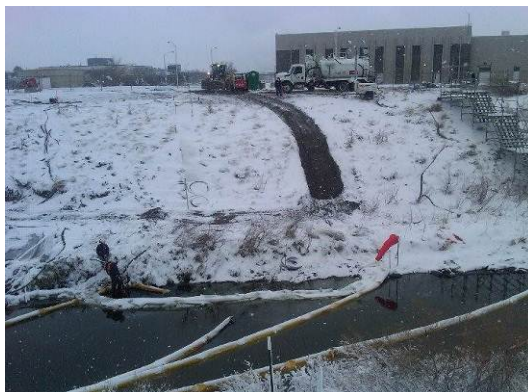
Containment, at the edge of the bank, of gasoline seepage with an earthen dam and booms (Source: US EPA)

At the spill point on the bank, an earthen dam (reinforced with sand bags) was built as an emergency measure and successive rows of floating and sorbent booms were also deployed on the water.

The accumulations of gasoline contained were pumped using vacuum trucks, mainly from within the earthen dam at the bank edge. This set-up proved to be very effective for capturing seepage of fluid pollutant that had infiltrated into the ground. Eight days after the incident was reported, the volume of gasoline recovered was estimated at more than 13 m³.

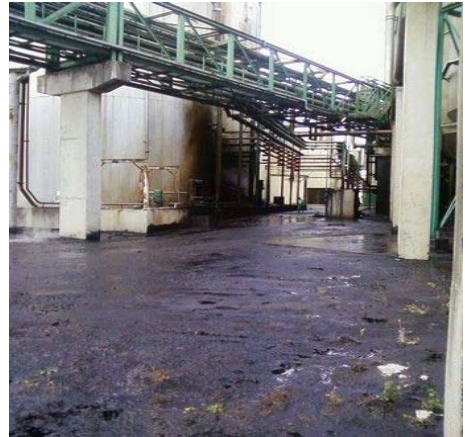
State of the site following the black liquor spill (Source: Synergi)

On the morning of 8th July 2011, a black liquor storage tank with a capacity of 600 m³ ruptured at a paper mill in Haute-Vienne, France. The tank, filled with 500 m³ at the time of the spill, released its contents into the retention tank. A wave effect caused the retention tank to overflow and part of the content escaped through the unprotected rainwater drainage network into the Vienne River. The operator, after activating its contingency plan, deflected the remains of the spill into the plant's aerated treatment lagoon. The French authorities (DREAL) estimated that 100 to 120 m³ had been retained by the retention tank, around 300 m³ deflected into the lagoon and around 80 to 100 m³ released into the Vienne River via the rainwater drainage network. Inspection of the tank by the French authorities (DREAL) revealed progressive wear by corrosion/erosion of the tank's cone double bottom, with undetectable infiltration between the bottom of the outer tank and its double bottom, thus accelerating corrosion.

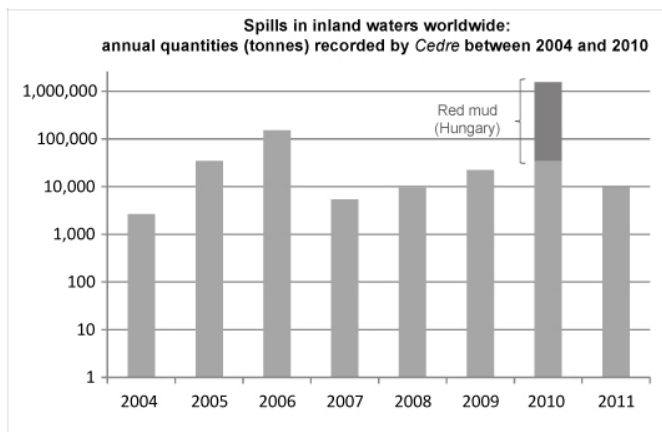
Figure 1

This value is lower than those obtained by the same approach for 2009 and 2010 (Figure 1).

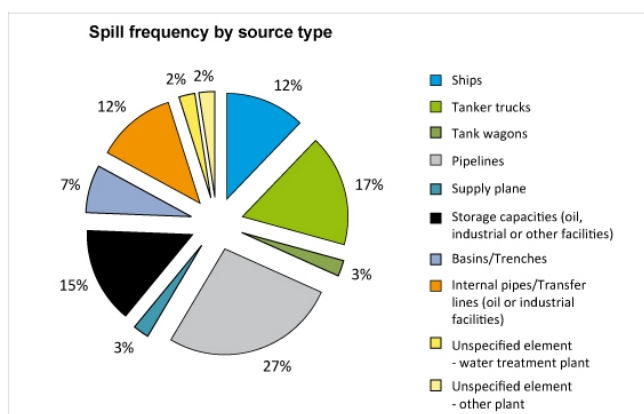
Figure 2

With the exception of **basins and trenches** (various facilities: refineries, mines, farming facilities), involved in 7 % of cases, the other sources identified each concerned less than 5 % of the spills recorded in 2011 (Fig. 2).

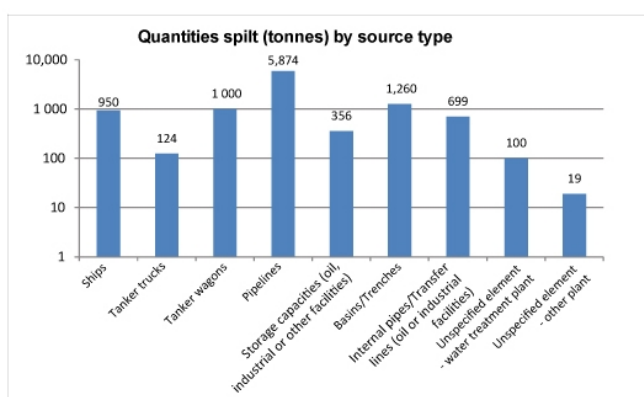
Figure 3

In terms of quantities, and in line with the observations in previous years, we note the major share (around 53 %) of **pipelines** in the 2011 total (Figure 3). The most significant spills (for which sufficient information was available) from pipelines occurred in North America, in particular in April, June and July in Canada⁵, in April⁶ and July (Cf. above, LTEI n°17) in the United States, and in December in Mexico⁷.

The other main contributors to the cumulated total were **basins and trenches** at various facilities – in this case oil, mining and farming facilities – which represented 12 % of the total volume (Fig. 3).

Then came **tank wagons** and **ships**, at a similar level with around 10 % and 9 % respectively of the total volume for 2011 (Fig. 3). With relatively low frequency in 2011, these mainly consisted of two contributing events: the derailment of a train carrying copper concentrate, in December in Australia (Cf. above, LTEI n°17) and the capsizing of the chemical barge *Waldhof*, carrying 2,400 tonnes of sulphuric acid, on the Rhine in January (Cf. LTEI n°16⁸).

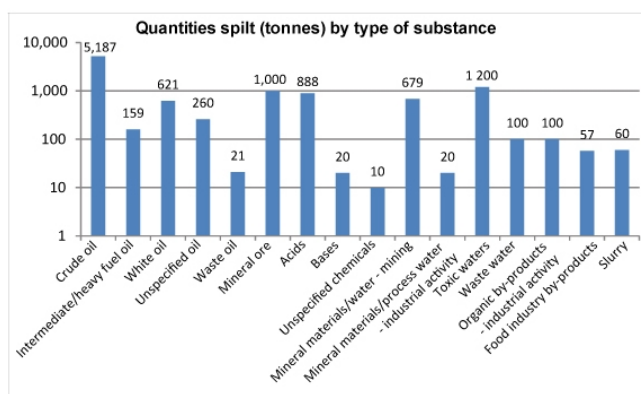
Figure 4

With over 5,000 tonnes, they are also responsible for half of the volume spilt in 2011 (Figure 4), due to 8 incidents, the largest of which (> 1,000 tonnes) was unquestionably the Rainbow Pipeline spill in April (Canada, Cf. LTEI n°16), responsible for over 80 % of the crude oil total in 2011.
