**CENTRE OF DOCUMENTATION, RESEARCH AND EXPERIMENTATION ON  
ACCIDENTAL WATER POLLUTION**

**Sea & Shore Technical Newsletter n°34**

**2011-2**

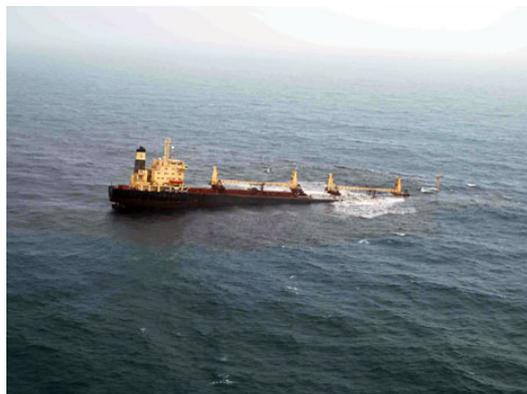
*Aerial view of fuel leaks from the sinking Rak  
(Source: Indian Navy)*

The ship was transporting 60,000 tonnes of coal from Indonesia to the State of Gujarat, and its bunkers contained 290 tonnes of bunker fuel and 50 tonnes of diesel. This fuel began to leak out on 6th August due to the influx of water into the vessel.

The initial leak rate was estimated at 1.5 to 2 tonnes/hour according to the Indian Coast Guard (ICG), which sent its equipment for survey and response at sea on site, including the spill response vessel *Samudra Prahari*. The main strategy considered was chemical dispersion, but lightering and refloating operations were deemed a priority despite difficult sea and weather conditions (monsoon season).

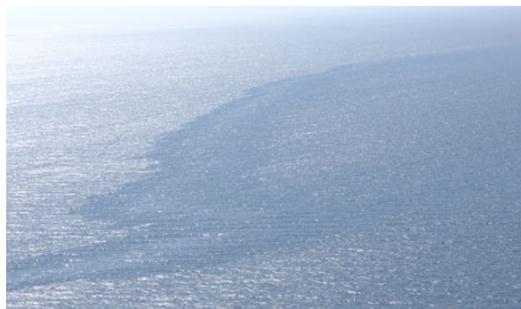
15th August: Surface sheen near the *Gannet Alpha* platform (Source: Marine Scotland)

On 10th August 2011, over 180 km off Aberdeen (Scotland), around 220 m<sup>3</sup> of crude oil was spilt into the North Sea due to a leak from a 95 m deep flowline running between wells E and F operated by the *Gannet Alpha* platform (on the Gannet offshore field operated by Shell).

One week after the incident, the leak rate of the oil remaining in the line was estimated at less than 150 l/day. Solid blocks (in total over 70 cement blocks) were placed on several sections of the depressurised (therefore floating) line, to hold it in position and to allow access to the valve (action conducted by ROVs and divers). This line was closed 9 days after the beginning of the leak, before the final stage of pumping the oil remaining in the line. After this date, no more oil was reported at the surface during aerial surveys by the MCA, with the exception of small amounts of sheen – which quickly disappeared – due to the disturbance of sediment on the bottom caused by operations to locate the leak point. An internal investigation was conducted to determine the technical causes of the leak.

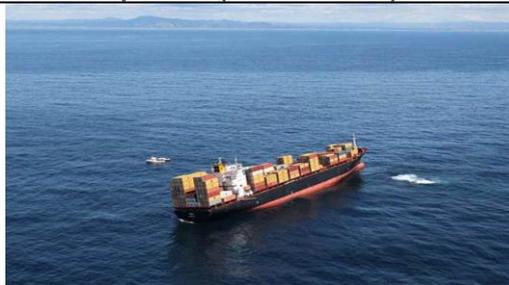
*The Rena with its bow section on Astrolabe Reef (Source: MNZ)*

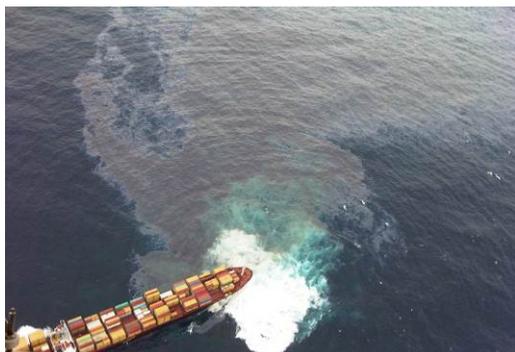
*6th October: leak of IFO 380 at sea from a cracked bunker tank (Source: MNZ)*

The structure, whose bow section was resting on the reef, was listing 10° to port and, due wave action, soon sprung leaks. A bunker tank cracked the day after the incident, causing a leak at sea of a volume later estimated at 350 m<sup>3</sup> of heavy fuel oil.

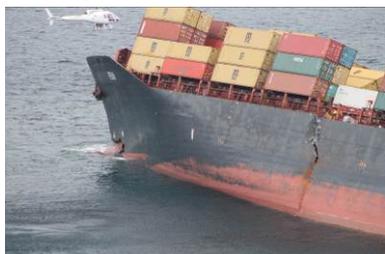
From 12th October: crack in the port side of the *Rena*

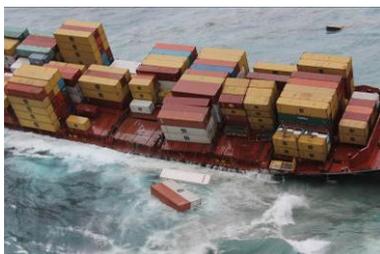
Severe list and loss of containers on 12th October

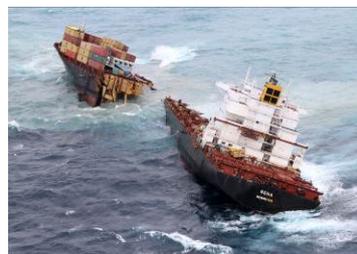
The *Rena* broken in two on 8th January 2012 (Photo source: MNZ)

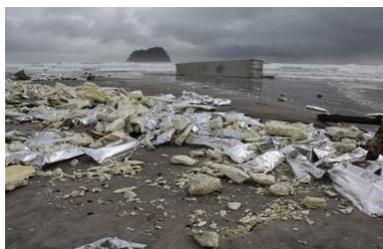
Grounding of bags of powdered milk (Source: MNZ)

Only 1 container of HNS (24 tonnes of alkyl sulfonic acid) fell overboard at the beginning of the incident, without affecting the environment due to its probable rapid dilution. The loss of containers generated all sorts of debris – cargo and burst (or dismantled) containers.

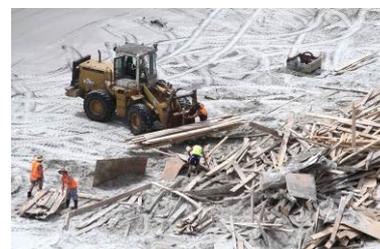
Timber on Matakana Island (Source: MNZ)

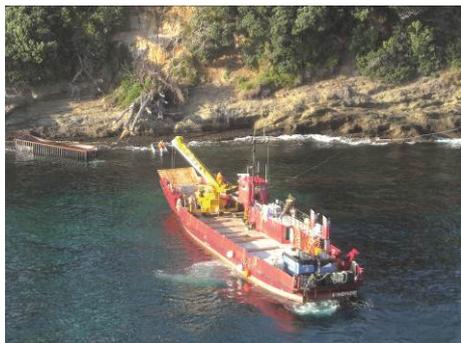
Recovery of containers by a barge  
(Source: Cedre)

When these containers washed up on the shore, they were visually inspected by experts contracted by the insurer to determine (i) the possible risks associated with their content and (ii) their treatment method (suitable option – decontamination, *ad hoc* waste treatment centres, recycling, etc.) in collaboration with local companies. After their recovery using variable equipment according to the accessibility of the coastal sites (road vehicles, helicopters, or even – on Motiti Island – barges), the containers were emptied and cleaned at an industrial site in Tauranga, for subsequent scrapping or reuse.

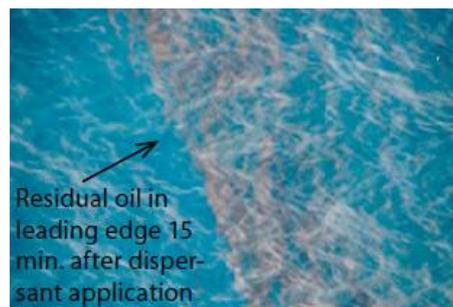
Visual observation of the persistence of the IFO 380 after spraying dispersant by helicopter (Source: MNZ)

After checking the environmental<sup>7</sup> and logistical prerequisites, initial assessments of the efficiency of spraying (by boat then by helicopter) Corexit 9527 and 9500 were performed in situ, on slicks 'chosen' on the basis of aerial surveys. This option was abandoned after 5 days of unsuccessful results due to the operational conditions (poor visibility and sea state), the form of the pollution (a lot of sheen or small fragmented slicks) and the fuel oil's characteristics (low dispersibility). In total, 3 m<sup>3</sup> of Corexit 9500 were sprayed, in a controversial context<sup>8</sup>.

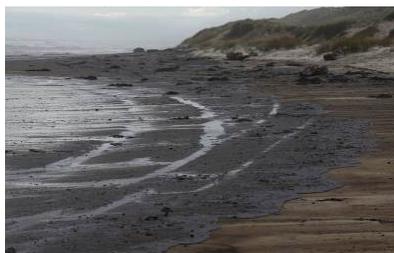
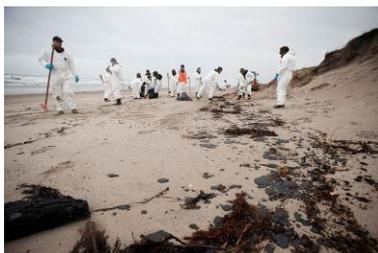
13th October 2011, Papamoa Beach: **Left:** trails of fuel oil on the beach (Source: MNZ); **Right:** manually collecting tarballs (Source: New Zealand Defence Force)

The fuel oil spilt at sea, in particular during the 6 days immediately following the incident, rapidly washed up on the shore (mainly at Tauranga), in the form of thin trails or tarballs (1 to 10 cm in diameter) weathered to varying degrees.

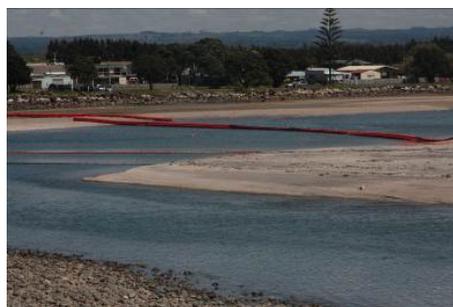
Protecting sites behind the dunes with containment booms (Source: Cedre)

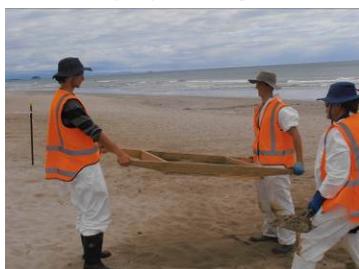
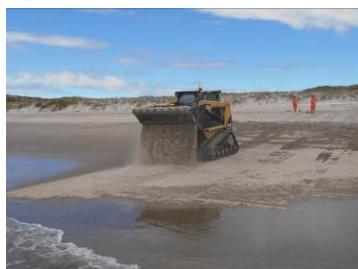
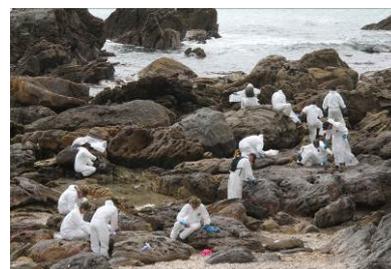
Final clean-up: volunteers fine-sifting the sand (**left**); moving sediment down to the surf zone for surfwashing (**middle**); manually scrubbing oil on rocks (**right**) (Source: MNZ).

On the beaches, the recovery of the remaining micro-tarballs, sometimes buried under the sand, locally required fine sand screening (sifters, possibly sand screening machines) or surfwashing operations (not requiring recovery by sorbent nets). On the rocks, scrubbing was completed where necessary by rinsing with moderate pressure hoses.

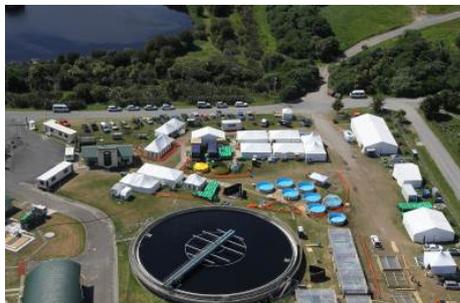
Installation of a temporary oiled wildlife response centre at Tauranga wastewater treatment plant (Source: MNZ)

In compliance with the National Contingency Plan (NCP), from the first days following the incident, the risk for these species resulted in the involvement of around a hundred staff specialised in the capture of and care for oiled wildlife: members of the National Oiled Wildlife Response Team referenced in the NCP, vets, ornithologists, etc. A temporary response centre, set up near Tauranga wastewater treatment plant, received just over 400 birds, including 345 Little Blue Penguins and 60 New Zealand Dotterels (i.e. 50 % of the population of the Bay of Plenty) captured preventively<sup>12</sup> then released for the most part between November and December (in 2012 the temporary on-site centre was demobilised and Massey University took over wildlife monitoring<sup>13</sup>).

- chemical dispersion, with the updating of recommendations on dispersant use and dispersant stockpile controls
- the management of the influx of volunteers, with a specific section designating a coordinator and detailing the training given to volunteers (and supervisors) in the event of an incident
- wildlife management, recommending the planned installation of bird care centres near wastewater treatment plants (effluent management).

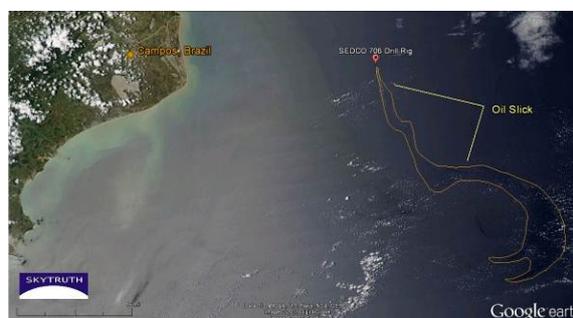
12 Nov. 2011: Satellite image (MODIS/Aqua) and visual interpretation of the spread of the surface pollution (Source: <http://blog.skytruth.org>)

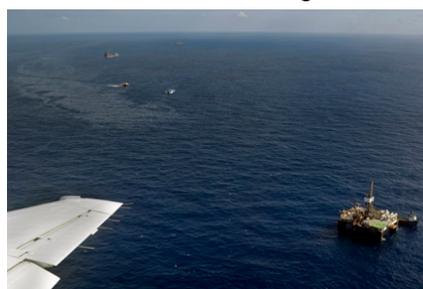
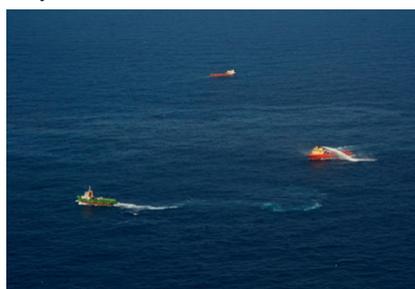
19/11: aerial view of residual crude oil seepage (*left*); response at sea (*mixing with jets of water*) (*right*) (Source: Chevron)

Chevron indicated that it applied "methods approved by the Brazilian government", in particular skimming and mechanical dispersion by mixing, with no use of chemical dispersants.

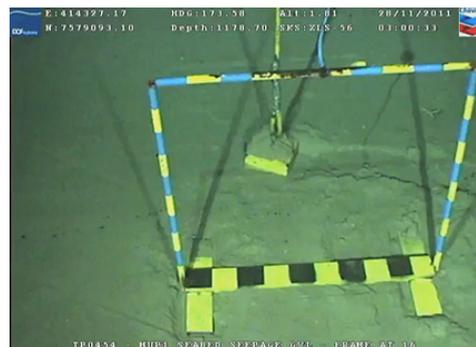
Video monitoring of intermittent seepage (oil droplets) 1,200 m deep (Source: Chevron)

Video surveillance of the seeps was set up to appropriately deploy the containment/recovery device.

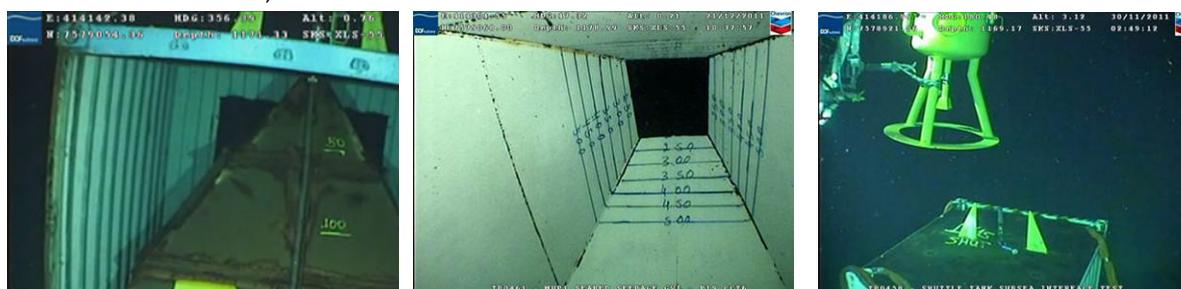
**Left:** Inside of the steel containment device sitting on top of a seepage point, containing a funnel structure; **Middle:** View of droplets rising by gravity inside the funnel system of the containment device; **Right:** Placing the shuttle tank on the steel containment device (Source: Chevron)

According to the information released by Chevron, these operations were continued into early January at at least half a dozen sites. The volumes indicated suggest a low seepage rate (for instance it seems that around 7 litres were collected in the first tank placed above seep P19 from 4th to 16th December).

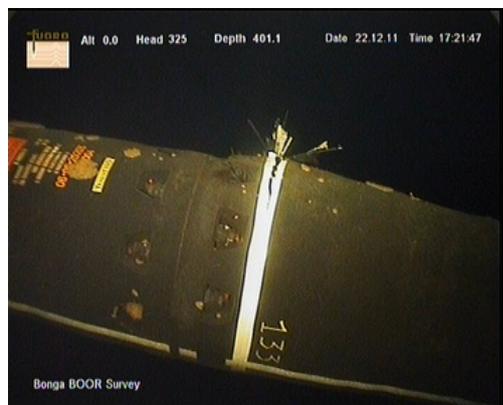
*Underwater view of the damaged export line  
(Source: SNEPCo)*

Meanwhile, SNEPCo temporarily suspended its operations in the oil field and began to search for the source of the leak by deploying a ROV. The following day, a breach was identified in a submarine line running between the FPSO and the loading buoy. The leaking line was immediately secured (by de-pressurising the line and shutting down the production well).

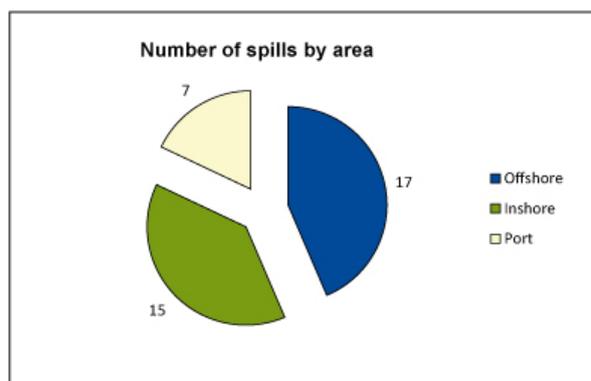
Figure 1

In 2011, Cedre recorded 39 spills involving volumes of over approximately 10 m<sup>3</sup>, for which sufficient information was available for statistical analysis. These spills occurred at a comparable rate offshore and inshore, and to a lesser extent (around 20%) in ports (Fig. 1). The total quantity of oil and HNS spilt during the year was just under 96,700 tonnes.

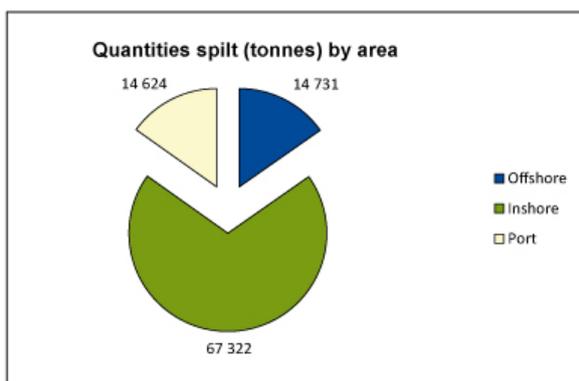
Figure 2

The spills in 2011 mainly occurred in inshore waters (Fig. 2), with much of the quantities spilt being due to vessels grounding, such as the *Godafoss*, *Oliva* (Cf. LTML n°33), *Rena* (Cf. above) and *Jui Hsing*<sup>18</sup>.

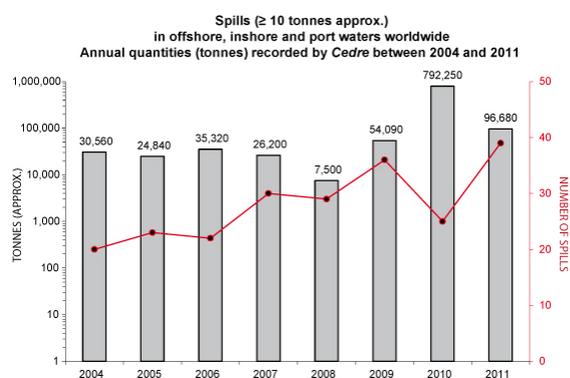
Figure 3

On the whole, this estimation is higher than those obtained using the same approach since 2004 (Fig. 3), with the exception of 2010, which was mainly dominated by the major spill due to the Deepwater Horizon accident (Cf. LTML n°29-30), for a similar number of events recorded (approximately 20 to 30, Cf. Fig. 3).

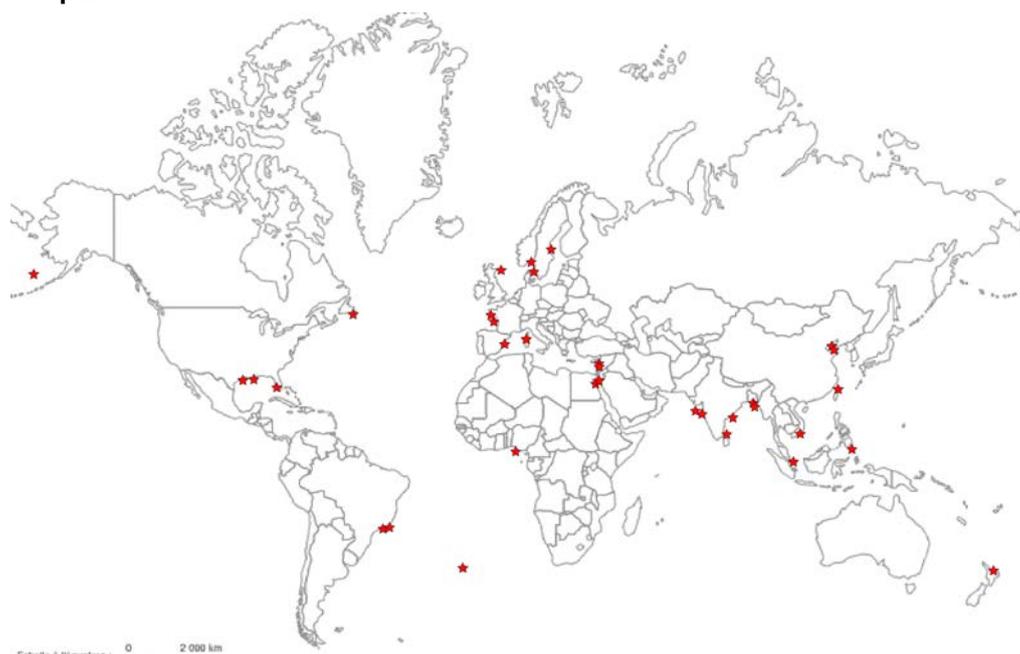
**Figure 4.** Location of oil and HNS spills (≥ approximately 10 tonnes) offshore and inshore in 2011 recorded by Cedre.

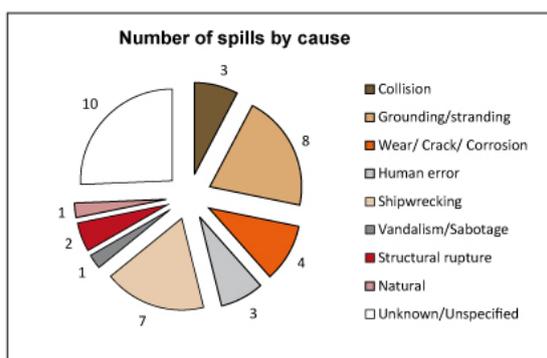
**Figure 5**

Analysis of the distribution of spills by cause shows a high frequency (26 %) of cases whose cause is **unknown or unspecified** (Fig. 5), half of which were related to offshore oil facilities. Although their contribution to the total volume was low (2%, Fig. 6), this lack of detail, in addition to the patchy nature of certain information on the volumes involved, should be kept in mind in the balance of this analysis.

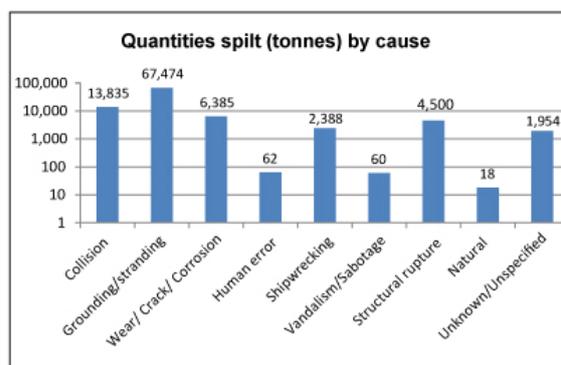
**Figure 6**

With a comparable frequency, **shipwreckings** at sea caused around half a dozen oil or chemical (cargo) spills. Although apparently exceeding 10 tonnes, the size of the spills generated by these events was often unspecified and their low contribution to the overall volume (2 %, Fig. 6) is probably underestimated.

Incidents related to structural deficiencies (**wear, crack, corrosion**) represented 10 % of cases, and around 7 % of the annual volume spilt (Fig. 6). The largest of these events was the crack in an

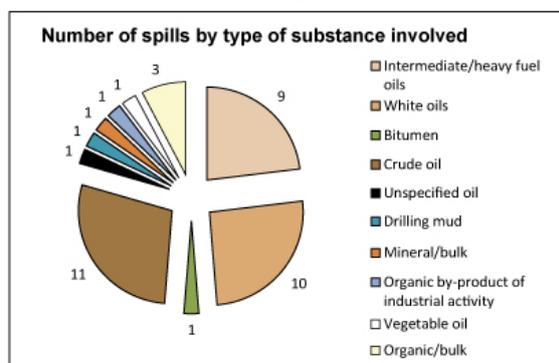
Figure 7

Spills of **bulk organic matter**, although only including 3 spills (i.e. 8 % of events, Fig. 7), represented the highest contribution (around 80 %) to the annual total (with almost 20,000 tonnes spilt, Fig. 8). These spills included the loss of tens of thousands of tonnes of food cargoes, in particular those of the *Hyang Ro Bong* (rice) and the *Oliva* (soya beans) (Cf. LTML n°33).

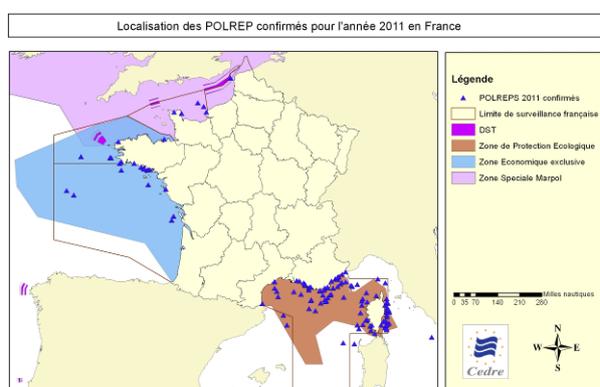
Location of confirmed POLREPs in 2011 in France  
(Source: *Cedre*)

The analysis of the distribution of reports in French waters is consistent with previous years, in particular along the shipping routes in the Channel (Ushant and Casquets traffic separation schemes in particular) and the Mediterranean (Genoa-Barcelona, Genoa-Valencia and Genoa-Strait of Messina routes).

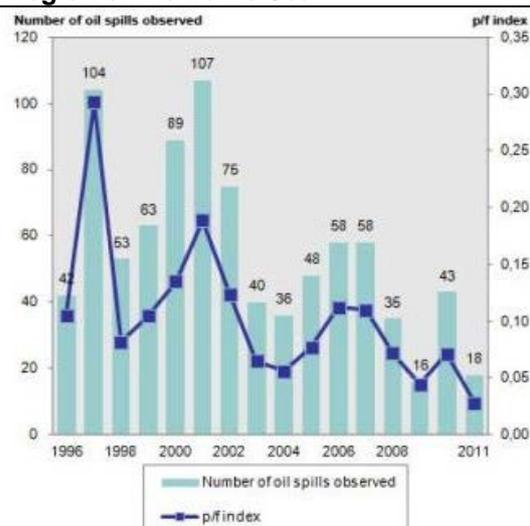
Number of oil discharges detected by Finnish aircraft (bar chart) and detection rate (line chart), between 1996 and 2011 (source: <http://www.helcom.fi>)

Meanwhile, the average volume of discharges significantly dropped in 2011 in the Finnish EEZ (30 litres compared to one to several hundred litres in previous years).

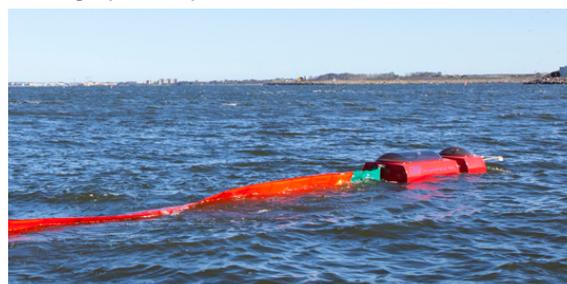
*View of the ASV towing a permanent fence boom  
(Source: Copenhagen Malmö Port)*

The vehicle, self-propelled by an electric engine (200 kg payload) and unmanned, is designed to be automatically launched in the event of a spill alert and to deploy a floating boom (light, permanent boom) by unrolling the boom from its storage reel and mooring itself to a pre-established port structure. The ASV can be radio-controlled live or its trajectories can be pre-programmed. The vehicle is guided by a GPS system.
