**CENTRE OF DOCUMENTATION, RESEARCH AND EXPERIMENTATION
ON ACCIDENTAL WATER POLLUTION**

Inland Waters Technical Newsletter n°19

LTEI 2012 - 2

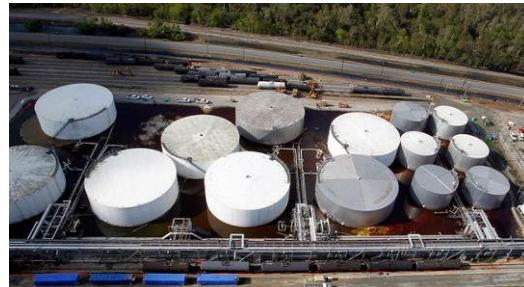
13/09/2012. Leaking tanks, at the Stolthaven New Orleans LLC chemical plant (Braithwaite), following Hurricane Isaac
(Source: D Grunfeld / Times-Picayune DR)

Among these events, for few of which details are provided, the most major incident appears to be the pollution of the Mississippi reported by Stolthaven New Orleans LLC, from its Braithwaite plant (Plaquemines Parish, Louisiana). On 28th and 29th August, the hurricane caused the Mississippi to breach a levee upstream of the plant, and to flood the plant under 4 m of water. It was not until the flooding subsided 6 days later that the personnel began to observe the damage suffered, in particular by the various storage tanks.

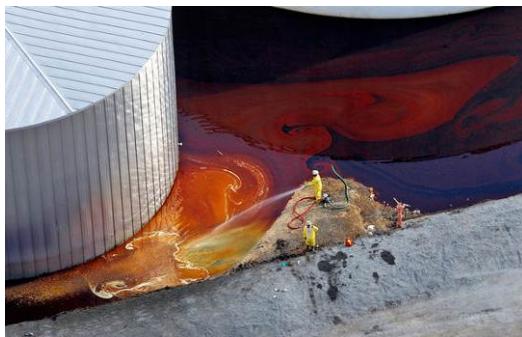
13/09/2012. Setting up recovery systems for pollutants contained in the retention basins.

The emergency response mainly consisted, once the flooding had subsided, in pumping the residual quantities of pollutant in the site's retention basins to a temporary storage capacity on-site, pending treatment at an appropriate facility.

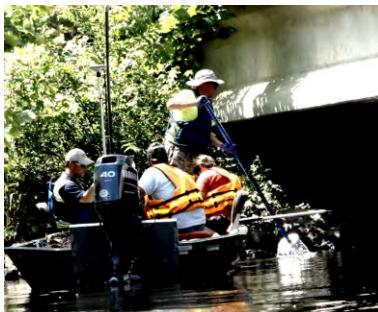
"Poling" operations georeferenced to locate/map sunken deposits (Source: US EPA)

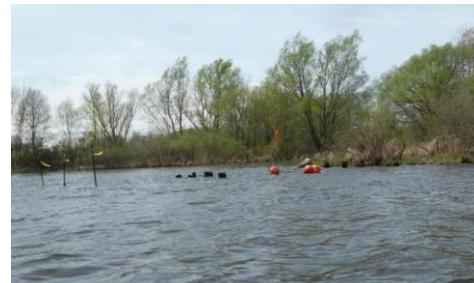
Sediment traps, indicated by buoys on a selected section of the Kalamazoo River
(Source: L. Smith/Michigan Radio, DR)

In addition to the removal work, sediment traps were set up in 2013 to capture any remobilised accumulations of bitumen (naturally or due to dredging operations). Located in selected areas (calm waters, conducive to deposits), these systems were composed of submerged and anchored beams, or trunks, attenuating the current and accentuating settling phenomena. The idea was to conduct recovery operations (e.g. dredging/pumping, sorption, etc.) at regular intervals to remove any deposited oil. To control the efficiency and utility of these systems (destined to be left in place for several years if need be), sedimentation collectors (sorts of earthen vases set into concrete-weighted blocks) were installed, and their content was regularly removed and sent to a laboratory for analysis.

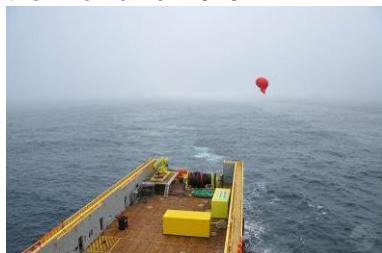
Testing OceanEye offshore (Source: Maritime Robotics)

It has a payload capacity of 3 kg, partly reserved for its cameras: high definition video and uncooled infrared¹⁵, whose images are transferred live by radio to the vessels present on site. It has a range of around 7 km (4 nautical miles) at 120 m altitude.

OceanEye, developed through a research and innovation programme¹⁶ funded by the Norwegian Coastal Administration and NOFO¹⁷, was tested and finalised in 2012 and 2013 during NOFO exercises at sea, during which it attracted great interest from international participants according to the Norwegian cooperative, with results ranking it as a "good operational tool" in conditions of low visibility (fog, dark, etc.). The device was first marketed in the 2nd half of 2013¹⁸.

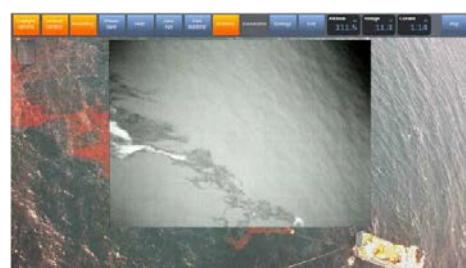
Imagery (visible and IR) acquired by OceanEye
(Screenshot/SOURCE: NOFO)

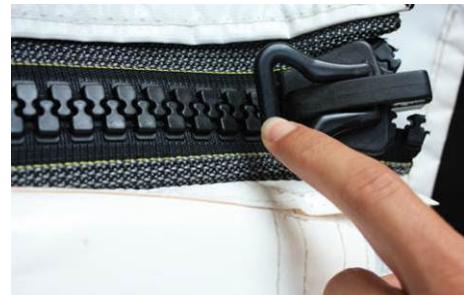
Close-up of the S140 connection system (Industrial Marine Zipper) (Source: www.eurofilet.fr/)

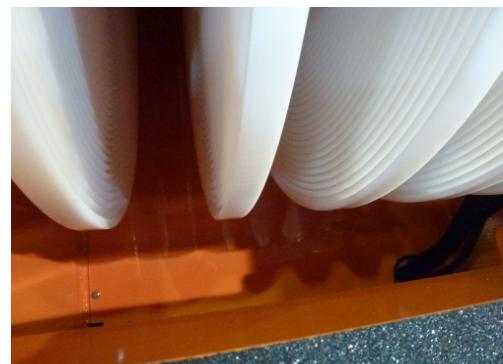
Close-up of the grooved surface of the Elastec X150 skimmer's oleophilic discs (Source: Cedre)

Based on a similar principal to that applied by the brand to its groove drum skimmer (see LTML 2006-2), this is a modified version of a disc skimmer in which each of the faces features grooves, increasing the contact surface between the oleophilic coating and the oil.

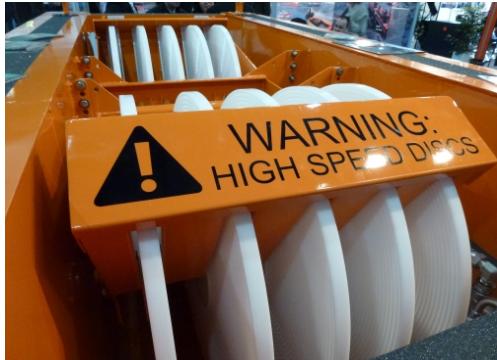
View of the X150 skimmer's two rows of discs (Source: Cedre)

The X150, smaller in size than the prototype, features 2 axes each bearing 5 grooved polyethylene discs, housed within a 2 m x 3 m steel frame. According to the manufacturer, the skimmer has a recovery rate of 150 m³/hour (hence the model's trade name).
