**CENTRE OF DOCUMENTATION, RESEARCH AND EXPERIMENTATION ON
ACCIDENTAL WATER POLLUTION**

Inland Waters Technical Newsletter n°20

LTEI 2013 - 1

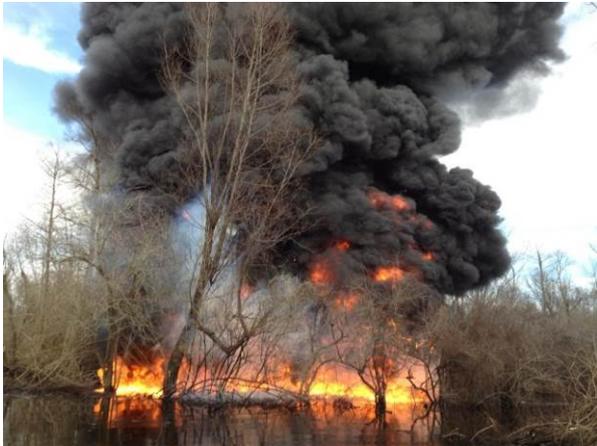
ISB operation (source: NOAA)

First, to improve the efficiency of ISB operations, conducted in waters around 1 metre deep, the slicks were thickened by containing them with booms. The oil was then ignited using propane torches. The shortest ISB operation lasted 5 minutes, while the two others lasted 25 minutes, and were self extinguished.

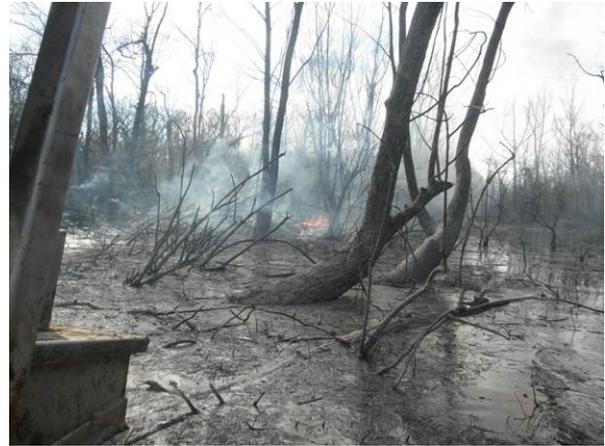
Slick residues after a burn (Source: NOAA)

The burn residues and accumulations of unburnt oil were then recovered on the water in various ways: manually using sorbents and by deploying oleophilic skimmers (mainly drum and rope skimmers).

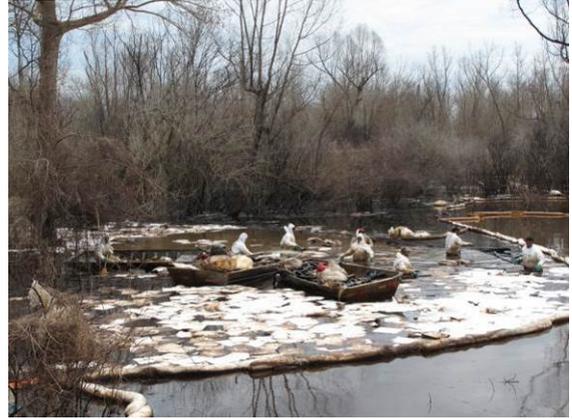
Manual recovery of oil remaining at the water surface using sorbents (Source: NOAA)

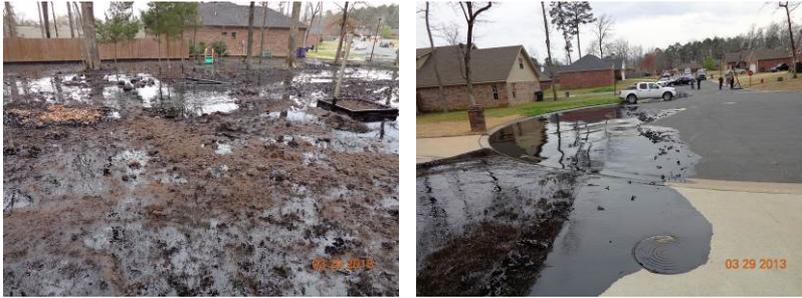
Day of the incident: heavily oiled ground in the leak area (left); Spread of the spill into the residential neighbourhood (right), across the ground and in water systems – note the flow of the oil into a storm drain (source: US EPA)

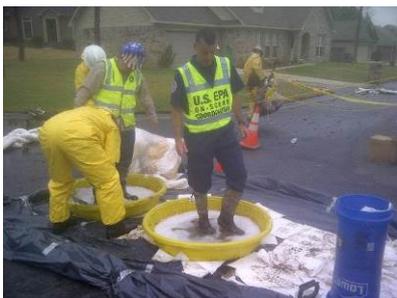
Decontaminating personnel (Source: US EPA)

These operations rapidly involved the mobilisation of major logistical support and the implementation of a complex organisation into operational sectors, summarised by ExxonMobil and its contractors in the form of regularly updated maps, providing the UC with the evolution of the situation in terms of the types of operations in progress and the organisation of associated resources (equipment storage, primary waste storage sites, decontamination areas for vehicles and personnel, etc.).

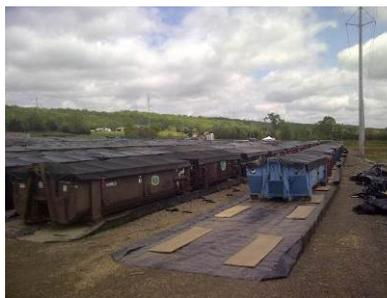
Oiled waste storage area (Source: US EPA)

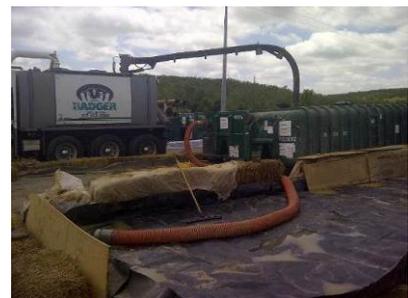
Separation of liquids and solids with a hydrocyclone (Source: US EPA)

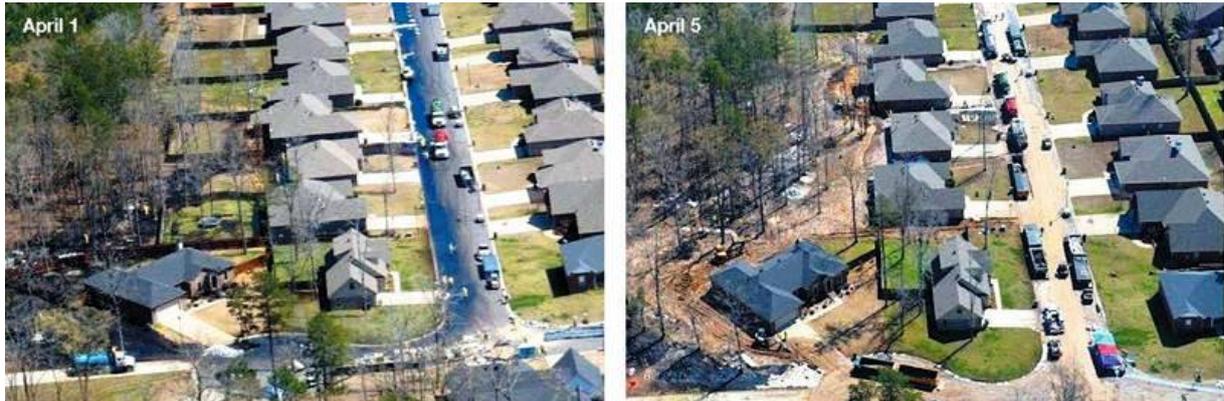
Short term results of clean-up operations at the surface in the residential area close to the leak point: Aerial view 2 days after the incident (1st April 2013; left) and 6 days later (5th April 2013; right) (Source: City of Mayflower.com).

One of the priorities of clean-up operations, which made rapid progress in the incident area (see aerial photos below), was to contain and recover the free crude oil as efficiently and rapidly as possible, so as to protect the watercourses and water bodies connected to the contaminated area, in particular Lake Conway, a major reservoir which also hosts significant recreational activity, potentially

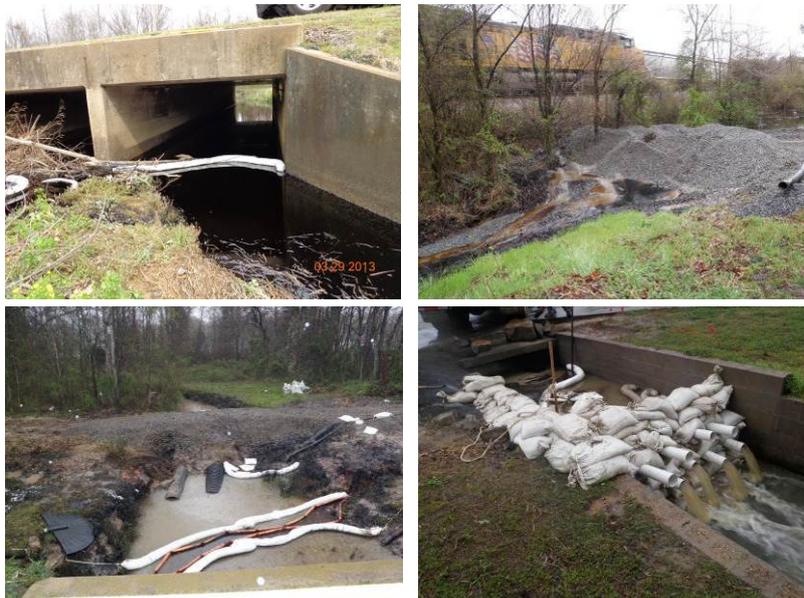
Various forms of containment of Wabasca heavy crude on the water: by sorbent booms (top left); by backfill (top right; note the penetration of the oil through the gravel); by filter barriers (bunds with pipes) in rivers (bottom left) and in a storm drain (bottom right) (source: US EPA).

A wide range of containment techniques (e.g. berms, floating booms, sorbent booms, filter systems, etc.) and pumping techniques (e.g. vacuum trucks, with or without suction heads) were deployed on the various types of contaminated surfaces: ponds, trenches, rivers, drains, storm drains, etc.).

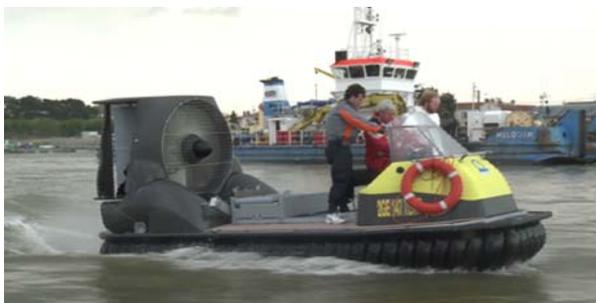
Loire estuary: MACP high speed stability tests (source: Cedre)

The MACP offers a total floor area of 7.5 m² (empty) providing it with stability in up to 10 knot winds, and has a run time of 5 to 8 hours depending on the tasks performed and speed (45 knots max.). The prototype was tested in spring 2013 on the Po River (Italy), then for a week in the Loire estuary (with support from GPMNSN⁵ and the municipalities of Saint-Brevin-les-Pins and Paimboeuf), and finally in Brest at Cedre's facilities. The observations recorded during these trials highlighted the platform's remarkable stability and manoeuvrability, ensured that it was unsinkable and able to provide a fast response – confirming the utility of the modular Hoverspill concept for the spill response tasks identified as well as its ability to perform these tasks.

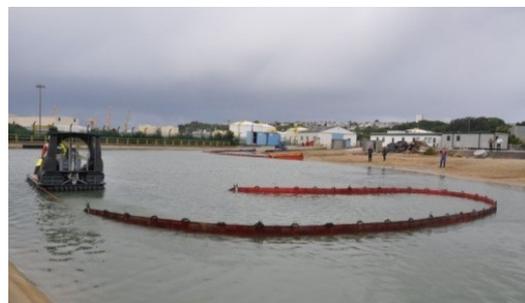
Cedre's water basin and man-made beach: towing a boom in a trawling configuration (source: Cedre)

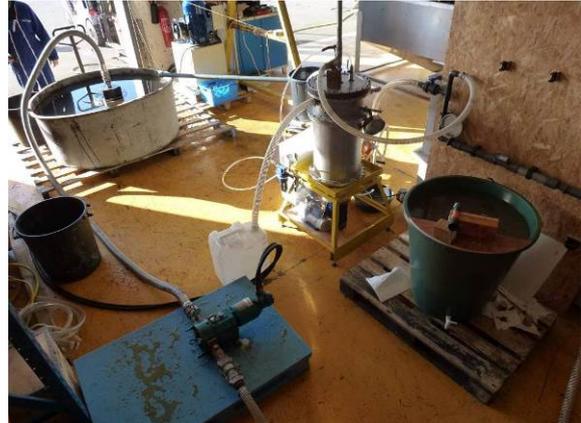
Testing the Turbylec, at Cedre, together with a DESMI Terrapin skimmer and a Börger AL25 pump (Source: Cedre)

For this part of the project, Cedre defined a recovery system based on equipment existing on the market, taking into account the size and power constraints dictated by the platform and the rate of the separator developed by Ylec: maximum weight of 25 kg for the skimmer and 50 kg for the pump, requiring a maximum hydraulic power of 25 kW to give a flow rate of less than 10 m³/h. Eight skimmers and two small pumps, preselected based on their low weight and compact format, were tested at Cedre using the French AFNOR standard, on oils of varying viscosities. Given the results of these evaluations, combined with an assessment of their ease of handling and flexibility of use, a combination of a weir skimmer (DESMI Terrapin) and a lobe pump (Börger AL25) was chosen.

The oil-water separation system also had to comply with strict requirements, in terms of size and weight, but also the range of oil (neat or mixed with water) handled, the inlet flow rate (around 7 m³/h) and tolerance of air ingestion (intermittent or continuous). It was also required to ensure a cut diameter <100 µm, be easily adjustable and easily dismountable on board for rapid cleaning in case of clogging with debris. To meet these requirements, an entirely new centrifugal separator, Turbylec, was designed. A Turbylec prototype was tested at Cedre and gave very good results for a wide range of oil densities. It proved to be easy to handle and disassemble.

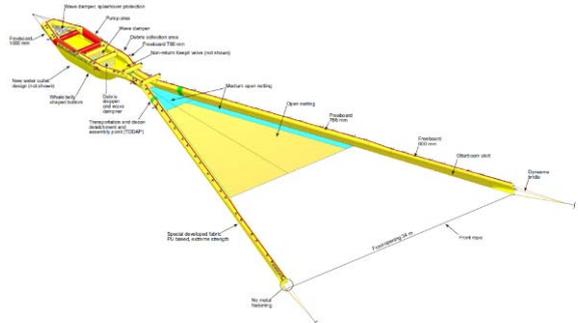
Diagram of the Current Buster 6 (source: NOFI)

The aim was to test various deployment conditions, in dynamic mode (towed behind 2 vessels, or 1 vessel with a boom vane) and in static mode (moored to a fixed point on the quayside and opening by a boom vane; reversal when the tide turned).

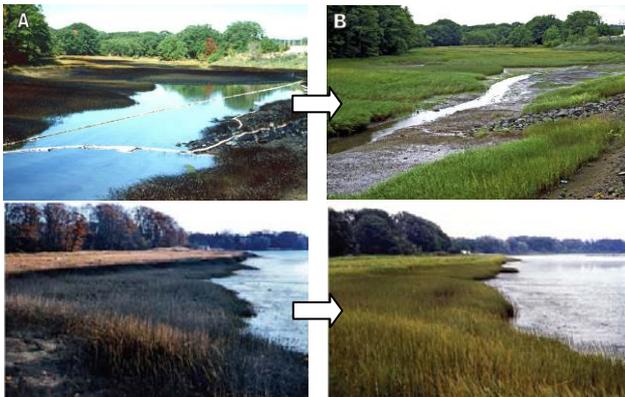
Past experience: natural self-cleaning of marshland along the Fore River (US). Left: heavy fuel oil (IFO 380) spill during senescence (die-back) (September 1996); Right: recovery of the habitat at the first growing season (July 1997). (in Michel and Rutherford, 2013; 2014)

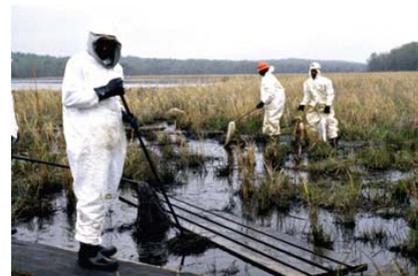
Manual recovery + use of sorbent mops on floating oil in a marsh (Patuxent River, Maryland, Spring 2000) (Source: J. Michel)
