**CENTRE OF DOCUMENTATION, RESEARCH AND EXPERIMENTATION ON
ACCIDENTAL WATER POLLUTION**

Sea & Shore Technical Newsletter n°39

2014-1

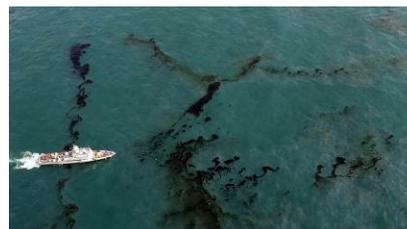
Trails and slicks of fresh IFO 380 following the collision of *Captain Vangelis L* (source: vesselfinder.com)

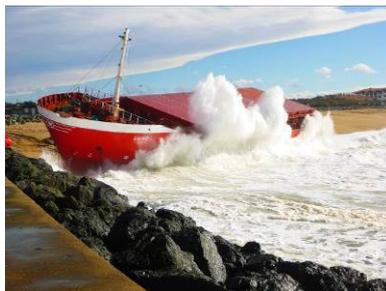
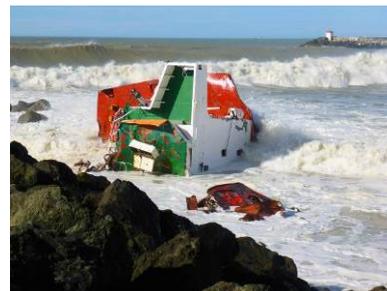
06/02/2014: Bow section of the Luno on Cavaliers beach (left) and bridge grounded at the end of the Cavaliers breakwater after breaking away from the stern section (right). No pollution was visible on the water or the foreshore (Source: Cedre)

During the night, the stern section – lodged on the end of the Cavaliers breakwater – in turn broke into two parts, which continued to break up, instantly releasing the fuel contained in the bunker tanks. The bow section, partially buried in the sand of Cavaliers beach, gradually became stabilised, but showed a 30° list although no leaks had yet been observed.

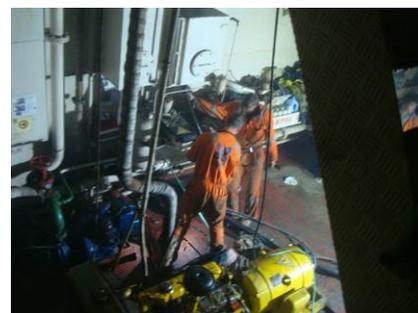
Preparing SMIT pumping equipment in the bow section of the Luno (Source: CEPPOL)

- SMIT Salvage was contracted to inspect the structure (jointly with representatives of CEPPOL and *Les Abeilles*) prior to pumping.
- Given the wreck's list and movements caused by the swell, this operation required major preparation work in terms of access and deployment onboard of personnel and pumping equipment (mobilisation of a ladder/platform provided by the fire brigade; safety measures, installation of hand rails, lighting, floor space, etc., access routes within the wreck). All the hydraulic power packs and tanker trucks were positioned on the breakwater.
- On 7th February, an attempt to remove the bunker tank's cover plate – immediately replaced – was suspended due to a risk of an uncontrolled release inside the vessel. The following day, a

hot tapping operation was carried out, successfully removing all the remaining diesel the same day⁷.

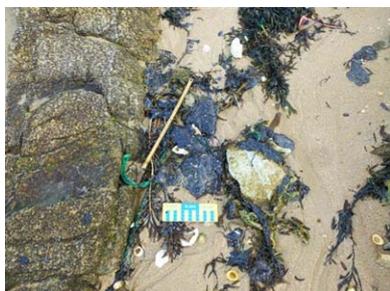
09/02/14, Le Croisic (Loire-Atlantique):
Accumulations of tarballs and patties on a
beach (Source: Cedre)

As a general rule, the pollution took the form of scattered balls of viscous fuel oil, or sometimes patties up to 40 cm in diameter.

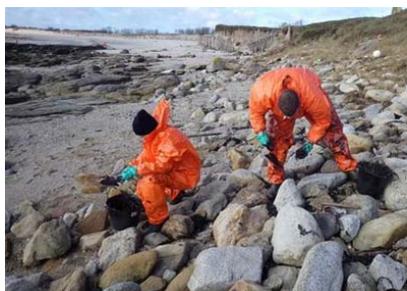
16/02/14, Hoedic (Morbihan): Manual
recovery operations implemented by the fire
brigade (Source: Cedre)

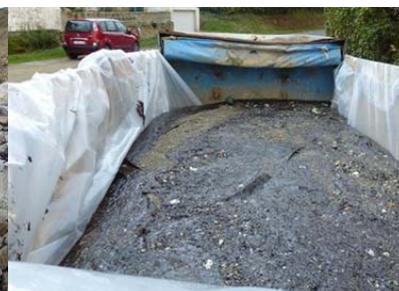
08/02/14, Piriac-sur-mer (Loire-Atlantique):
primary storage of collected waste in a lined
skip (Source: Cedre)

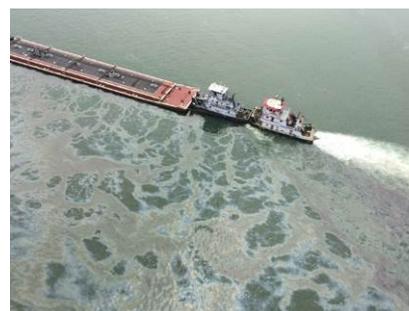
Heavy fuel oil spill from a damaged barge in Houston Ship Channel (22nd March 2014, Texas, US) (Source: USCG)

One of the starboard tanks was damaged and rapidly released the 640 m³ of fuel oil it contained in a narrow and particularly busy shipping channel between the Gulf of Mexico and the oil facilities of south-east Texas (Galveston, Houston).

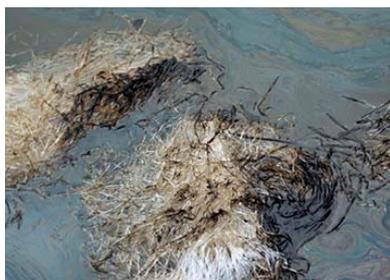
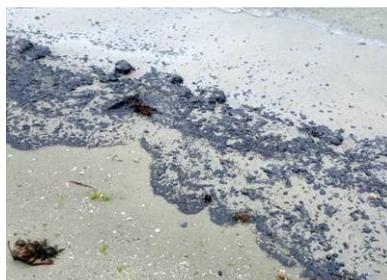
D₄₁: Mop sorbents used to protect and clean up riprap on Texas City Dike (left); accumulations of heavy fuel oil along the high tide mark on shores close to the spill (Big Reef) (Source: NOAA).

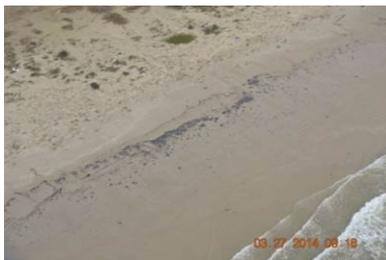
D+5: Localised deposits of emulsified heavy fuel oil on the beaches of Matagorda Island (Source: USCG/Unified Response)

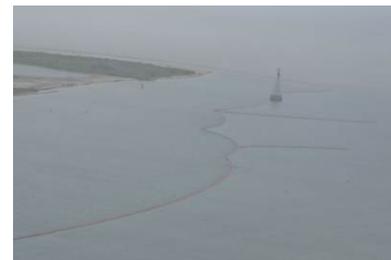
D+6: Laying floating boom for shoreline protection (Matagorda Island) (Source: USCG/Unified Response)

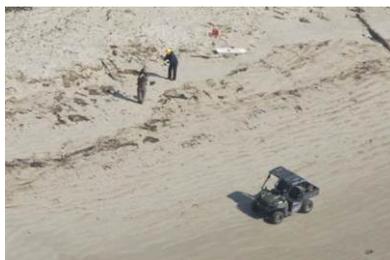
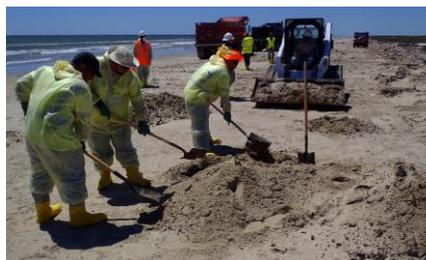
D+7: Shoreline survey on Matagorda Island using light-duty vehicles (left); D+8: manual collection of sand (right) (Source: USCG/Unified Response)

The island was divided into twelve 5 km stretches, on half of which oil had come ashore, and 3 of which were considered "heavily oiled" by the UC.

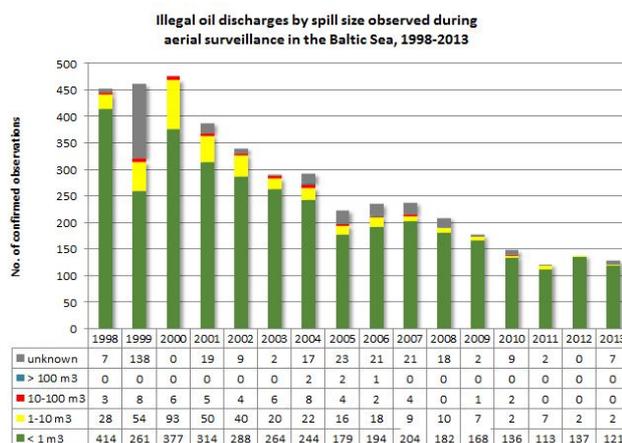
In 2013, 130 confirmed mineral oil spills were thus reported in the Baltic Sea, based on a total of 4317 flight hours.

With the vast majority of these spills representing less than 100 litres, this was the lowest estimated total volume recorded so far (11 m³).

More significantly, we note the overall decrease in the Pollution per Flight Hour (PF) index over the last 2 decades, despite constantly increasing vessel traffic. In terms of the future outlook, the report indicates the need to further increase night flights (but also to equip aircraft with specialised detection equipment) which represented 15% of flight hours in 2013. The contribution of the CleanSeaNet (CSN) satellite surveillance service, provided by the European Maritime Safety Agency (EMSA), was also mentioned, having reported over 100 possible detections in the Baltic

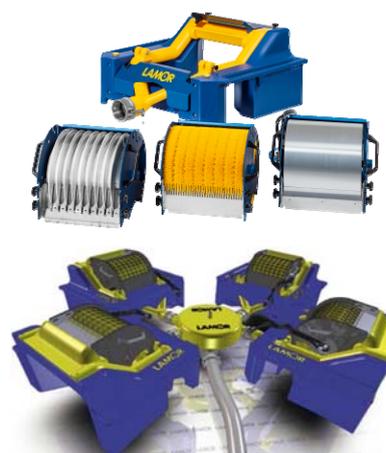
According to the manufacturer, this oleophilic skimmer has undergone full tests at Ohmsett testing facilities, which apparently confirmed its efficiency both on light and highly viscous oil.

It can be connected to a vacuum system or a suction pump and, with a draught of less than 13 cm, is suitable for use at coastal and port sites, as well as in inland waters (rivers, lakes, etc.).

*Photo and diagrams of the LMM 25
(Source: Lamor.com)*

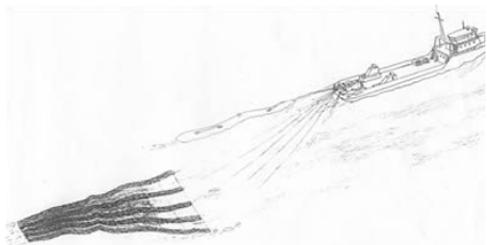
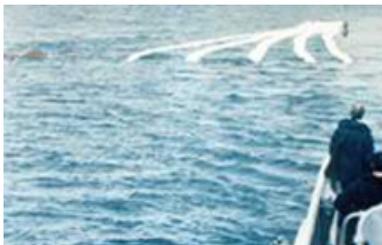
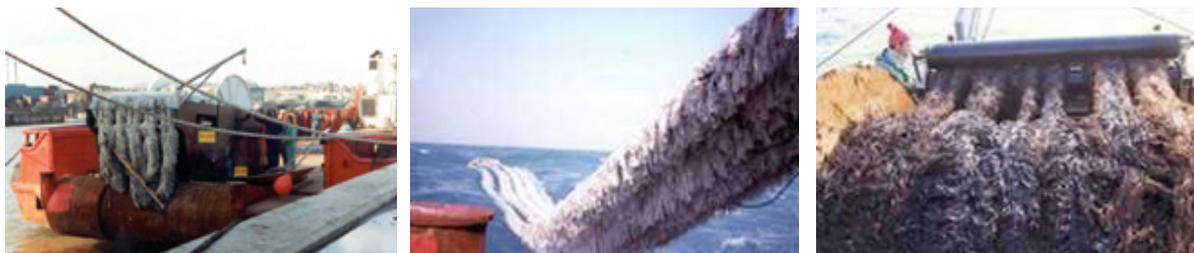
The general concept of the equipment remained the same as that of the equipment that Cedre had the chance to see deployed on the water during a demonstration in 1979, then in 1982 for a deployment trial (without oil) carried out in Plymouth from a French Navy vessel: a mop of oleophilic material, at the time 5 pairs of oleophilic ropes woven together, was towed at low speed behind a tug or supply vessel and held open either with a paravane (initial version) or an outrigger (new version).

This mop is deployed from a wringer unit reel which is used to periodically squeeze the oil out of the mops while hauling them onboard.

Above and below: initial version of the Force 7 (source: www.opec.co.uk)

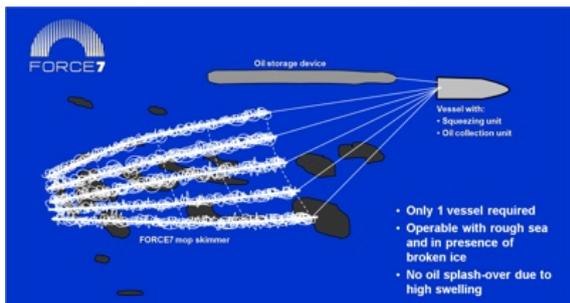
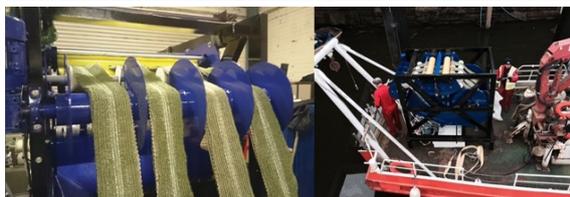
Drawing upon the skills of the SMEs involved in this project, the main amendment to the system resides in the type and design of the oleophilic materials used. The 5 pairs of strands of polypropylene fibres, 75 cm wide, have been replaced with 4 multilayer bands designed to promote the recovery and retrieval of heavy oil, while also being efficient on light oils.

The small-scale trials conducted have shown that the textile structure is capable of recovering 2 times its own weight in oil, with over 90% efficiency (i.e. 90% oil in the mixture recovered).

Above and left: new version of the Force 7 (source: www.force7.eu)

On 26th February 2015, a large-scale trial was conducted in Cardiff Bay, confirming that the system performed well at various towing speeds, up to 5 knots.

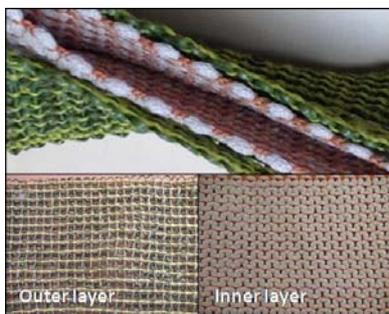
Left: textile developed through the Force 7 project

The advantage highlighted by the system's designers is, like for the initial system, its capacity to respond in rough sea conditions (hence the name Force 7), thanks to its deployment by a single vessel and the movement of the oleophilic textile in sync with the water's movements.
