**CENTRE OF DOCUMENTATION, RESEARCH AND EXPERIMENTATION ON  
ACCIDENTAL WATER POLLUTION**

**Inland Waters Technical Newsletter n°22**

**LTEI 2014 - 1**

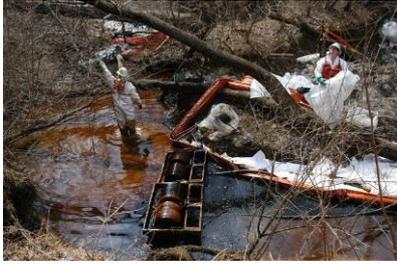
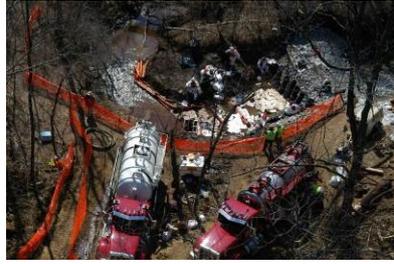
Left: deploying Elastec oleophilic drum skimmers; Right: Vacuum trucks (source: Ohio EPA).

Meanwhile, containment booms were deployed to stop the oil from spreading: the main priorities were to protect the Great Miami River, downstream, and to contain and recover floating oil by pumping (using vacuum trucks) and skimming (using oleophilic skimmers in particular).

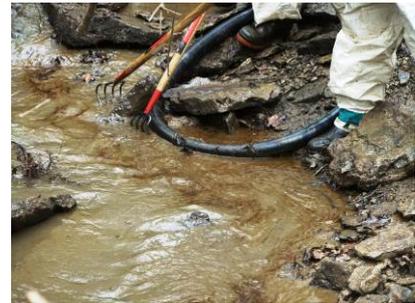
Remobilisation of infiltrated crude oil by scraping/tilling sediment (Source: wvxu.org)

On the banks, the oil which had infiltrated locally into the sediment was remobilised by scraping/tilling the sediment, using lightweight tools (such as rakes) and concentrated using hoses by pushing it towards containment areas for subsequent recovery.

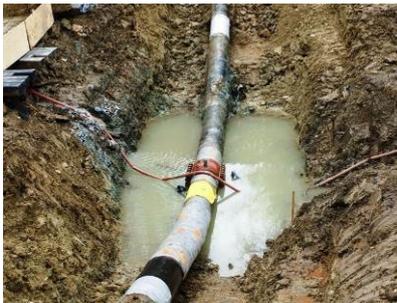
Repair clamp (in red) on ruptured section of the line, pending replacement of the section (source: wvxu.org)

Sunoco Logistics Partners LP announced the repair of the pipeline, which was reopened 7 days after the spill had been reported.

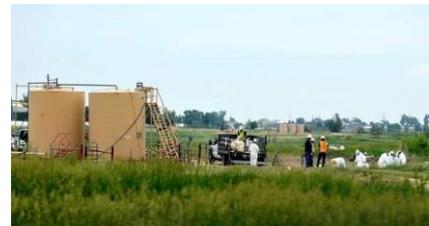
View of the spill site (Source: <http://niobrarachalk.com>)

On 17th June 2014, on the premises of a Noble Energy Inc. facility situated on the bank of the Cache La Poudre River (Colorado, United States), a crude oil storage tank dropped from its foundation as the banks of the watercourse had become undercut by erosion.

As the tank dropped it damaged a valve, releasing 30 m<sup>3</sup> of its contents.

The leak was discovered on 20th June: the majority of the oil had been carried away by the watercourse, contaminating vegetation along a 400-metre stretch of banks downstream, where clean-up operations were then organised. This area is highly sensitive in terms of ecology and tourism, with the Cache La Poudre River being classified as a Wild and Scenic River.

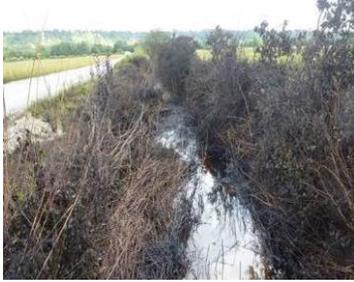
Polluted ditch close to the leak (note the path made of backfill built to access the site) (Source: Cedre)

The pressure in the pipeline caused the vegetation in the area around the leak point to be sprayed with oil, and the fluid crude oil flowed into the neighbouring drainage channels.

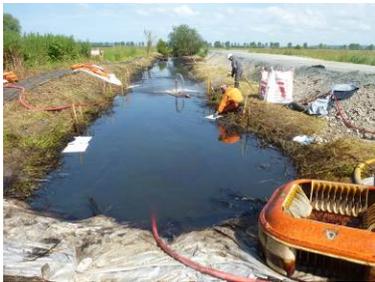
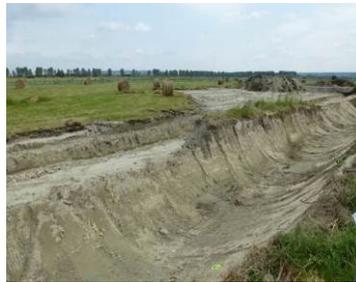
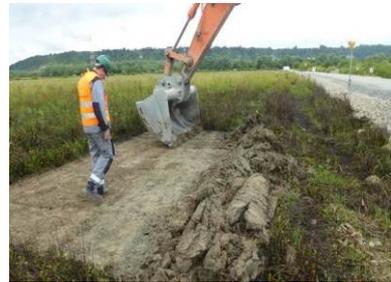
Skimming (oleophilic disc skimmer) accumulations of crude oil in a drainage channel (FOST responders) (left); Removing contaminated soil: ditch excavation (middle); Scraping the surface of grasslands (right) (Source: Cedre)

They consisted in pumping floating oil using vacuum trucks, as well as skimmers in certain areas. Contaminated soil (ditches, grasslands and ponds) was removed, with the excavation of a 5 to 60 cm deep layer according to areas. As earth with the same characteristics was available within the vicinity of the site, the grasslands and ditches were able to be refilled to their initial levels. Grasses contaminated by airborne oil particles were scythed.

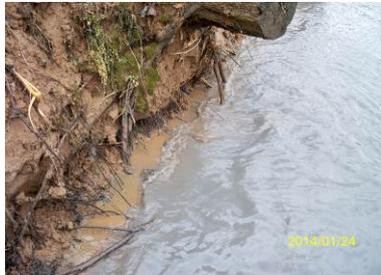
Left: Grey waters of the Dan River caused by coal ash slurry (Source: NC DENR);

On 2nd February 2014 in Eden (North Carolina, US), an incident at a retired Duke Energy steam station was reported to the North Carolina Department of Public Safety Emergency Response Center (ERC): Duke Energy reported the rupture of an ageing storm water pipe ( $\varnothing=1.20$  m) under a coal ash storage basin<sup>5</sup>. Around 39,000 tonnes of coal ash slurry flowed through this breach in the pipe and into the nearby Dan River, tinting the water grey.

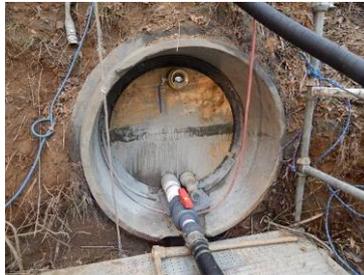
Right: Definitive sealing of the outfall of the leaking pipe (source: Duke Energy).

On 6th February, Duke Energy announced that the leaking stormwater pipe had been sealed.

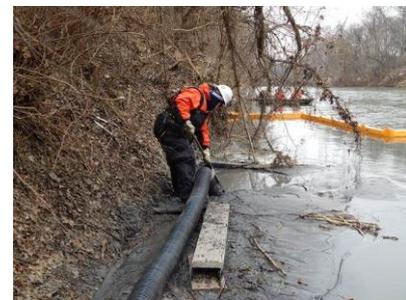
Pumping of ash deposits on the banks (source: Duke Energy)

From February to July, alongside the monitoring of environmental contamination, clean-up operations were carried out by the company under the supervision of the US EPA. They mainly consisted in dredging deposits and accumulations of ash in specific areas identified along the banks and in the river bed, using pumps and dredgers.

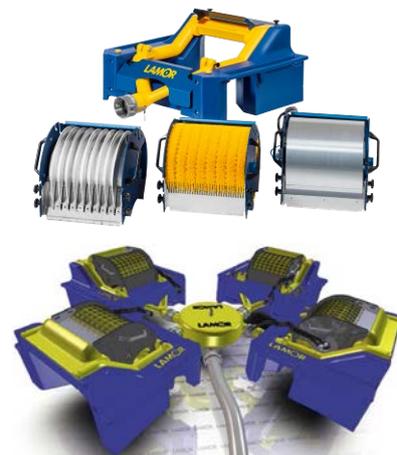
Photo and diagrams of the LMM 25  
(Source: lamor.com)

According to the manufacturer, this oleophilic skimmer has been fully tested at Ohmsett testing facilities, confirming its efficiency both on light and highly viscous oil.

It can be connected to a vacuum system or a suction pump and, with a draught of less than 13 cm, is suitable for use at coastal and port sites, as well as in inland waters (rivers, lakes, etc.).

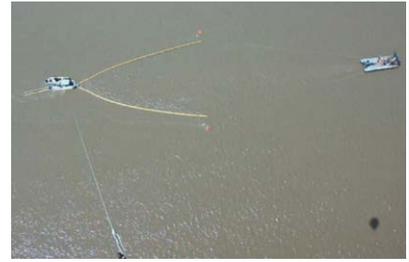
Overview of the R3S system from the OceanEye (Source: Elastec)

This R3S system is highly reminiscent of the Rapid Deployment Skimmer System by SUPSALV (U.S. Navy Supervisor of Salvage and Diving) based on a similar design although of a suitable size to work in more open waters and which required 2 workboats to tow the floating booms in a pair trawling configuration.

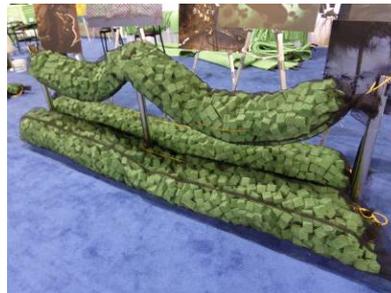
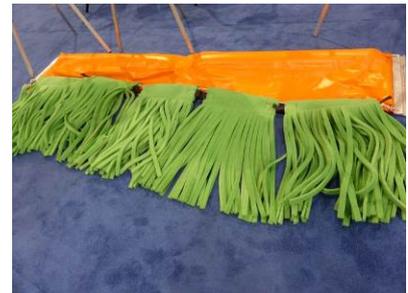
IOSC 2014: OPFLEX sorbent Cube Boom (left) and Eelgrass (right, here used with sections of fence boom) (Source: Cedre)

Its open-cell cavity structure (comparable to that of a sponge for instance) is said to have a good oil sorption capacity and means that these foam products can be reused 5 to 6 times after extracting the oil by squeezing/wringing, thus reducing the quantity of waste to be disposed of. OPFLEX exists in various shapes and sizes: pads, belts, eelgrass...

We note in particular the existence of forms providing a large surface area for contact between the sorbent and the environment: the Cube Boom, composed of cubes (5 cm edge) contained within a mesh tube and the Eelgrass form, designed to collect oil at the surface or in the water column.
