# Cedre

**BULLETIN**

Grounding of the

*T.S. Taipei* in Taiwan

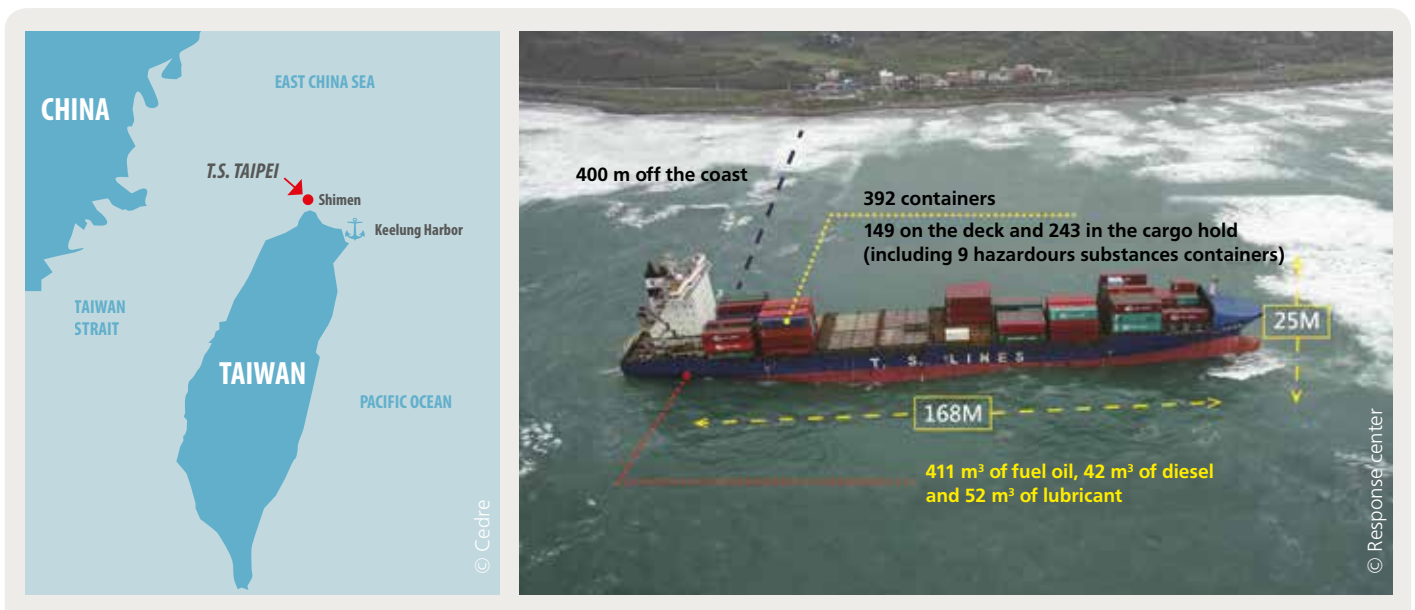
Incident site location

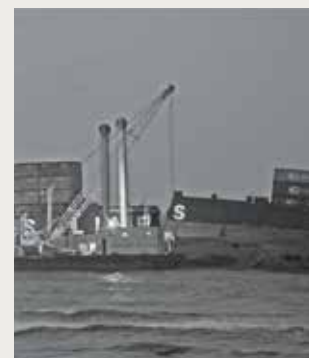
CCTV system

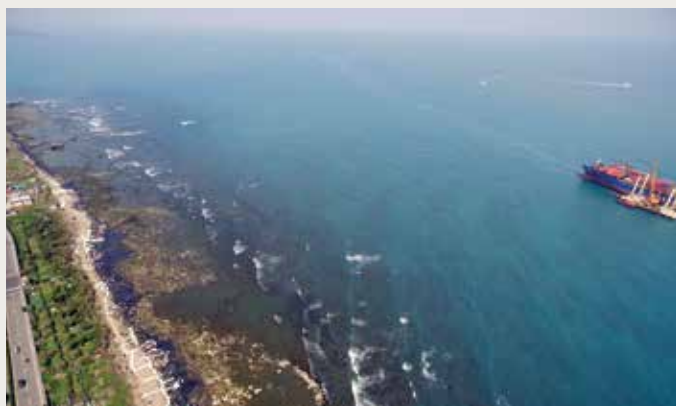
Surveillance pollution by UAS

lite, an unmanned aircraft system (UAS), coastal surveillance radar, CCTV and other technical equipment, and stayed alert in predicting possible locations where oil might reach the coastline with an oil drift simulation system.

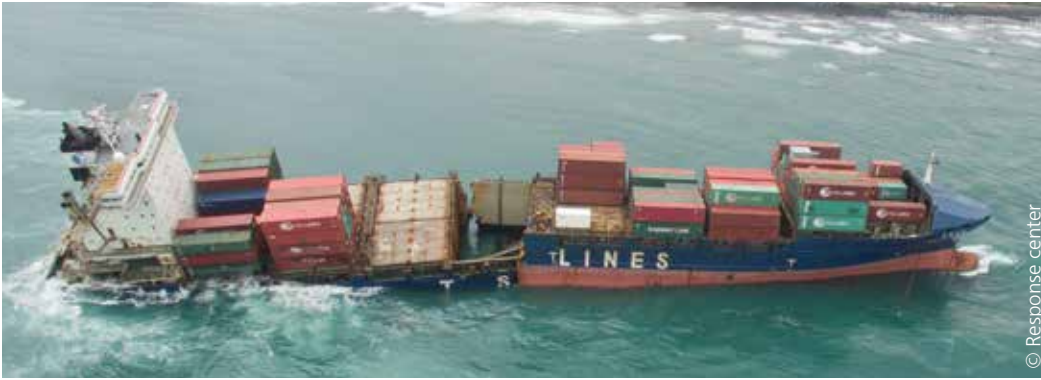
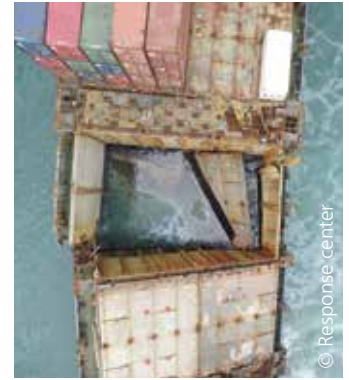
## Damaged ship hull

apart and listed 25 degrees towards starboard under the constant pounding of high winds and powerful swells. As the rear section broke away, 2 pieces of hatch covers, each weighing 30 tonnes, fell into the cargo holds, smashing several containers and cracking 2 fuel tanks that were yet to be extracted. As a result, further oil leakage was detected due to the damage to the fuel tank and hull, which in turn

caused more pollution to the submerged containers on board and surrounding waters.

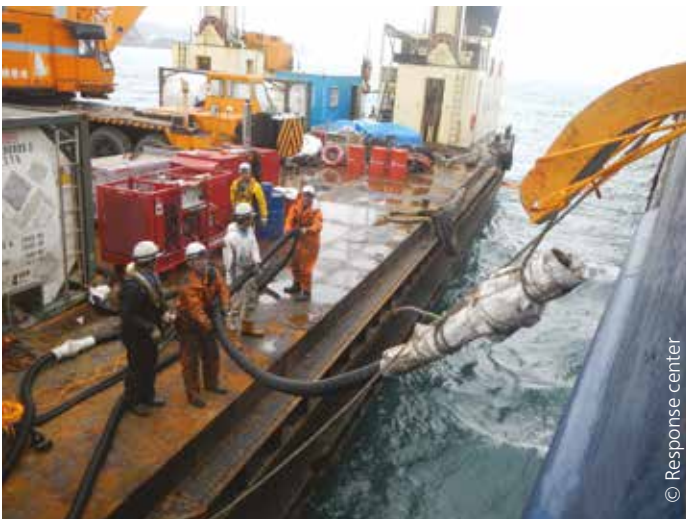
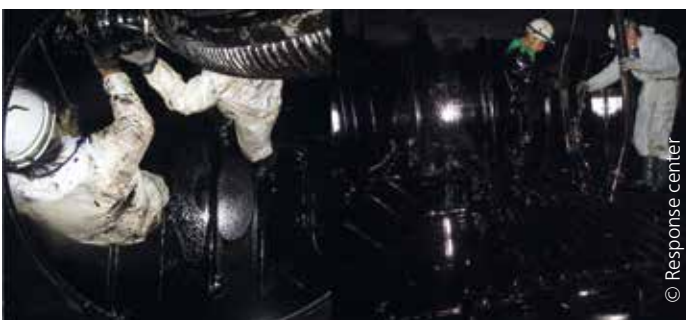
## Fuel and oil extraction from the hull

hull, the starboard side of the rear section and around the stern to contain any further oil spills, and fuel and oil tank extraction started again. At this time, the breached fuel tanks were filled with seawater and goods spilled from damaged containers. Manual labor was employed to remove the goods from the tanks before the fuel could be pumped, which added extra difficulty to the entire operation.

As the remaining fuel was extracted from the damaged fuel tanks, the next job in line was to extract the oil from the lubricant tank which was below the water line in the partially submerged engine room. In the process, the ventilation duct had to be sealed since the pressure prevented further extraction after 1 m<sup>3</sup> of oil was extracted.

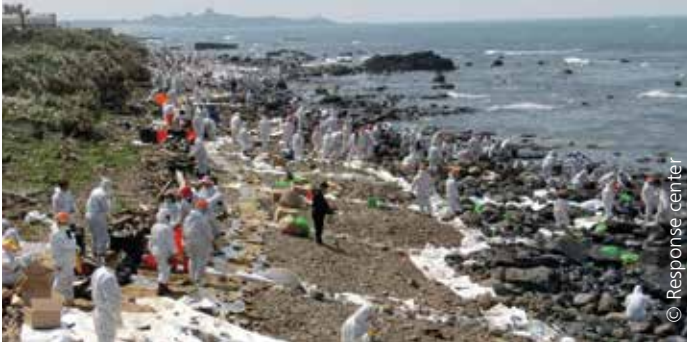
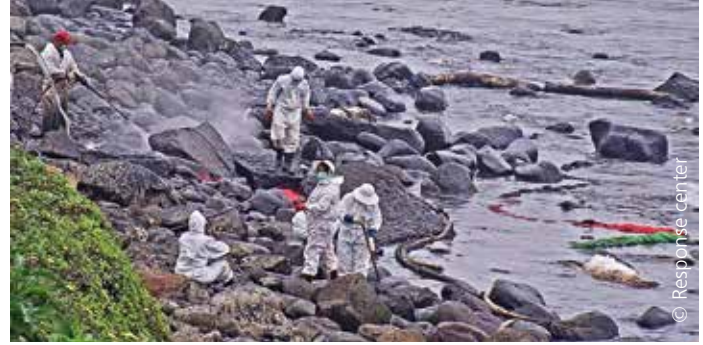
### Shoreline cleanup

water jet, pebble surfaces using low-pressure water jet, and hard-to-clean oil pollution using high-temperature, high-pressure water jet. Stage 3 was targeted towards restoring the beaches to their original appearance by placing cleaned rocks and pebbles below the low-water line, thus allowing erosion by tidal differences and disintegration by microorganisms in order to remove the oil residue left on the rocks. From the onset of the incident on 10<sup>th</sup> March until the end of coastal cleaning on 11<sup>th</sup> May, 11,937 labor counts were dispatched to carry out clean-up operations and recovered 66,402 litres of oil from the shoreline and 128,039 kg of oil-contaminated garbage, helping restore the coasts of Shimen back to their previous state.

As compensation for the economic losses caused by the incident to local residents and fishermen, they were hired and trained by the ship owner's coastal response team for the clean-up efforts. The coastal clean-up consisted of three stages. Stage 1 aimed to clean the pollution that would potentially move or further spread, including the coastal oil pollution that could be removed directly, garbage that was contaminated by oil spill and the tar balls on the beaches. Stage 2 was set to clean the oil on rocky surfaces using high-pressure

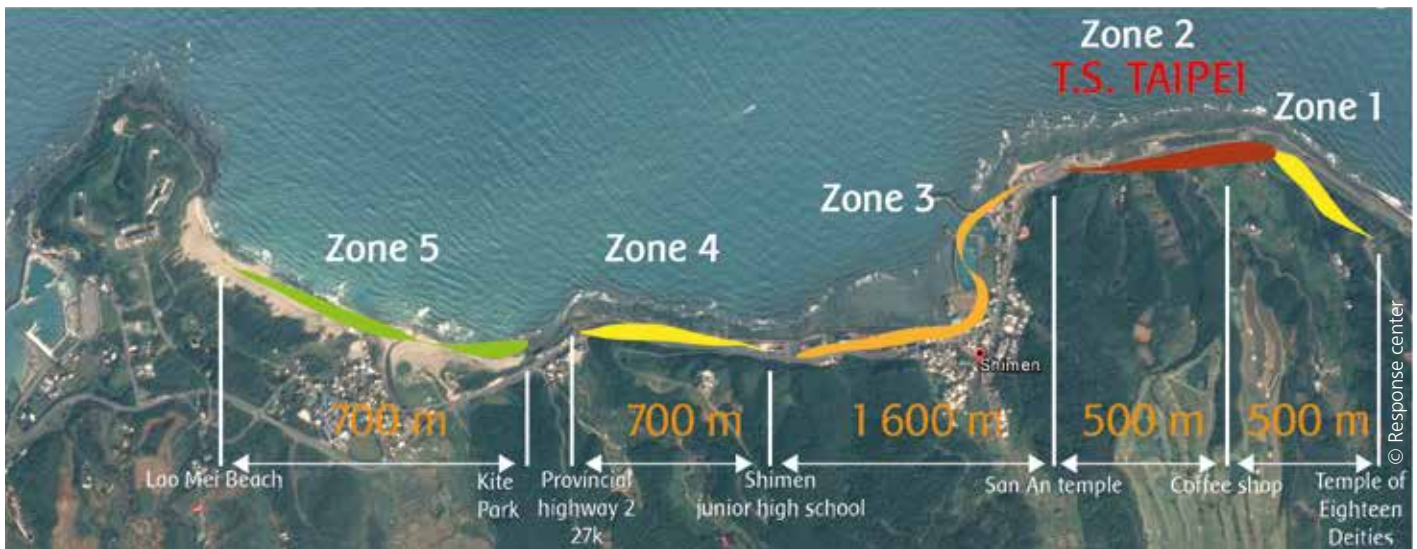
Map of strandings on the coastline

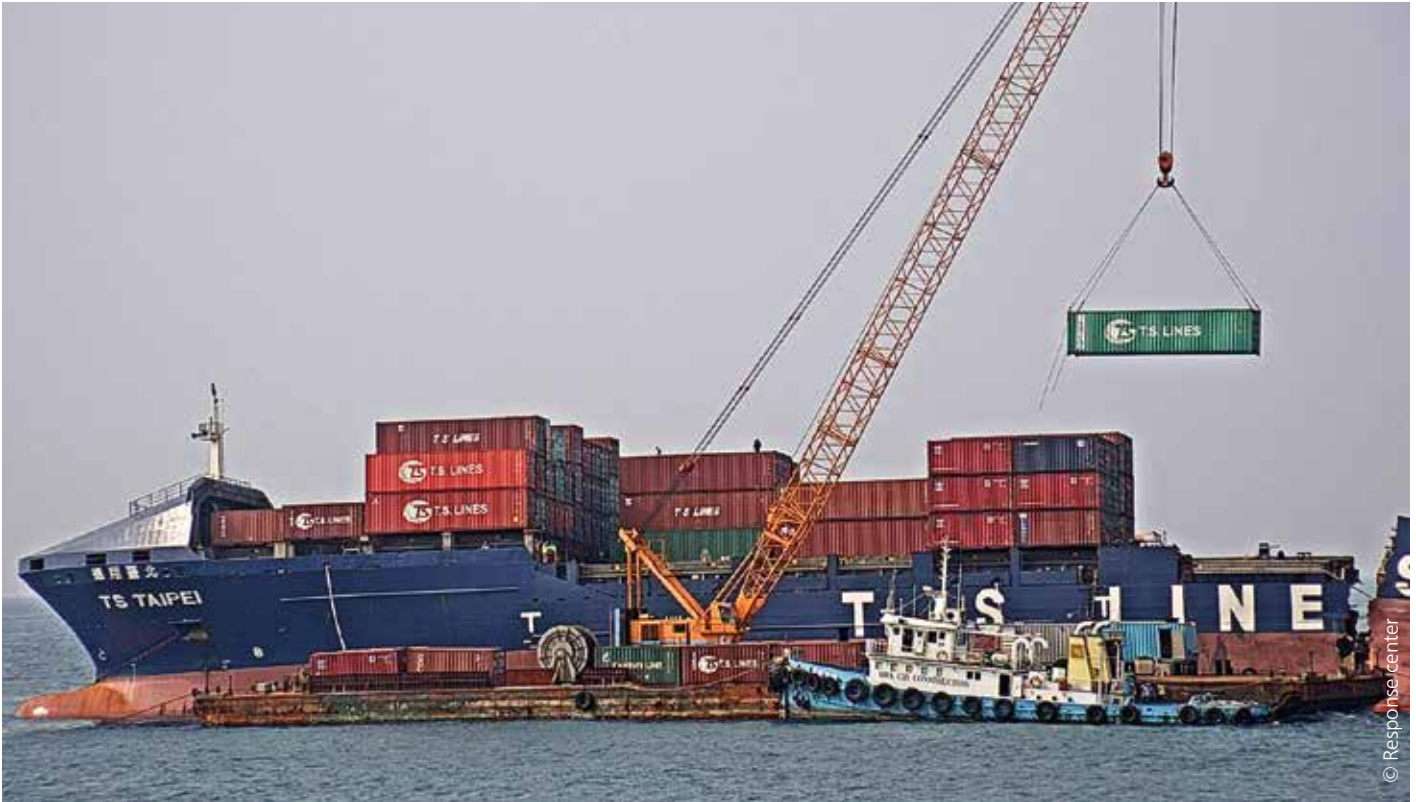
**Removal of upper deck containers**

The container removal started on 1<sup>st</sup> April as the fuel and oil extraction from the ship hull came to an end. This work aimed to remove containers on deck and in the cargo holds that were not damaged by water. On the front deck, there were containers loaded with cargo, eight of which contained hazardous substances, while those on the rear deck were empty. The priority containers to be removed were those containing hazardous substances, followed by the heavy containers on the front deck, empty containers on the rear deck and those in the undamaged cargo holds.

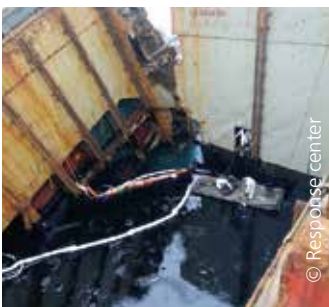
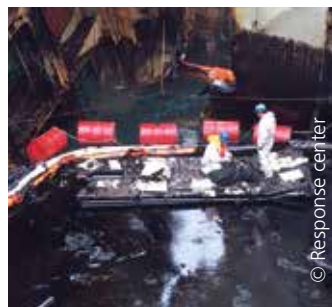
**Removal of residual oil in cargo holds**

hold were removed, the attention shifted to clean the fuel and oil spilled into cargo hold #3 and the objects scattered and soaked in oily water. These objects from the damaged containers were mostly backpacks and long rolls of plastic fabrics. These plastic fabrics were entangled and soaked in oily water. The space-limiting conditions made manual cleaning very difficult, let alone the use of a skimmer. Therefore, professionals were sent down to the floor of the cargo hold

to cut and fetch these oil-soaked objects out of the oily water before the following oil skimming and cleaning could be conducted. After most of the spilled oil and oil-soaked garbage had been removed, high-pressure water jet was used to remove the oil residues on the bulkhead and containers, and the stripped residues were removed using ropes, balls and patches of absorbents as well as saw dust. The cleaning of residual oil and oil-contaminated objects in the cargo holds was completed on 5<sup>th</sup> May.

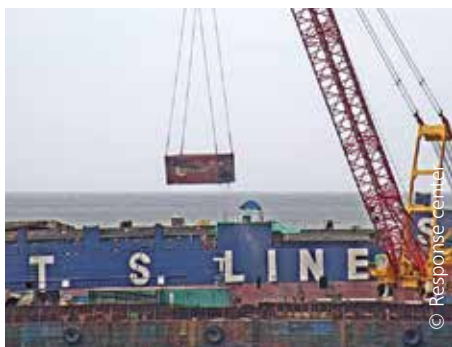
The response team started lifting all the hatch covers on 25<sup>th</sup> May. With the confirmation of hull stability, the soaked containers in the cargo holds were lifted out one by one to allow the water to drain before placing the lifted containers onto the deck barge. Oil absorbent materials, such as absorbent ropes and fabrics, were used throughout the draining and lifting process to prevent residual fuel and oil from contaminating the surrounding waters.

Lifting of submerged containers

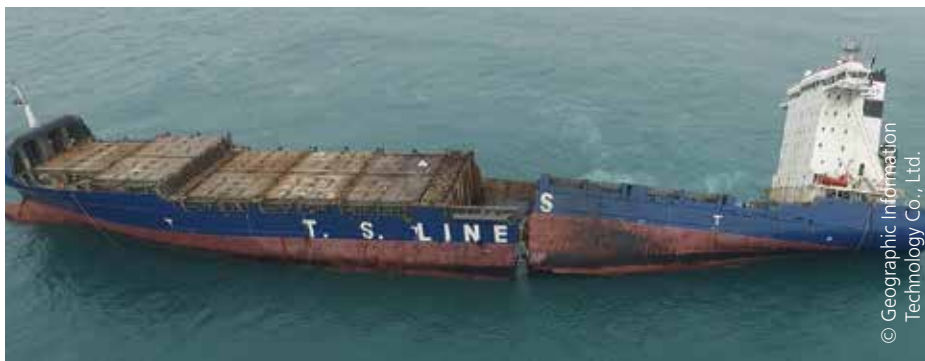
The rear section with a 32-degree list

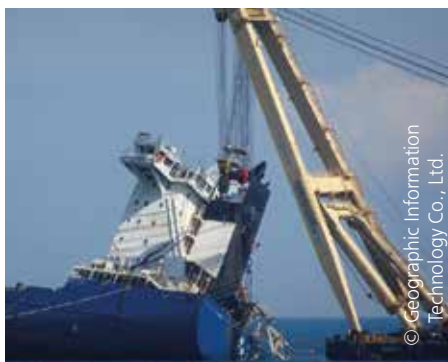
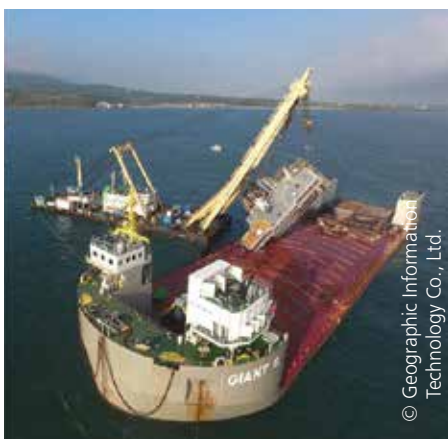
The salvage team started to remove the on-board living quarters, weighing approximately 650 tonnes, on 11<sup>th</sup> June in order to stabilize the rear section by reducing the weight for the following refloating and tow-away. The separation was performed with torches and chains. Before cutting, all flammable materials were removed. Once preparations were complete, cutting started on 19<sup>th</sup> June. After experiencing several chain-breaking incidents, the living

Removal of living quarters

quarters were separated successfully and lifted from the shipwreck on 22<sup>nd</sup> June and placed on the semi-submersible deck barge the following day.

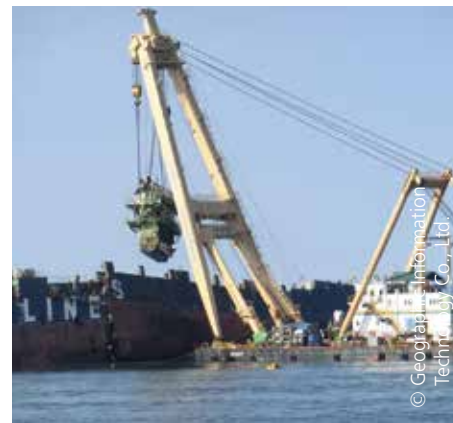
With the living quarters being removed, the removal of 450-tonnes engine started on 23<sup>rd</sup> June. During this phase, much of the work, which involved stopping leaks, cutting, pumping and securing the sling, was done in an oily water environment due to the significant damage to the engine room. The team lifted the engine off the shipwreck on 1<sup>st</sup> July and the engine was loaded on the deck barge on the next day.

Removal of the engine

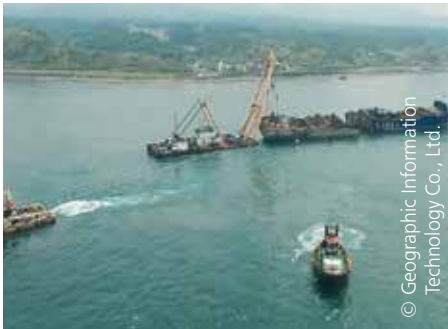
The rear section of shipwreck was refloated, towed away and loaded on the semi-submersible deck barge

even with the living quarters and engine removed, greatly exceeding what the 1,000-ton floating crane could handle. The water pumping was a continuous effort on the rear section as the structure was massively damaged and the leaks were almost impossible to stop. However, the team managed to have the section lifted and towed away from the site using the floating force during the high tides on 22<sup>nd</sup> July. With the floating crane lifting the stern and leaks roughly stopped, the salvage team started to refloat and tow the section away with 2 tugs during high tides. As the process went on, the hull was breached again and taking on water, and the bottom became jammed on the rocks, not to mention a few snapped cables on the tugs. Despite the odds against the operation, the team managed to tow the rear section off where it was aground on 25<sup>th</sup> July and loaded the section on the deck barge on 27<sup>th</sup> July. The damaged and rugged bottom of the shipwreck made it difficult to secure it to the barge deck. However, the salvage team secured the wreck on the deck on 31<sup>st</sup> July using wood/blocks as auxiliary supports. On 1<sup>st</sup> August, this part of the shipwreck was hauled away from Shimen to Keelung Harbor for disassembling.

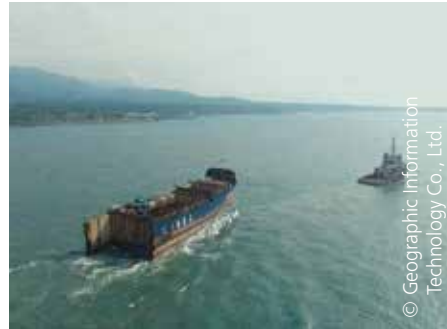
The front section of the shipwreck was refloated and towed to Keelung Harbor

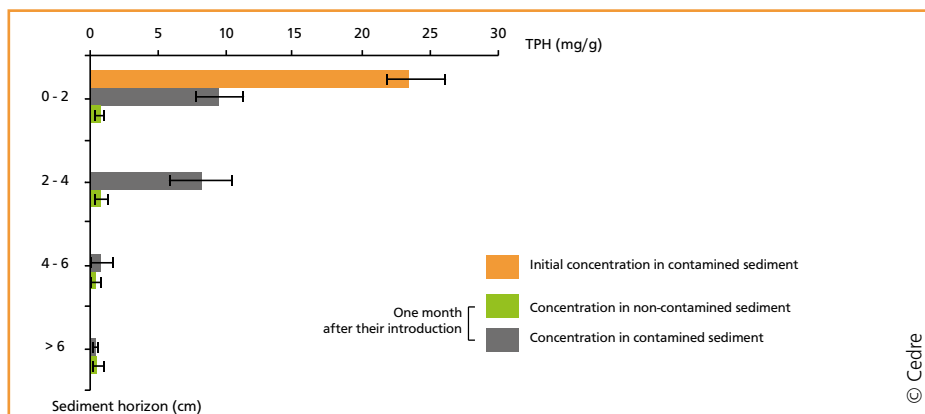
More detailed chemical analysis of the concentrations of alkanes and aromatic compounds showed a high level of degradation, reaching 90 % after only 4 weeks of exposure. This degradation level was achieved due to the presence in the sediment of hydrocarbon-adapted bacterial communities which was also confirmed by the microbiological analyses. These bacteria, known as hydrocarbonoclastic due to their capacity to break down hydrocarbons for their development, are therefore naturally present in this type of environment, which explains the level of biodegradation obtained.

Fig. 1 - Total petroleum hydrocarbons (TPH) measurements in the sediment by depth

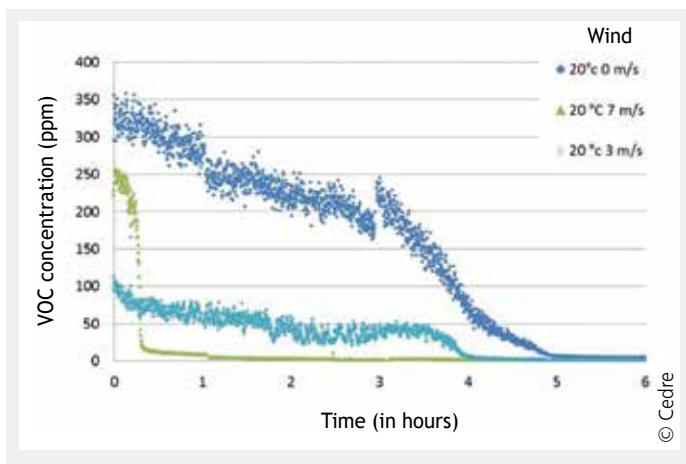
**Fig. 1 - Evolution in n-butyl acrylate concentrations above the water surface measured at 3 wind speeds**

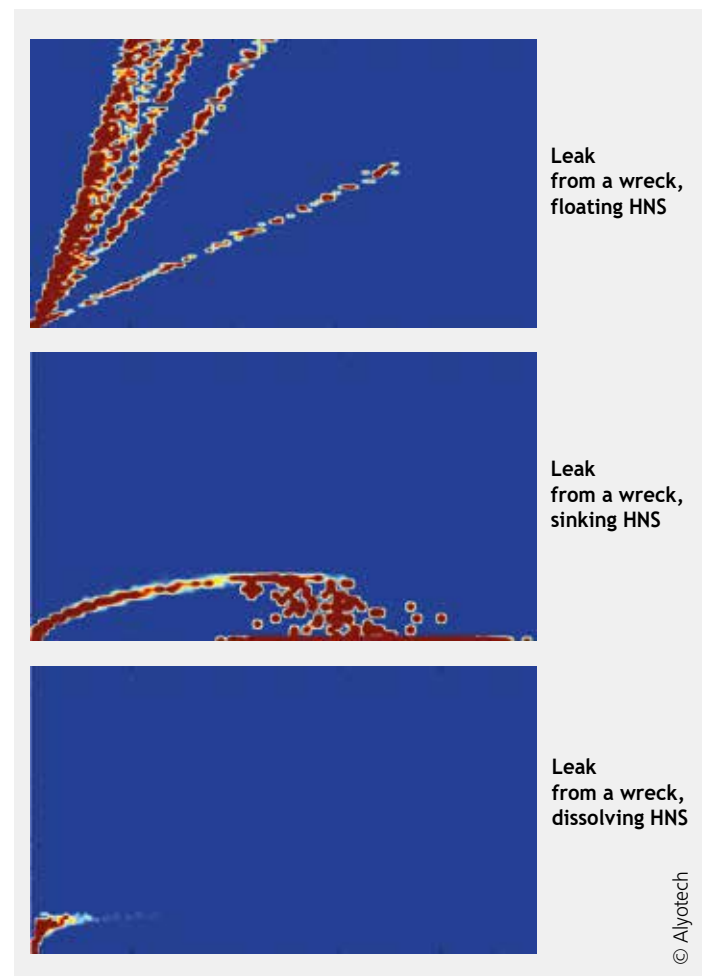
**Concentration profiles in the water column (ChemSPELL model and NASA GISS Panoply viewing tools)**

All the experimental results obtained were used to calibrate and validate the chemical fate modelling systems. A 3D mathematical modelling system was developed for several leak scenarios (surface vessel, pipeline, wreck, etc.).

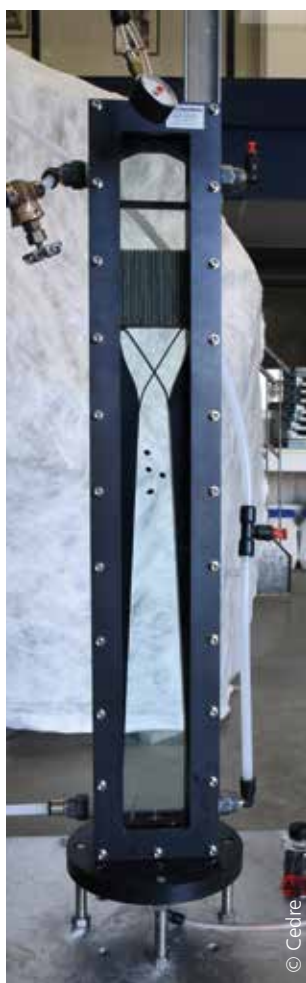
But what on earth is it??? The C<sup>3</sup> is an innovative experimentation device designed to place a fluid particle in suspension in a liquid environment using a countercurrent. The concept was invented by the *Ecole des Mines d'Alès* and Cedre as part of the Blow Out 2 project and the CounterCurrent Column (C<sup>3</sup>) was designed and built by Ylec Consultants. This system is set to be used to study the dispersion and dissolution of oils, chemicals and gases, in order to characterise their fate as they rise through the water column in the event of an accidental subsea release. This information is essential for responding as efficiently as possible to subsea spills and mitigating their impact on the aquatic environment.

Studying chemical dispersion of oil in the countercurrent column

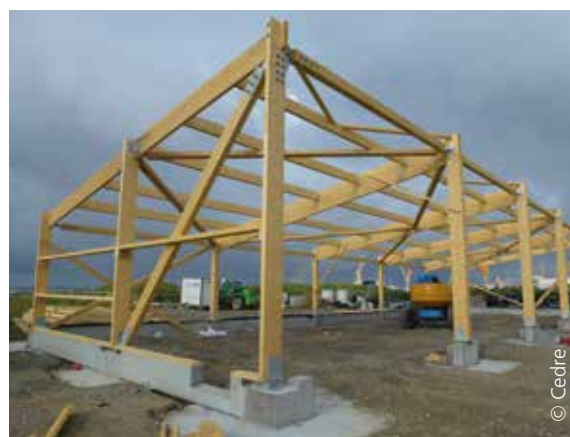
Cedre's storehouse under construction

This simplistically designed outbuilding has a glued laminated timber structure and was chosen as the most cost-effective solution. It is built on large concrete slabs connected by horizontal beams. The structure's dimensions were determined in order to suit the relatively heterogeneous ground in this polder. The forward and rear walls are covered with rot-proof wooden cladding and the two end walls are composed of polycarbonate panels offering natural light. The floor is a single layer of bitumen similar to that used for road surfaces. It has 5 large sectional doors facilitating access to each of the stored vehicles.

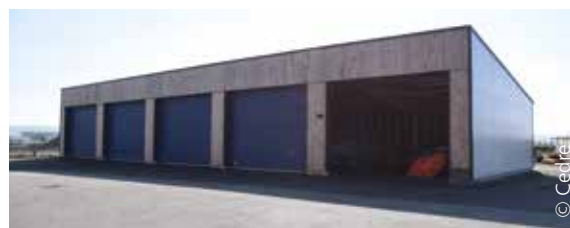
Cedre's storehouse completed
