**CENTRE OF DOCUMENTATION, RESEARCH AND EXPERIMENTATION ON
ACCIDENTAL WATER POLLUTION**

Sea & Shore Technical Newsletter n°44

2016-2

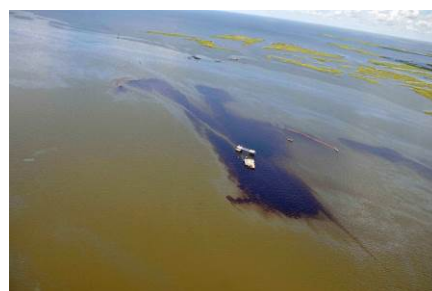
July 2016: Drift and spread of a crude oil spill from an abandoned flow line (Barataria Bay, Louisiana) (Source: USCG)

USCG aircraft based in New Orleans were mobilised in order to assess the spread of the spill, which rapidly affected an area of over 2,000 hectares (8 square miles) in Barataria Bay, including areas of coastal marshland vegetation.

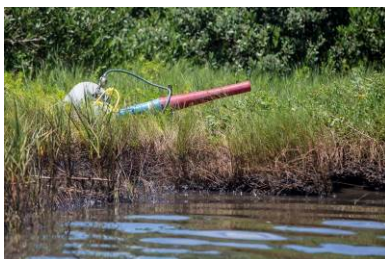
Deploying booms from an airboat (left); Setting up bird scaring gas cannons (right) (Source: J. Dermansky / RR)

Furthermore, concern over impacts on coastal and marsh-dwelling birds, due to contact with oiled vegetation in the area affected by the spill, led to acoustic bird deterrents (gas cannons) being deployed throughout response operations.

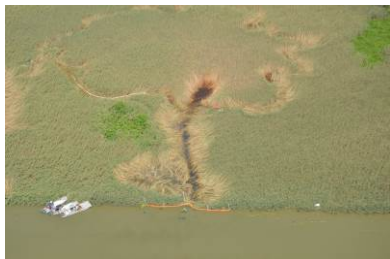
28/07/2016: Aerial view of the oiled streams in the estuarine marshland (Southwest Pass), due to a leak of crude oil from a pipeline (Source: USCG)

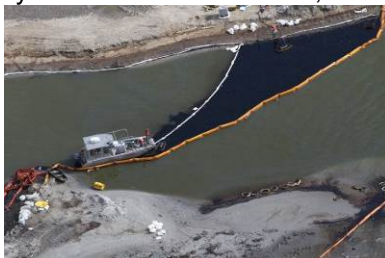
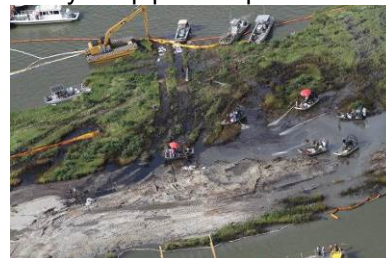
8/9/2016, Chenier Ronquille barrier island: **Left:** Booms laid diagonally to contain the free oil accumulating along the coastline; **Right:** Rinsing oiled vegetation using low pressure hoses deployed from airboats; containment systems on the water for remobilised oil (Source: www.nola.com/RR)

Deposits of crude located along the vegetated shorelines were remobilised by rinsing (using low pressure hoses), before being contained and pumped off the water. Six days after the spill, the authorities announced that around 25 m³ of oily water had been collected from the water. We are not aware of the final figures for these operations. The environmental impact of the spill proved to be limited: the UC estimated that approximately 200 birds were oiled to various degrees in the affected area. Around 10 specimens were captured to be cleaned and rehabilitated.

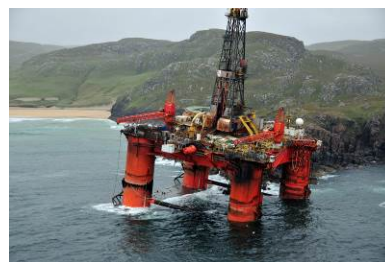
The Transocean Winner rig grounded on the Isle of Lewis (source: UK MCA)

Nevertheless, the day after the rig ran ashore, the Transocean and SMIT Salvage experts who boarded the rig to assess its damage found that 2 of the 4 onboard diesel tanks were cracked and leaking. According to the UK Maritime and Coastguard Agency (MCA), in charge of supervising the operational management of the incident, the platform had been transporting 280 tonnes of diesel when the incident occurred. MCA estimated the maximum volume spilt at 53 tonnes, a quantity unlikely to generate a significant environmental risk given the low persistence of this type of fuel as well as the high dissipation potential due to weather conditions (subsequently confirmed by observations).

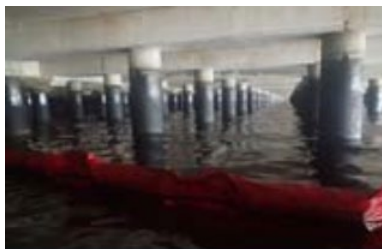
Containment of heavy fuel oil trapped under wharfs (built on concrete piles) at the ATB Vitol oil terminal (Source: ITOFF)

The highest levels of oil were reported at the oil terminal, near to the spill point, i.e. on a wharf and on its supporting concrete piles, which were more difficult to access.

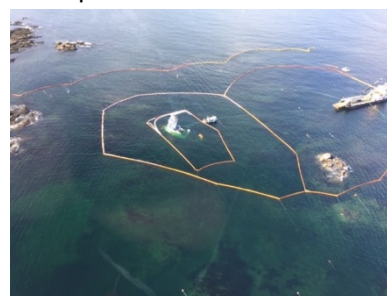
*Laying booms around the submerged Nathan E. Stewart
(Source: WCMRC)*

To compensate for the equipment transport times (around 20 hours according to press sources), WCMRC commissioned a local company (Shearwater) to immediately deploy booms around the *Nathan E. Stewart*. The tribal authorities of Heiltsuk First Nation were also involved in this initial response action (see below).

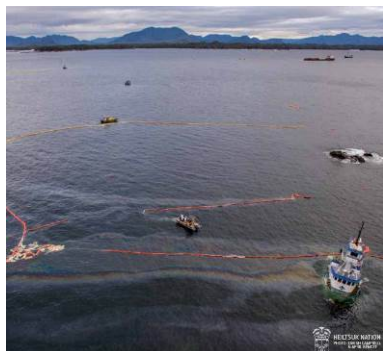
*Containment system broken loose due to adverse sea and weather conditions
(Source: Heiltsuk Nation)*

Response actions at sea – mainly containment and recovery – were slowed by the remote location of the site (not easily accessed from the shore) and adverse sea and weather conditions, which caused operations to be suspended at times over the first days following the incident (furthermore, the extensive spread of this light product in this open environment hindered, if not prevented, the recovery of significant quantities on the water).

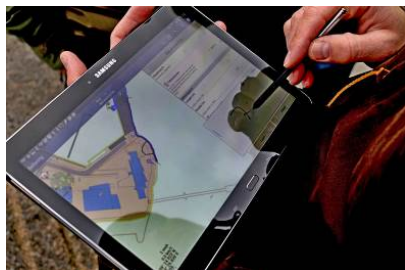
Source: <http://kystverket.no/>

Furthermore, the need was also felt to optimise the system's capacity to integrate detailed/precise data. In response to these needs, NCA and NOFO worked together to develop a mobile app (for smartphones, tablets, etc.) dubbed *Strandappen*, to collect data via standardised forms (as well as photographs, videos, etc.) and quickly upload them to a geographic information system which compiles all the spill surveys (on foot, from aircraft, at sea, etc.) and the different types of operations implemented.

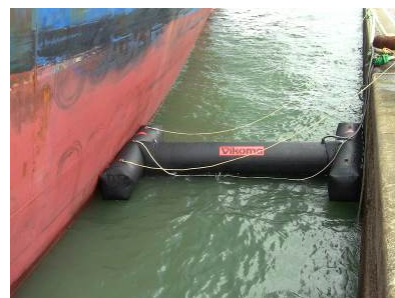
View of the VikoSeal deployed between a ship and the dock (Source: <https://www.vikoma.com/>)

According to the manufacturer, the device has high abrasion resistance and high tensile strength (in particular resistance to towing and compression) – vital given the conditions in which it is used – thanks to its vulcanised neoprene. The draught of this boom is around 10 cm.

The Vikoseal comes in 2 sizes, approximately 3 m and 4.5 m wide. In addition to its preventive role, as described above, the manufacturers claims that this device can be used in emergency response as a spacer for conventional booms deployed for instance around a grounded, leaking vessel (in order to provide a recovery/skimming area for floating substances).

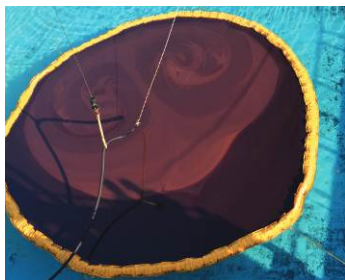
Prototype of the HARBO T-Fence Boom™ being tested at OHMSETT (source: HARBO)

This system aims to effectively contain a floating oil spill thanks to its seakeeping performance in swell. Its performance appears to have been proven in the test conditions used in late 2014 at the OHMSETT facility²⁴ during the concept development phase (although we note that these tests did not cover the deployment manoeuvres).

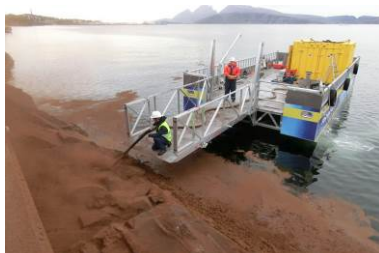
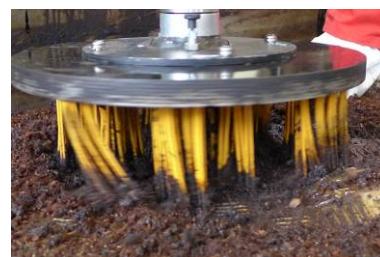
Shoreline clean-up by bulk sorbents: spraying (FoxBlower, left) then mixing (FoxMix, right) of particles (Source: www.hhenriksen.com)

Powered by a small 4-stroke engine, a rotating head with interchangeable brushes, selected according to the type of substrate to be treated (pebbles, wave-cut platforms, etc.), mixes the sorbent particles (fibres, shavings, granules, etc.) with the oil.

This is a compact, lightweight system that can be operated by a single operator and transported across beaches with limited access. This device is reminiscent, in terms of its form and purpose, of the MOSE (Mechanical Oil Spill Equipment) developed a few years ago through the research and innovation programme Oil Spill Response 2010²⁷, and since manufactured and marketed by MOSE Innovation.

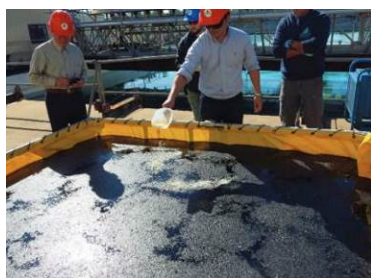
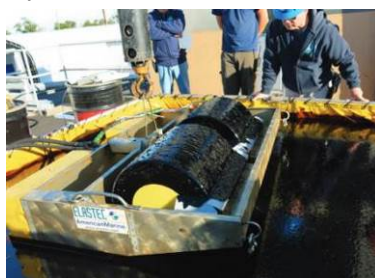
Mesoscale tests: spreading i-Petrogel flakes on crude ANS (left); skimming with an oleophilic drum skimmer (TDS Elastec, right) (Source: OHMSETT)

- The first phase consisted in formulating and developing a gelling agent with a high absorption capacity for ANS crude oil, before producing samples whose absorption performance was assessed in the laboratory. This performance (absorption capacity, kinetics) was then validated at mesoscale (in 3 m x 3 m experimental tanks at the OHMSETT facility) through tests on various formulations during which the skimming and pumping of the gelled oil were also tested.
- the second phase aimed to establish a production process to manufacture larger quantities of the gel, in the form of flakes to enable it to be applied by aircraft, and to conduct new tests (application, efficiency, skimming using oleophilic drum skimmers, etc.) in operational conditions close to those expected in the Arctic, at the OHMSETT facility.

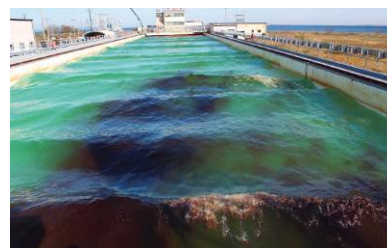
Large-scale evaluation of the effectiveness of approved dispersants in warm water and wave conditions (source: BSEE)

The dispersant effectiveness was estimated according to the oil distribution, after treatment, between the 2 phases, i.e. the residual slick and the water column. The droplet size distribution was also measured using Laser In-Situ Scattering and Transmissometry (LISST).

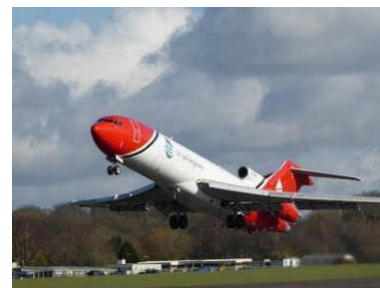
The British firm T2 Aviation won the tender issued by OSRL to select, modify and certify an aircraft which would meet these requirements. The chosen aircraft, 2 medium-haul Boeing 727-2S2F (RE) planes, now chartered by OSRL²⁹ were modified to accommodate 7 dispersant tanks (with a total capacity of 15 m³), pumps and the newly developed Tersus Spray System. Spraying operations are implemented at around 40 metres altitude at a speed of 150 knots (similar to that of the Hercules plane).

(Source: OSRL)

Based in Doncaster (UK), the *G-OSRA* and the *G-OSRB* comply with specifications approved by the UK Civil Aviation Authority and by the European Union Aviation Safety Agency (EASA). These specifications include compliance of the spray system with current flammable fluid certification requirements (e.g. double-skinned tanks and pipework, the ability for the system to maintain

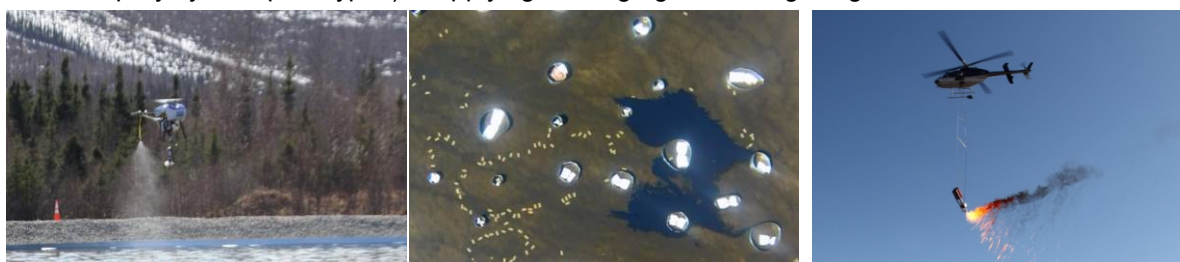
*Trials in experimental basins (8,400 m²) at the Poker Flat Research Range (AK-USA). **Left:** drones spraying herding agents; **centre:** aerial view of slick concentration/thickening operations; **right:** ignition by Heli-torch (source: SL Ross/University of Alaska Fairbanks)*

A presentation was given on the work of the IOGP Arctic Response Technology JIP, which funded (late 2014) the construction of a test basin in Alaska (Poker Flat Research Range), under the supervision of SL Ross Environmental Research Ltd and the University of Alaska Fairbanks (UAF) which have since used this facility to jointly assess the effectiveness of aerial systems (helicopter, drones, spray system prototypes) in applying herding agents and igniting oil slicks.
