RECOVERY OF SUNKEN AND BURIED OIL IN COASTAL WATER DURING THE ERIKA SPILL

ABSTRACT: *The Erika spilled a very high density, high PAH content persistent heavy fuel oil that impacted over 400 kms of France's West Brittany coastline resulting in a protracted period of shoreline cleanup. One of the sites oiled by the HFO was Pen Bron, located seaward of the Croisic salt marshes. This large and very environmentally sensitive area with extensive salt pans and bivalve production was polluted by a significant spill of sunken oil buried in the sediment. In view of the risk to local resources and amenities, operations were undertaken to remedy the sunken oil spill: the pollution was mapped and cleanup techniques studied to define the optimum technique for removing the oil that sank and was buried in an area subject to strong tidal currents. Site restoration was conducted in two stages:*

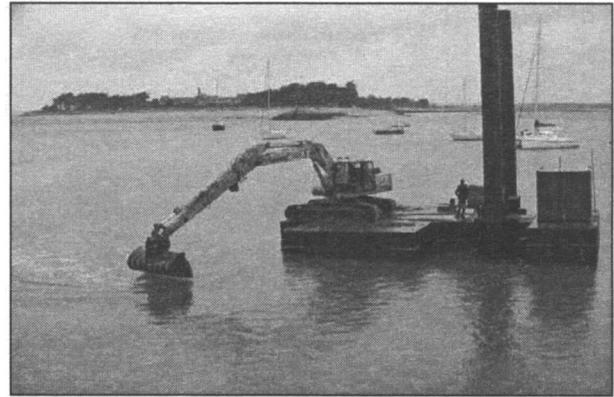
Figure 3. Mechanical shovel on the pontoon.

Dredging heavily polluted sediment. The excavator was a mechanical shovel of large dimensions mounted on a floating barge (figure 3). The shovel was a 2 cubic metre bucket fitted with a filter to drain the sand (figure 4).

A surface area of 1,500 sq m (including a 700 sq m area of very heavily polluted sand) was removed down to a depth of about 30 cms involving the subsequent removal of 800 tonnes of heavily polluted sand. This technique proved to be very quick and enabled response teams to cater to first line emergency requirements and in particular the fact of being able to open the saltpan sluice gates.

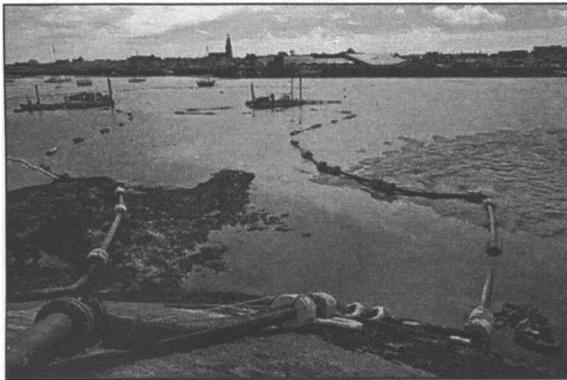
Figure 6. Overall view of the dredging system: two suction dredges anchored on piles and the hoses that deliver the polluted sand and water to the settling lagoon.

Collecting polluted sand by suction dredging (figure 6). Collection and recovery of the polluted sand was performed by

two identical anchored suction dredgers that could move on. A blade cutter located at the end of the dredging arm cut up the recovered materials whilst a pump recovered and delivered them at a rate of 240 cu m per hour via semi-rigid hoses (internal diameter : 250 mm) to a settling lagoon.

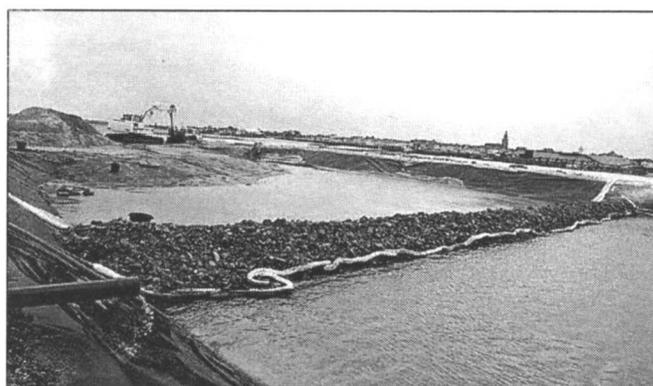
Figure 12. The pools separated by the stone wall/mound. The temporary storage facility for dredged sand.

The sand. In pool number one the sand fractions that were nearly fully cleaned were forced against the stone wall and settled quickly as the grain size was relatively coarse. The sand thus settled was then collected by a mechanical shovel and stored temporarily and drained at the edge of the lagoon. Samples were taken to ascertain the residual oil content and the testing was done quickly on the spot using UV - visible photospectrometry in a field lab set up nearby the work site. Depending on the field lab findings, the sand could either be put back into the environment nearby on an exposed section of the coastline for « surf washing » or else shipped to Donges as waste.

Disposal as waste. It was agreed that the very polluted sand with an oil content in excess of 1,000 ppm (top limit for this technique) would be shipped to Donges (figure 12).
