**CENTRE OF DOCUMENTATION, RESEARCH AND EXPERIMENTATION ON
ACCIDENTAL WATER POLLUTION**

Inland Waters Technical Newsletter n°28

LTEI 2018

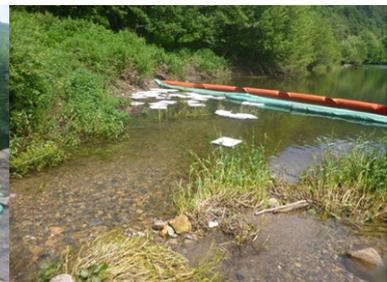
Photo 3 (source: Cedre)

The response operations therefore mainly focused on the Bramont River, and more specifically on its confluence with the Tarn River where the high flows nevertheless made it difficult to deploy effective containment systems in the first few hours following the spill. Two days after the incident, residual quantities of heating oil were recovered there via the implementation, by the SDIS, of equipment comprising successively (from upstream to downstream): (i) a flat construction boom lined with a sorbent boom (with sorbent pads in the collector pool (photo 1); (ii) a water reservoir (approximately 25 m x 10 m, dug using a power shovel), creating a lull in the river and the re-coalescence of the heating oil mixed in the upstream sectors (then recovered using sorbents placed at the weir) (photo 2); and (iii) a floating boom lined with a sorbent boom on the Tarn River (photo 3).

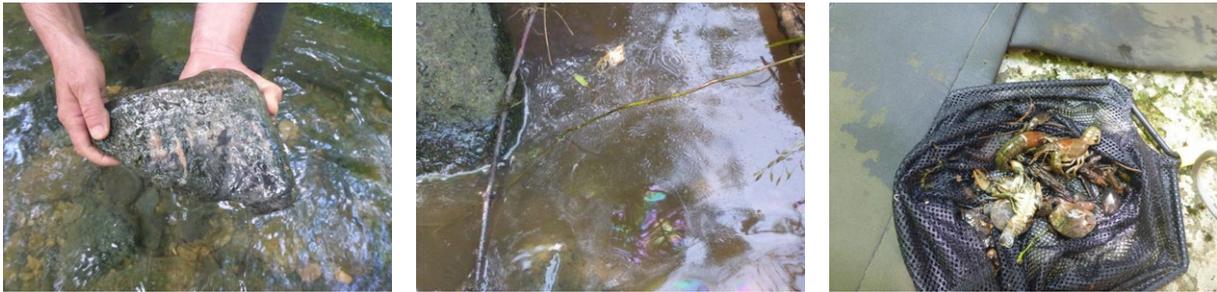
Consequences of the mixing of the heating oil: traces of emulsified oil trapped on the underside of stones (left); release (sheen) from loose substrates (centre); impacted individuals of freshwater species living on stony/gravelly bottoms (white-clawed crayfish - *Austropotamobius pallipes*) (right) (source: Cedre)

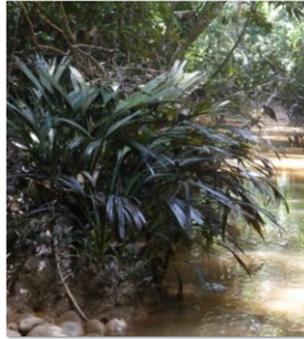
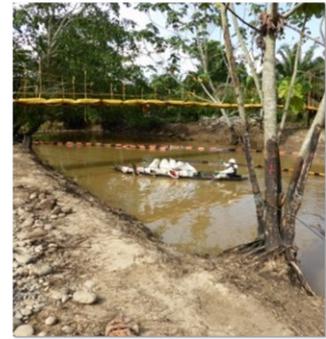
Assessment conducted following the emergency response operations: oiled vegetation (**left**); removal of bags of oiled solid waste (**right**) (source: Cedre)

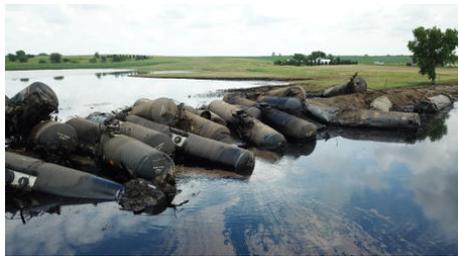
Spill of crude oil from rail tank cars into the Little Rock River (source: www.nts.gov)

On 22nd June in the state of Iowa, approximately 600 m³ of crude oil spilt into the Little Rock River following the derailment of a rail convoy comprising 33 tank cars, an accident caused by the collapse of waterlogged soils due to the river having burst its banks.

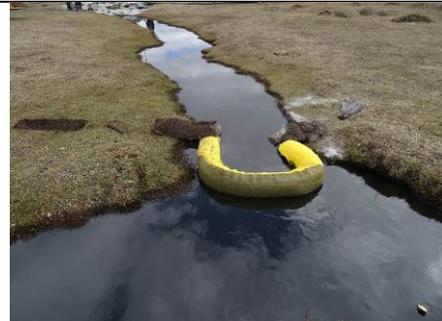
*Oil containment using sorbents on the Río Cullen
(source: DR/Agencia UNO)*

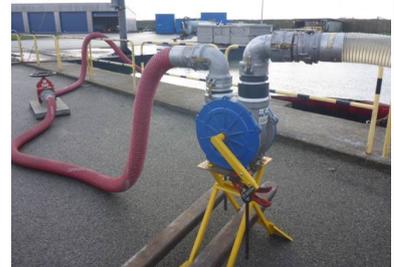
View of the Zelda II HVLS equipped with hand cranks (source: Cedre)

Twenty-two pumping trials were conducted using fluids of increasing viscosity: water, medium viscous oil (class II; 1,500 cSt), and heavy fuel oil (class III; 12,200 cSt).

To estimate the potential for implementation without mechanical means, the trials were performed⁶ using hand cranks, operated by two operators – whose appreciation of the level of difficulty was also noted. Some prospective trials were conducted using a hand-held power tool (mixer).

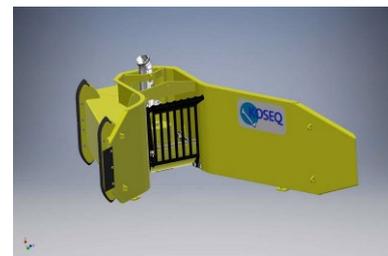
View of the Koseq Compact 2.5 sweeping arm (source: Koseq)

In the autumn of 2018, Koseq also announced an even smaller model, the Compact 2.5 measuring 2.5 m in length and weighing 200 kg, which is more specifically geared towards responding to small-scale spills – in port areas or in confined spaces (water bodies, rivers, etc.), for example.

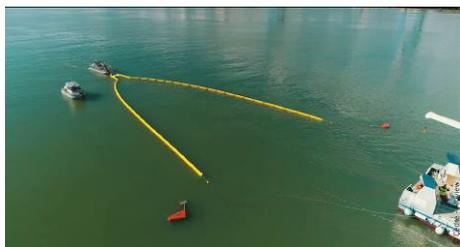
R3S system: FOST-1 in support/recovery, towed by the Bonne Anse (source: Cedre/Altiview)

The R3S, designed for the dynamic recovery of oil slicks in shallow waters with strong currents, combines a small recovery barge¹¹ and – on its bow – a MARCO Portable Filterbelt Skimmer,¹² located at the apex of a V-shaped collector pool, itself formed by two sections of permanent light booms (Optimax), separated by two deflectors (Boomvane) towed by a service vessel (here the SPB’s *Bonne Anse* buoy tender) operating at low speed.

Under the conditions of the assessment in dynamic mode (wind under 5 knots, no waves), and once the correct configuration of the booms was obtained (“V” shape), the system proved to be correctly manoeuvrable. The progressive increase in trawling speed made it possible to visually assess (by the appearance of vortexes along the deflection arms) the limit of effectiveness of the system at 2.1 knots (relative speed at the system’s inlet).

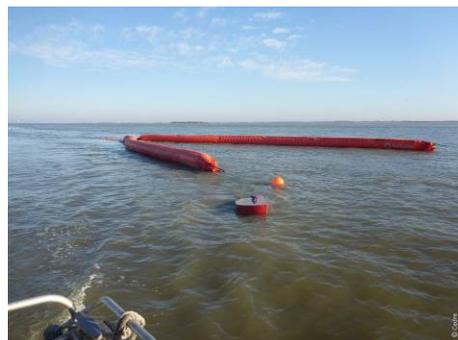
View of the NO-T-600 OilTrawl being towed by the *Bonne Anse* (out of shot) using the Trawldoor paravane (foreground) (source: Cedre)

The deployment of the OilTrawl by the *Bonne Anse* alone (19 m; 2x175 hp) using the Trawldoor paravane made it possible to avoid the coordination and communication issues encountered when towing with two vessels. In this configuration, the sea state capability of the system proved to be very satisfactory, both in a straight line and in any sharp turns. A loss of the simulated pollutant started to appear at around 3.5 knots of relative current measured at the system's inlet. It should be noted that the internal inflatable spiral reinforcement system appears to help the deflector arms adapt well to the deformations of the water surface (troughs of about 50 cm during the trials).

The robustly designed and relatively easy to install Trawldoor paravane proved to be sufficiently heavy to require lifting equipment for launching (here, the *Bonne Anse*'s deck crane). Finally, the trials in static mode confirmed the possibility of installing the OilTrawl alongside a dock using a paravane to keep the arms open to the current, and to perform the slackwater turning manoeuvre previously performed on other equipment tested on the site.

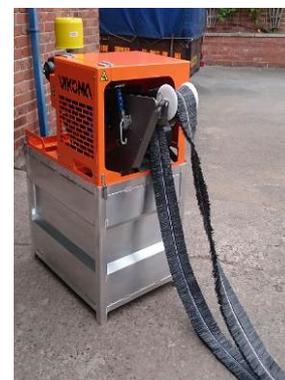
The Vikomop oleophilic band skimmer (source: Vikoma)

While it is essentially designed for an industrial market (treatment of polluted water), the reduced size of this model, its stainless steel construction, and its availability in thermal (diesel) or hydraulic versions contribute to making it a potentially interesting mobile system (in terms of transportation and deployment, for example) for certain emergency situations: in front of docks, in the event of the impossibility of launching large skimming heads, etc. The manufacturer indicates the availability of bands in lengths of between 3 and 120 m, and in two types depending on the oil to be recovered (light or heavy/viscous). The relatively simple design of the device apparently also enables easy installation, operation and maintenance.

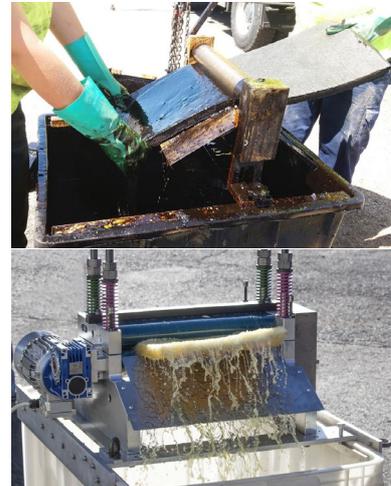
Various models of the FF-Wring (source: Test1)

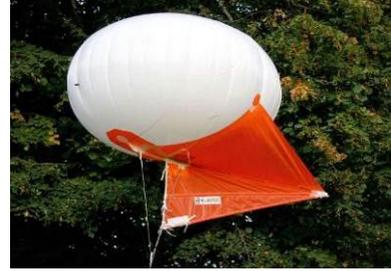
Aerostat 3 (source: Elastec)

Since 2018, American company Elastec has been marketing the Aerostat 3, a small-volume (3 m³) tethered balloon advertised as a compact and relatively inexpensive version of an aerial surveillance system that is also simpler to operate than a drone, for example, and requires less expertise.

Inflated with helium, the aerostat can remain in a stationary position for extended durations to enable real-time monitoring of floating pollution or even to check the effectiveness of response systems (containment or recovery, for example) using an on-board camera equipped with a wireless communication system.

Equipped with a signalling system (radar deflector and LED lighting), the Aerostat 3 is designed to be able to attain altitudes of up to 200 m, secured to an anchoring system by means of a rope made of UHMWPE¹⁷ fibre (Dyneema, from Dutch company DSM) chosen for its resistance (torsion, abrasion, etc.), its light weight, and its low elongation/deformation properties. It is also worth noting that the small on-board digital camera (action camera) is mounted on a gimbal stabiliser with three motorised axes, controlled remotely via software and a joystick.

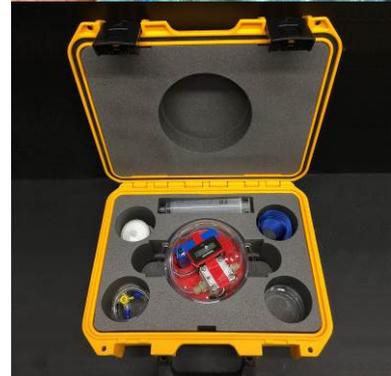
Detailed view of the CLAM system and the complete field kit (CLAM 5000) (source: aqualytical.com)

This system has been tested by various US government agencies (and notably by NOAA in 2018). One of its advantages is its autonomy of 48 hours. This enables the analysis of large volumes of water and thus, as required, (i) the integration of conditions over a relatively long period of time, as well as (ii) the ability to detect very low concentrations (below detection limits in one-litre samples of water, according to the comparative assessments conducted by NOAA). In addition, cartridge extraction enables storage for several weeks prior to laboratory processing, a major advantage over more usual spot water sample analyses that require shorter deadlines.

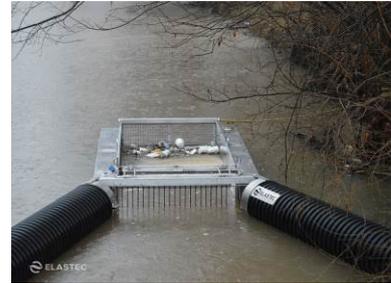
Brute Bin floating litter recovery pontoon with Brute Boom deflector booms (source: Elastec)

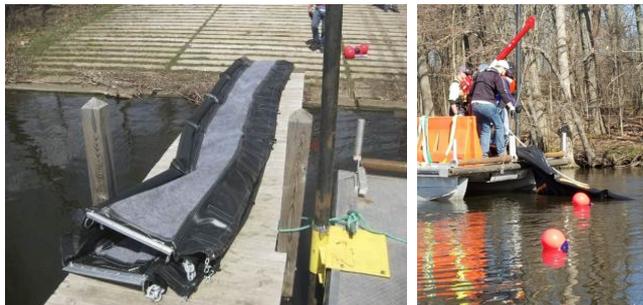
Left: view of a section (7.6 m x 90 cm) of the underwater deflection barrier prototype for rivers with strong currents; Right: lifting the deflection barrier using a winch. Note the use of plastic construction barriers filled with sand as underwater anchoring points (source: USCG Research and Development Center)

Initial assessments were conducted on the Kalamazoo River (Morrow Lake area, Michigan), a site chosen to evaluate the performance and limitations of a system designed to deflect oil drifting close to or on the bottom towards recovery areas under strong current conditions. These trials focused on the maintaining of the system (configuration, position, motion, sag, scour, tension, etc.) over periods of up to 24 hours and using various mooring methods depending on the type of substrate of the river bottom.

As this is a prototype developed by the RDC, the precise characteristics are not detailed at this stage. However, the design of the submerged system is similar to a silt curtain of PVC construction, with the upper edge consisting of a permanent flotation element to hold a skirt made of X-Tex filter fabric (from Ultratech International) in a vertical position.¹⁹ The lower edge comprises a PVC sheath accommodating the components ensuring ballast, tensioning, and mooring on the bottom (chains, slings, etc.). Its dimensions are relatively imposing (sections of 7.6 m in length and 90 cm in height).

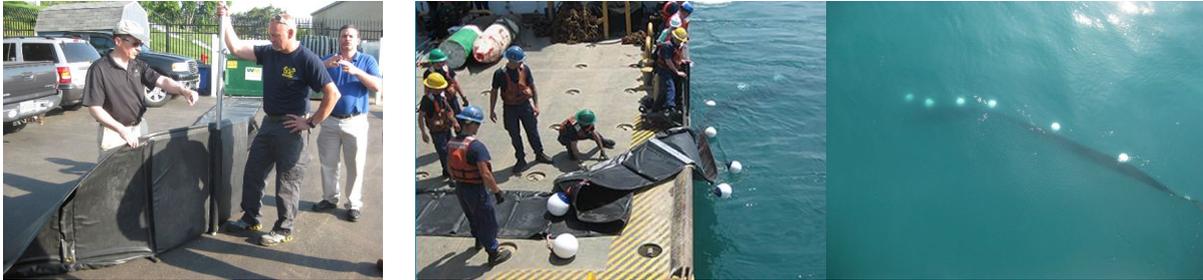
Views of the underwater barrier prototype developed by the USCG RDC for deployment in areas of relative hydrodynamic calm (source: USCG Research and Development Center)

the implementation of a second underwater barrier concept, anchored to the bottom from a USCG vessel with the help of divers, this time with the aim of preventing the spread/migration of locally sunken oil in areas of relative hydrodynamic calm (river meanders, lakes, possibly seabeds/coastal bottoms, etc.). During these trials, the prototype's installation/removal procedures and its *in-situ* performance (sea state capability/configuration) were assessed using a video camera mounted on an ROV.

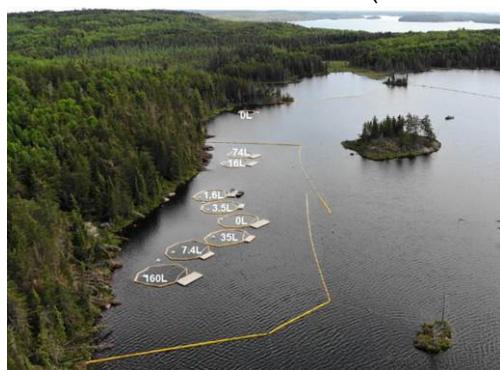
Aerial view of the mesocosms (with indication of the volumes of dilbit spill) (source: Shah et al., 2019)

Each mesocosm measured 5 m in diameter and between 1.5 and 2 m in depth. Their surface was delimited by oil booms and the water column was isolated using a polyethylene film. Each mesocosm was equipped with a rod device enabling samples of the water column to be taken at different depths.

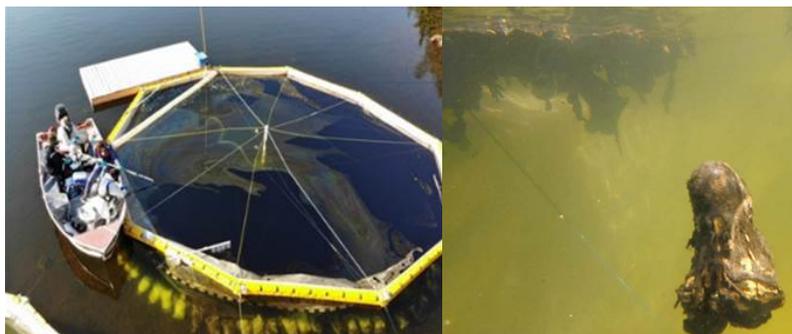
Left: spilling of dilbit into a mesocosm; **Right:** weathered dilbit in a mesocosm with fragmentation into balls and submersion/sedimentation (source: Stoyanovich et al., 2019)

After 10 days of weathering, due to the evaporation of the lighter compounds, a progressive submergence of the dilbit was observed for the mesocosm with the lowest volume of the substance (1.6 litres). After 30 days, the photo records showed the presence of balls of dilbit in the midwater or on the bottom for all of the conditions studied.
