# Portuguese Maritime Authority

# Dealing with a wreck stranded on a port breakwater: **THE CORAL BULKER**

## **INFORMATION DAY OF CEDRE IN PARIS – 6thOCT2003**

### **Dealing with a wreck stranded on a port breakwater: THE CORAL BULKER**

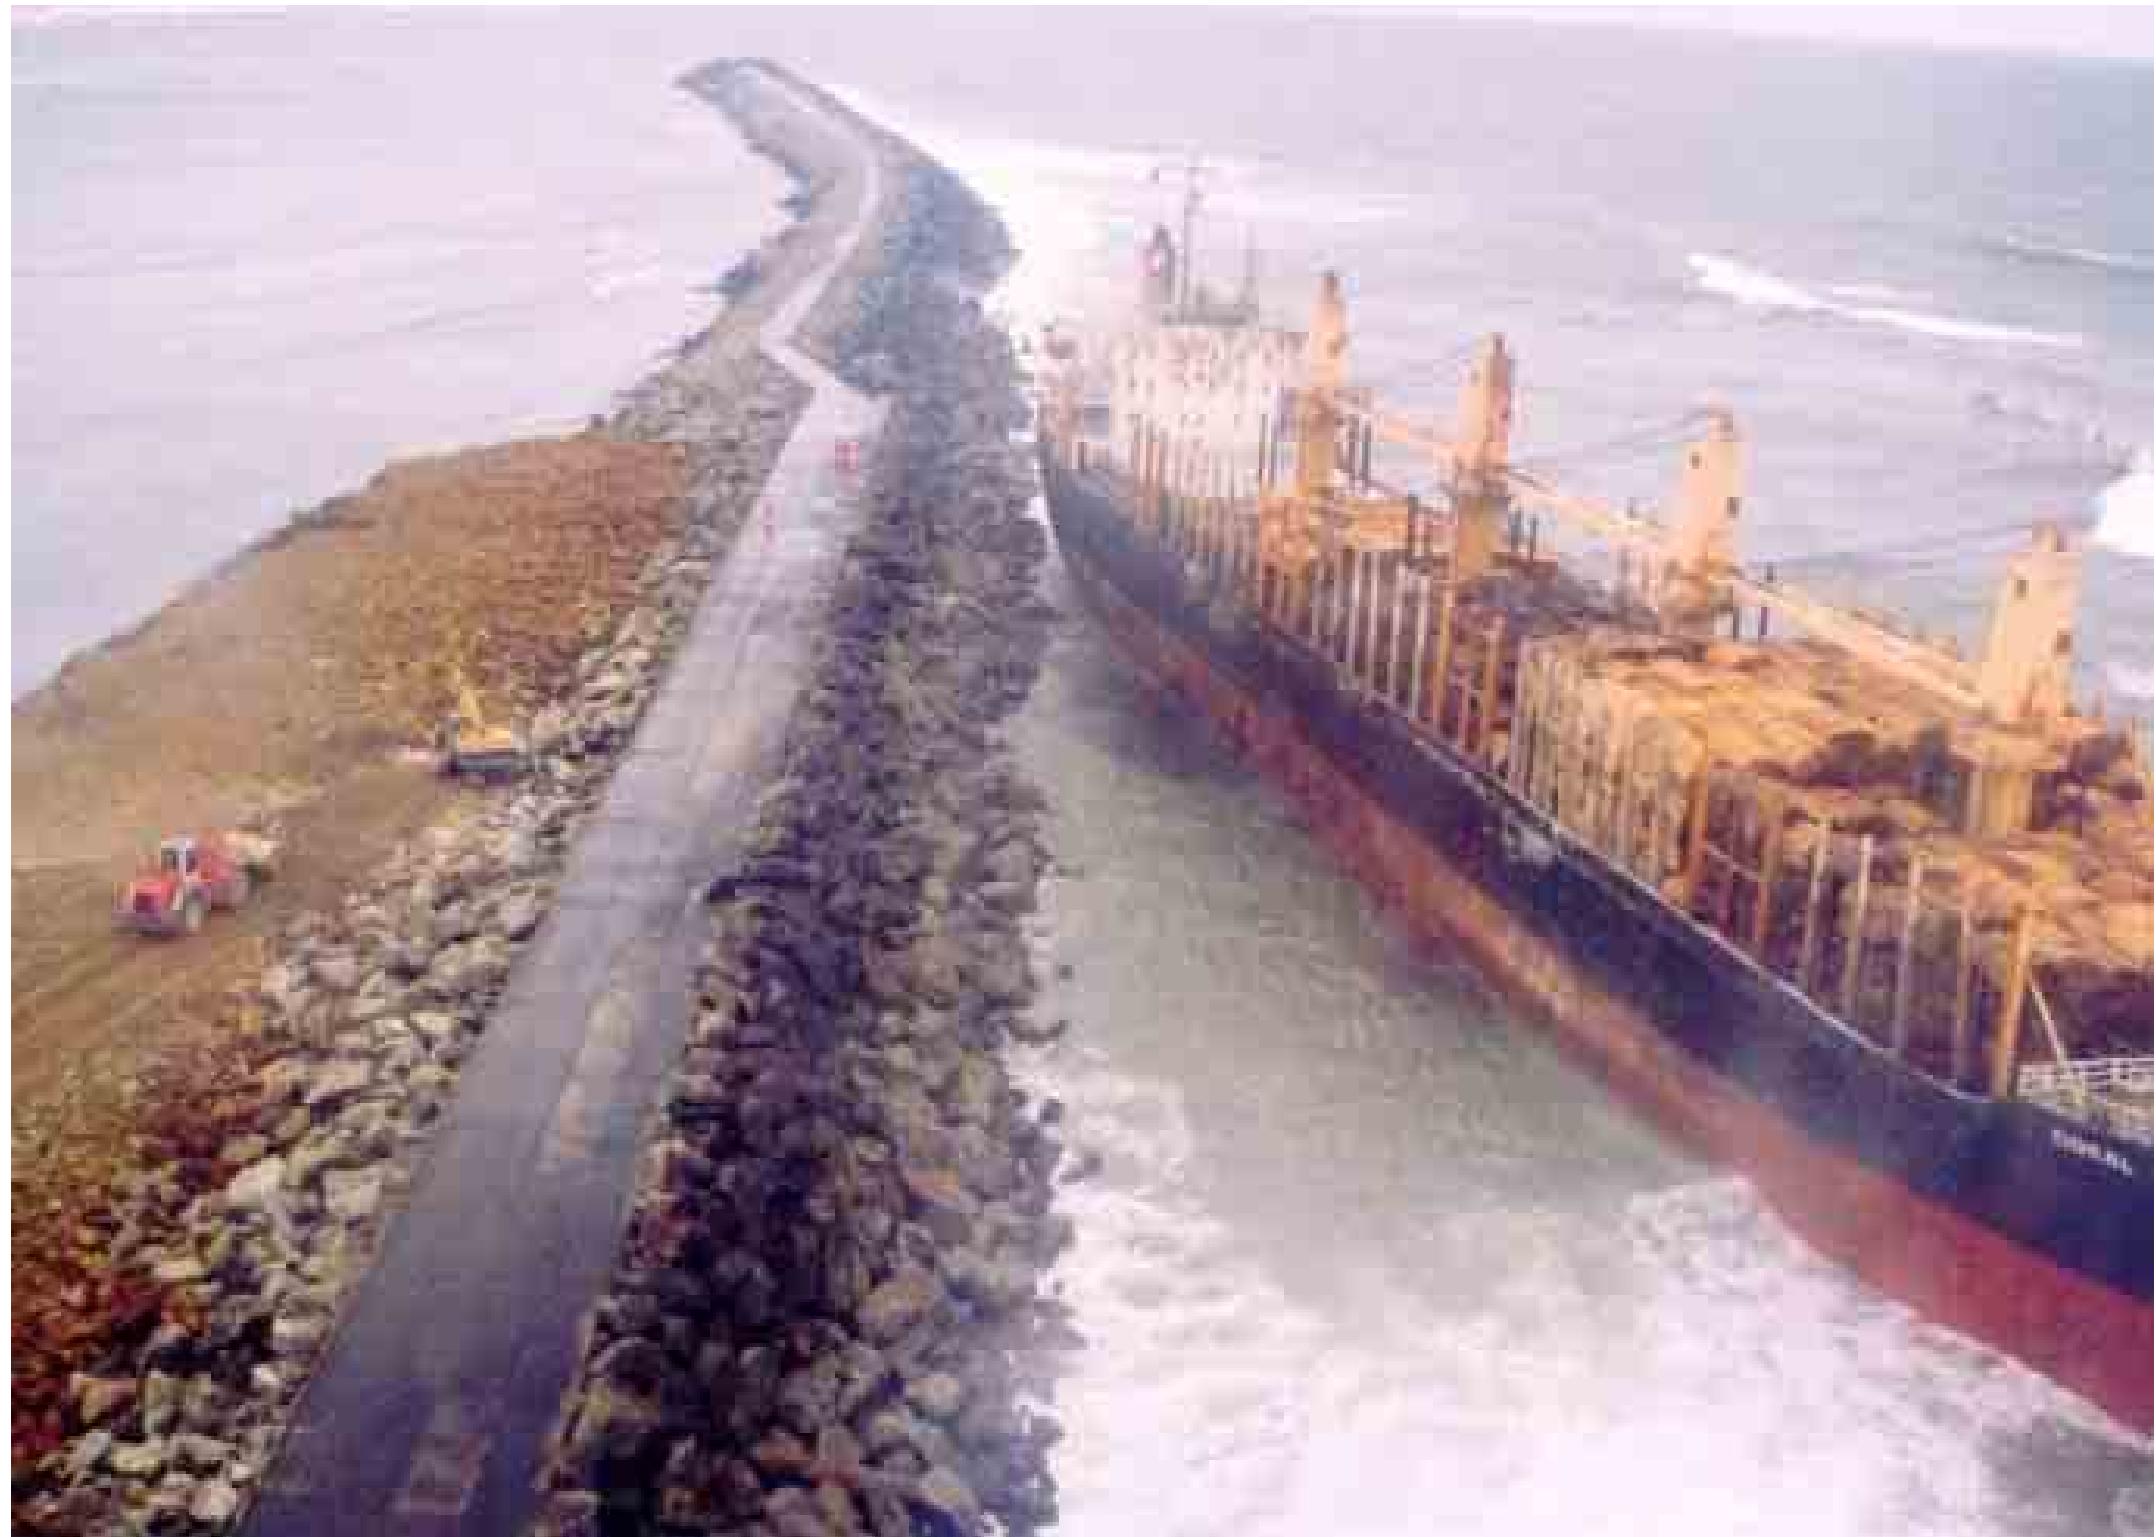
However, with the increase of the bad weather conditions and sudden violent storm of wind by the end of 25<sup>th</sup> DEC, the Coral Bulker dragged her anchor, ran aground adjacent to the northern breakwater and was stranded on it. [Slide 3](#)

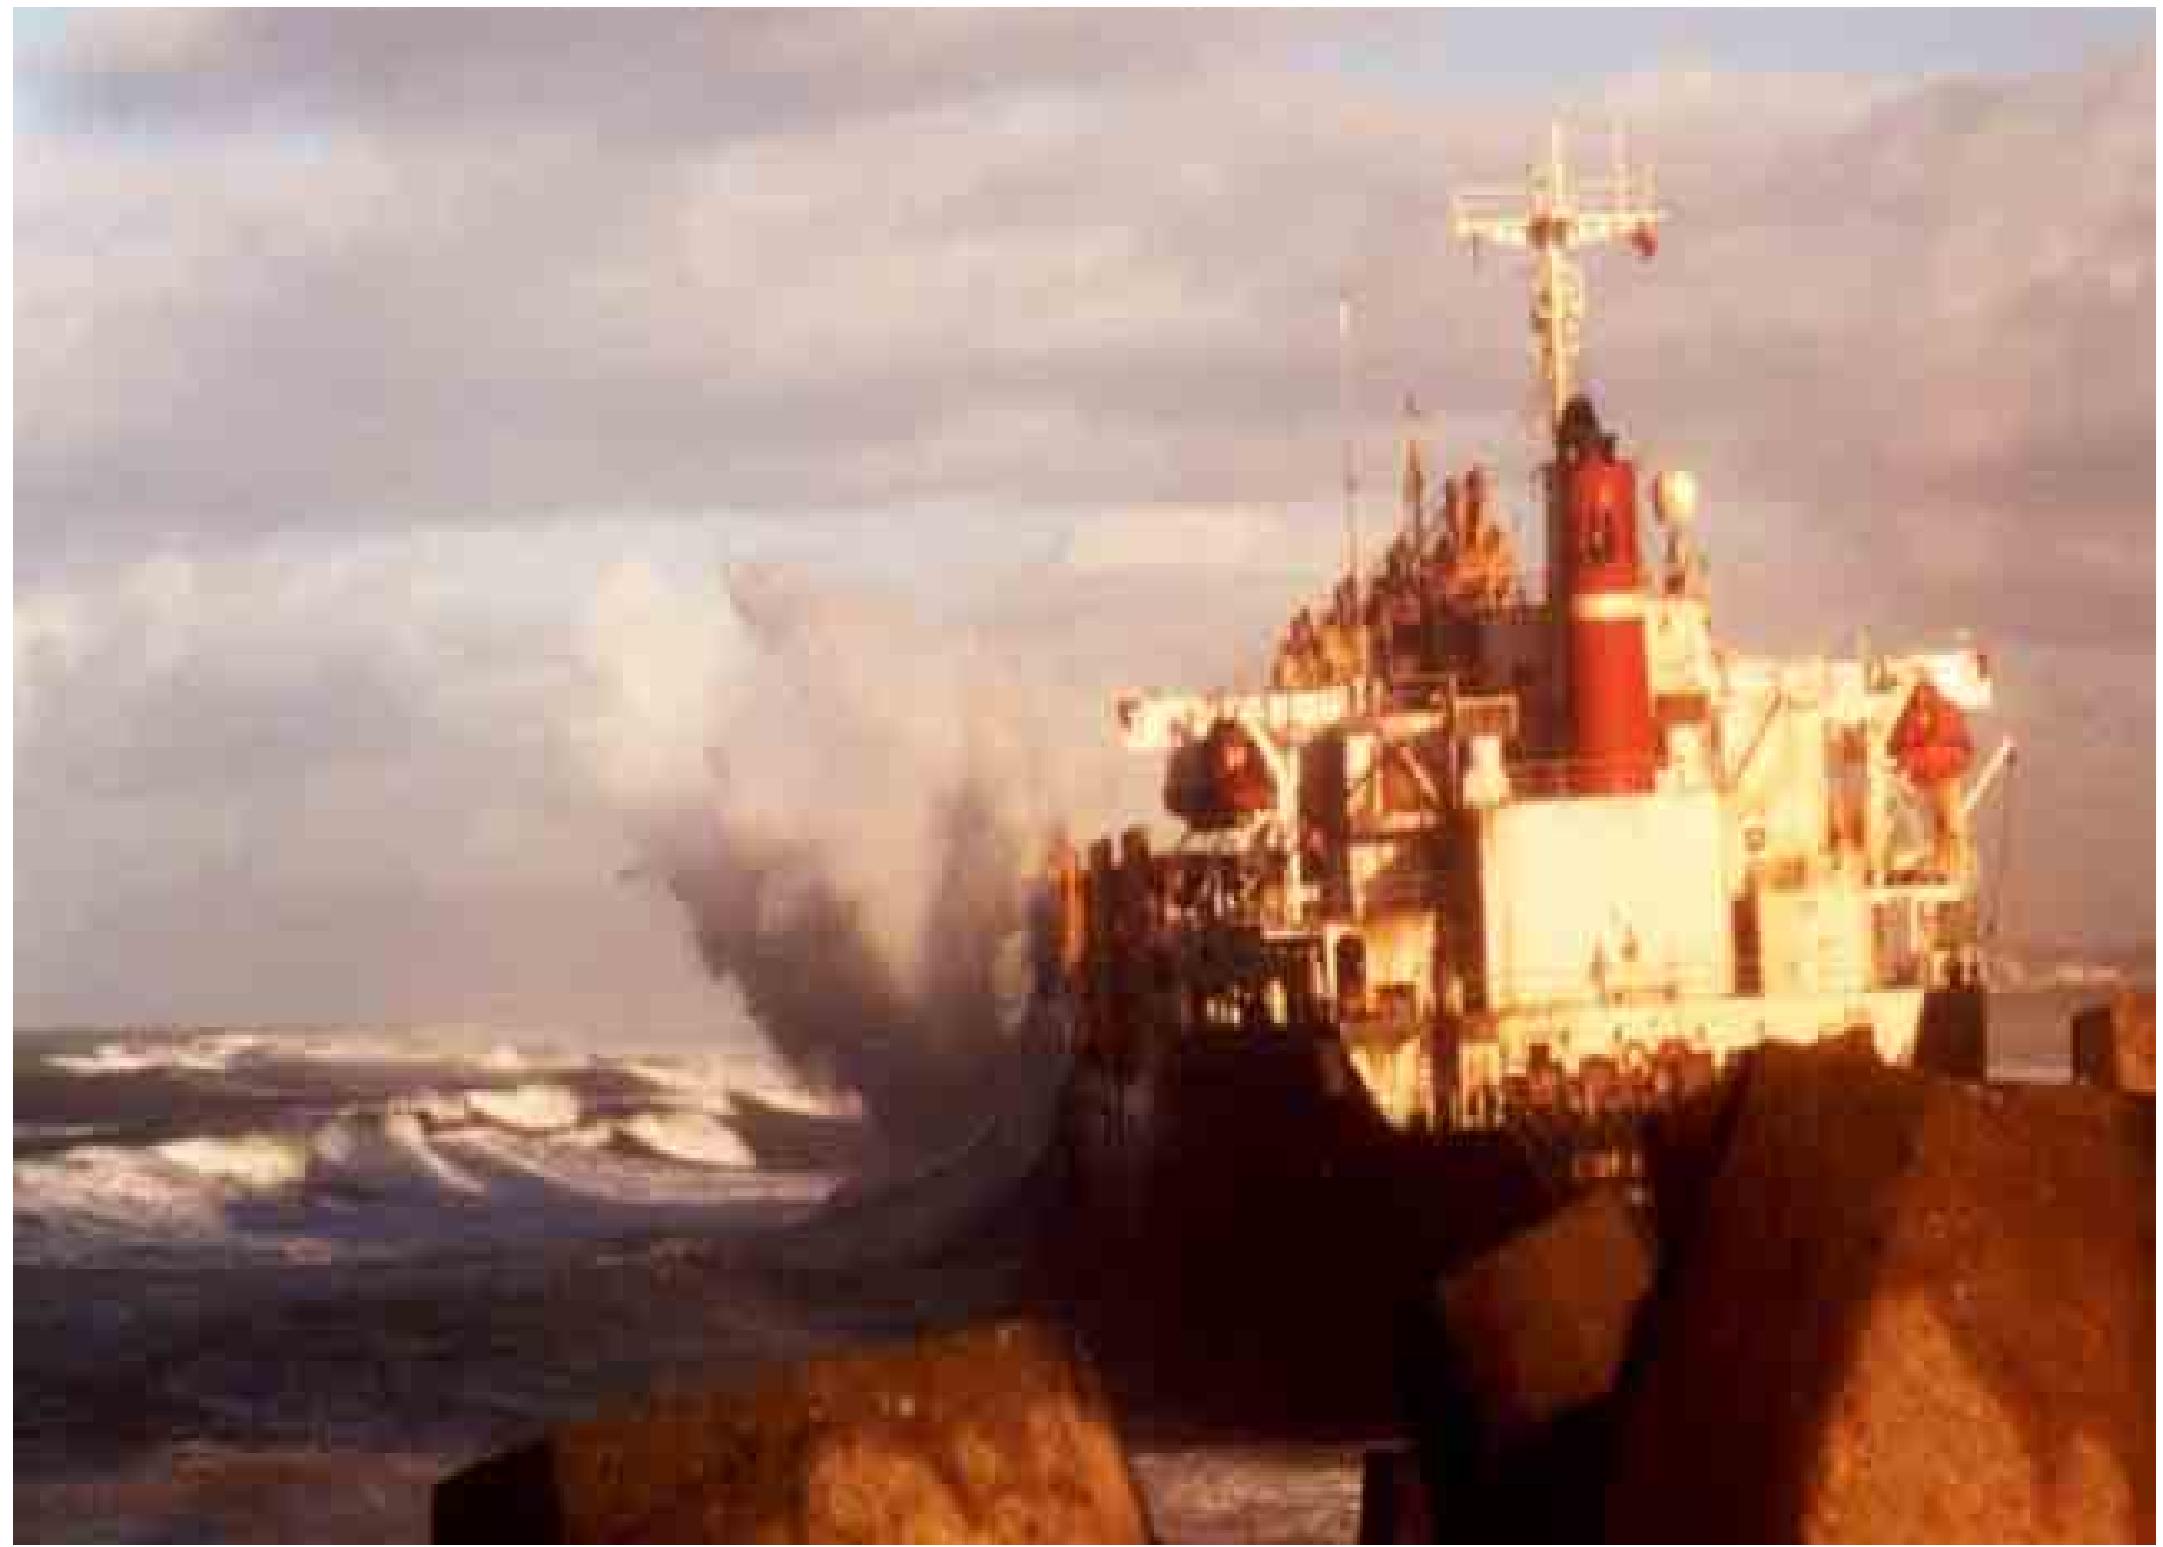
The stern of the ship was around 15 meters from the breakwater and the bow around 50 meters. [Slide 4](#)

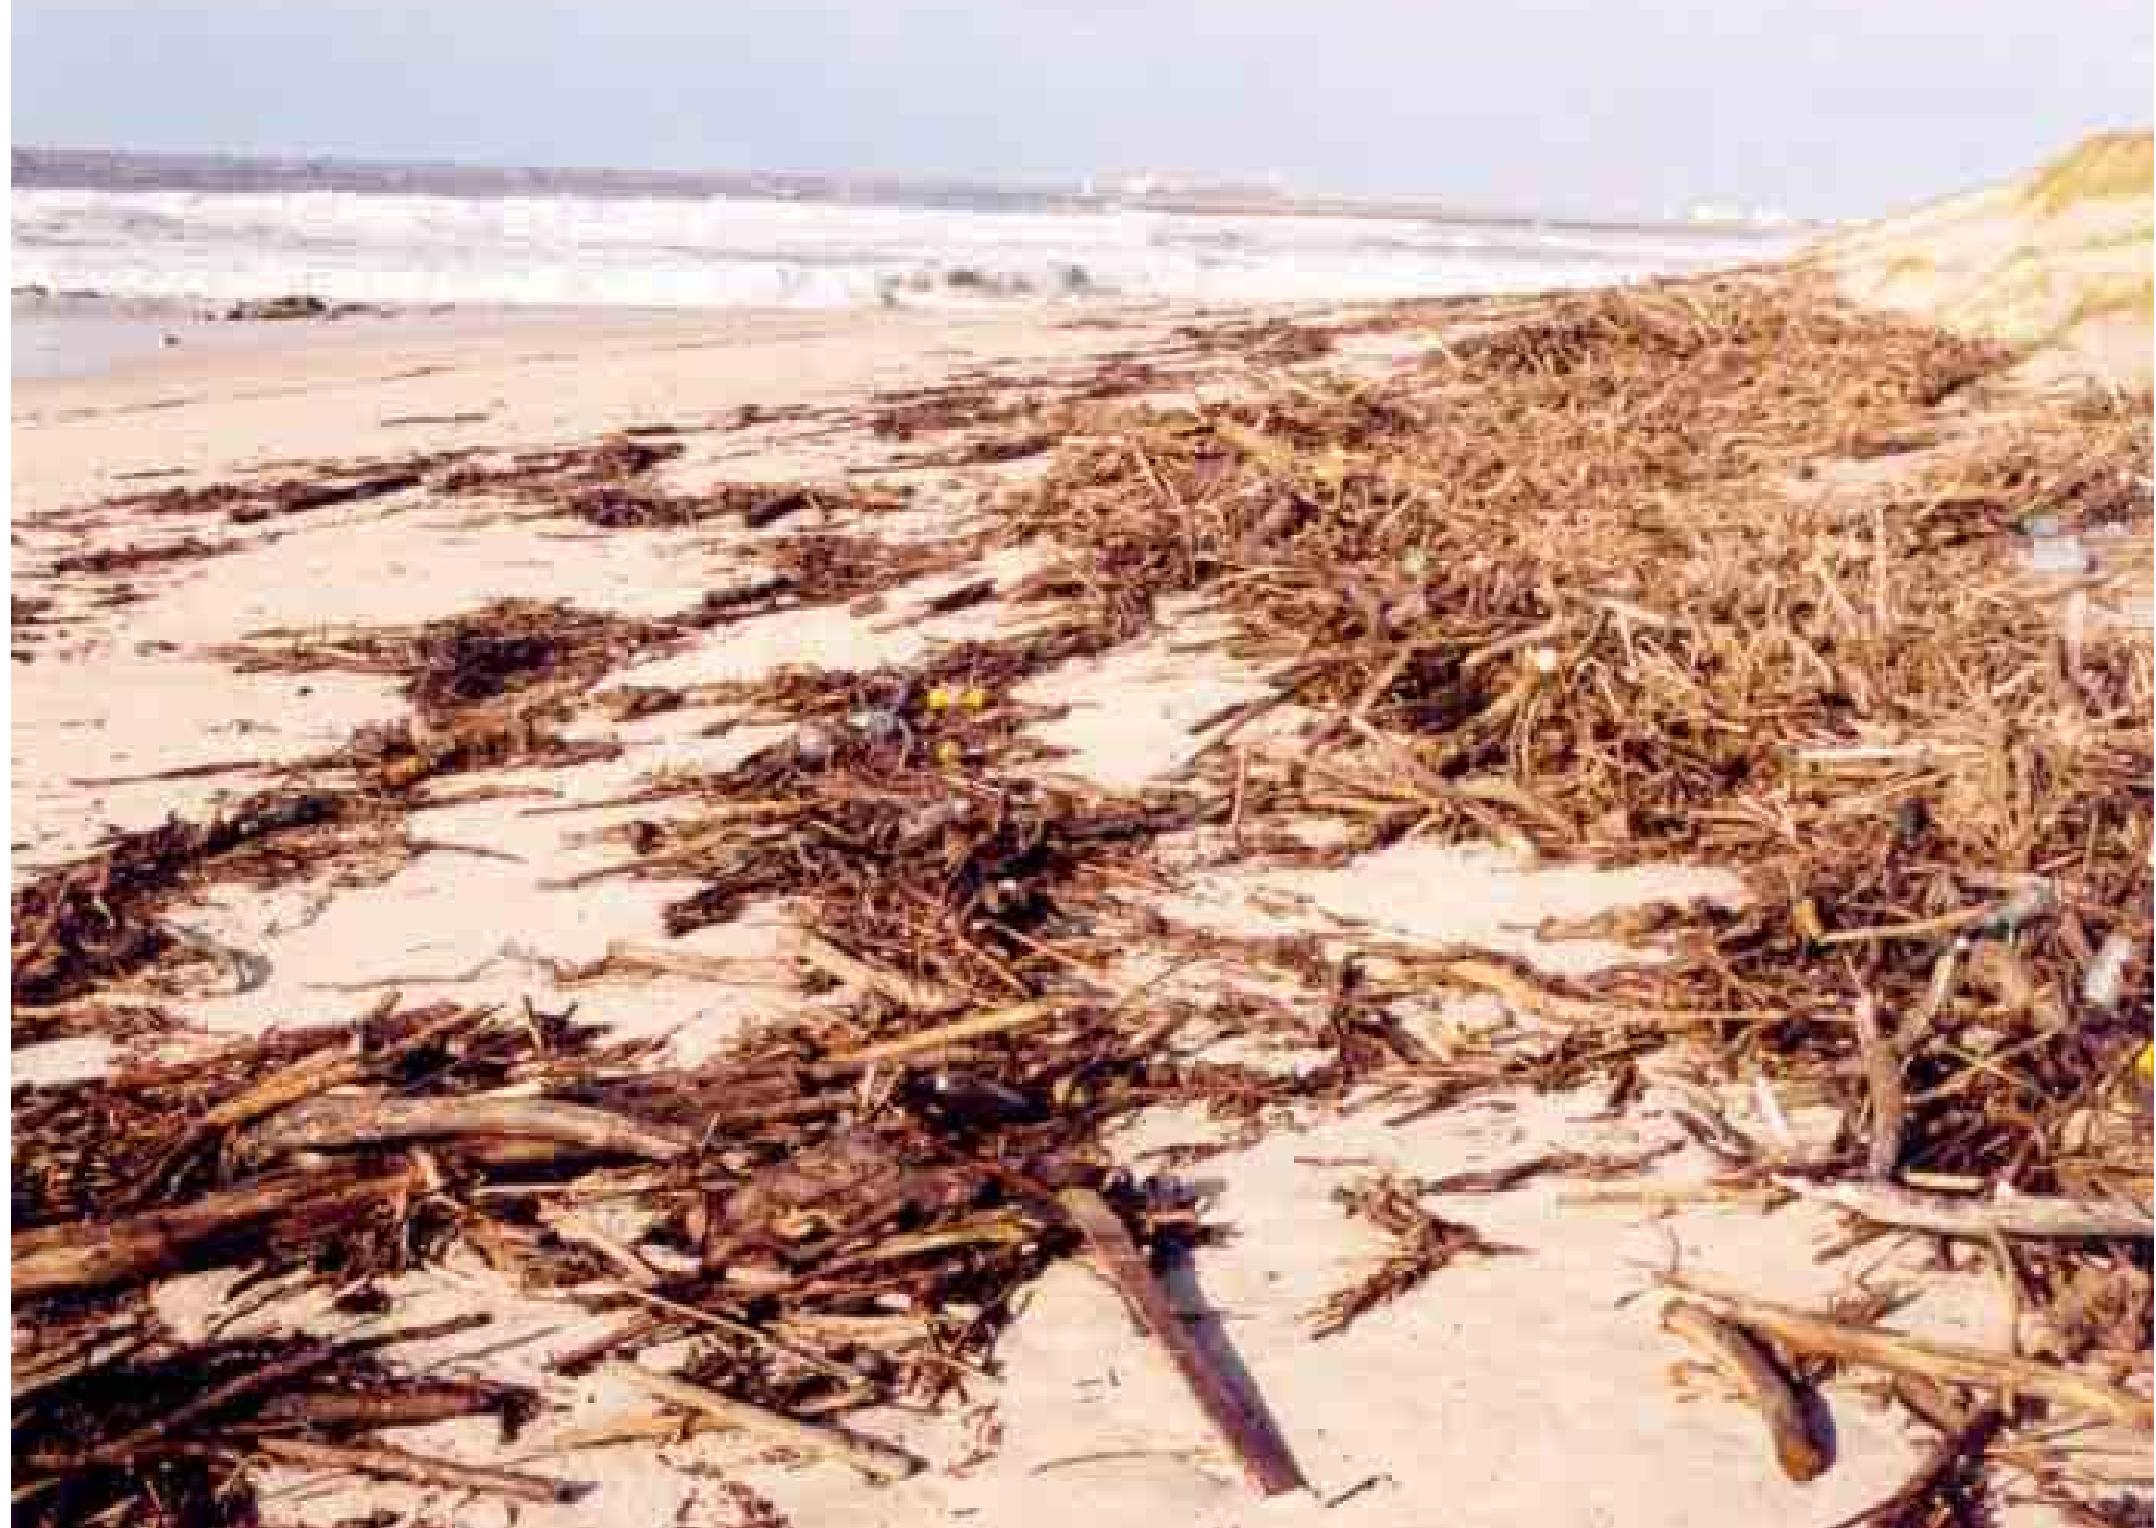
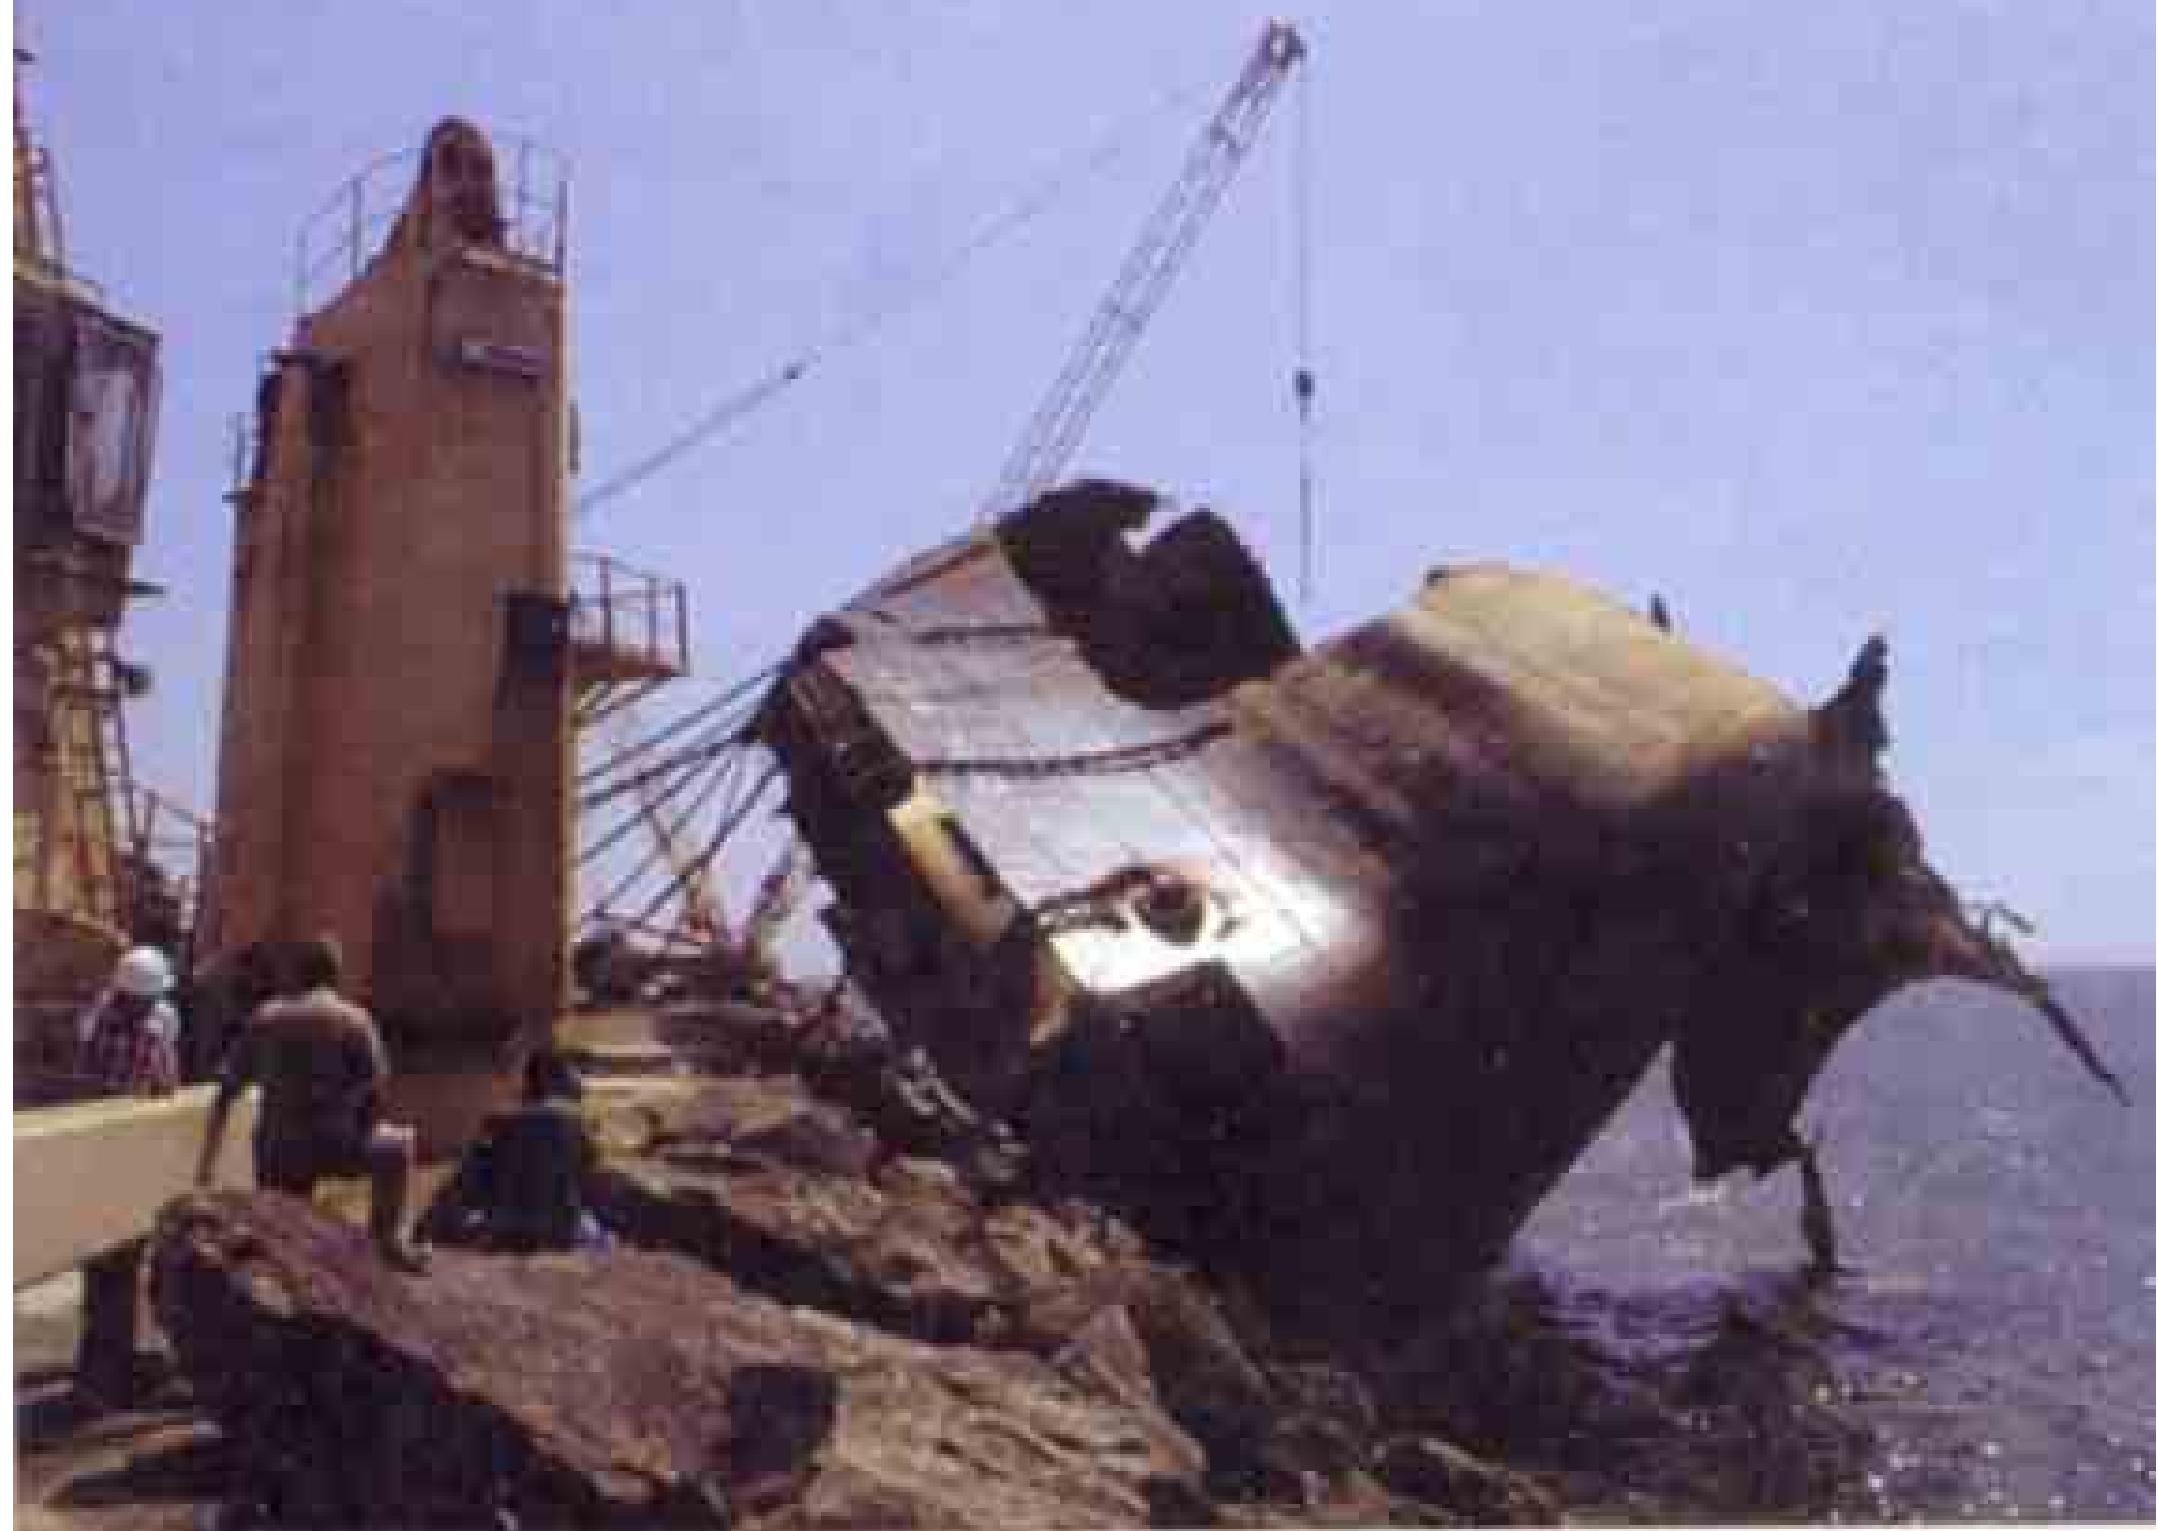
For that purpose, some human and material resources were placed to recover the spills rising near the ship, the rocks and the beaches near by. ([slides 9 and 10](#))

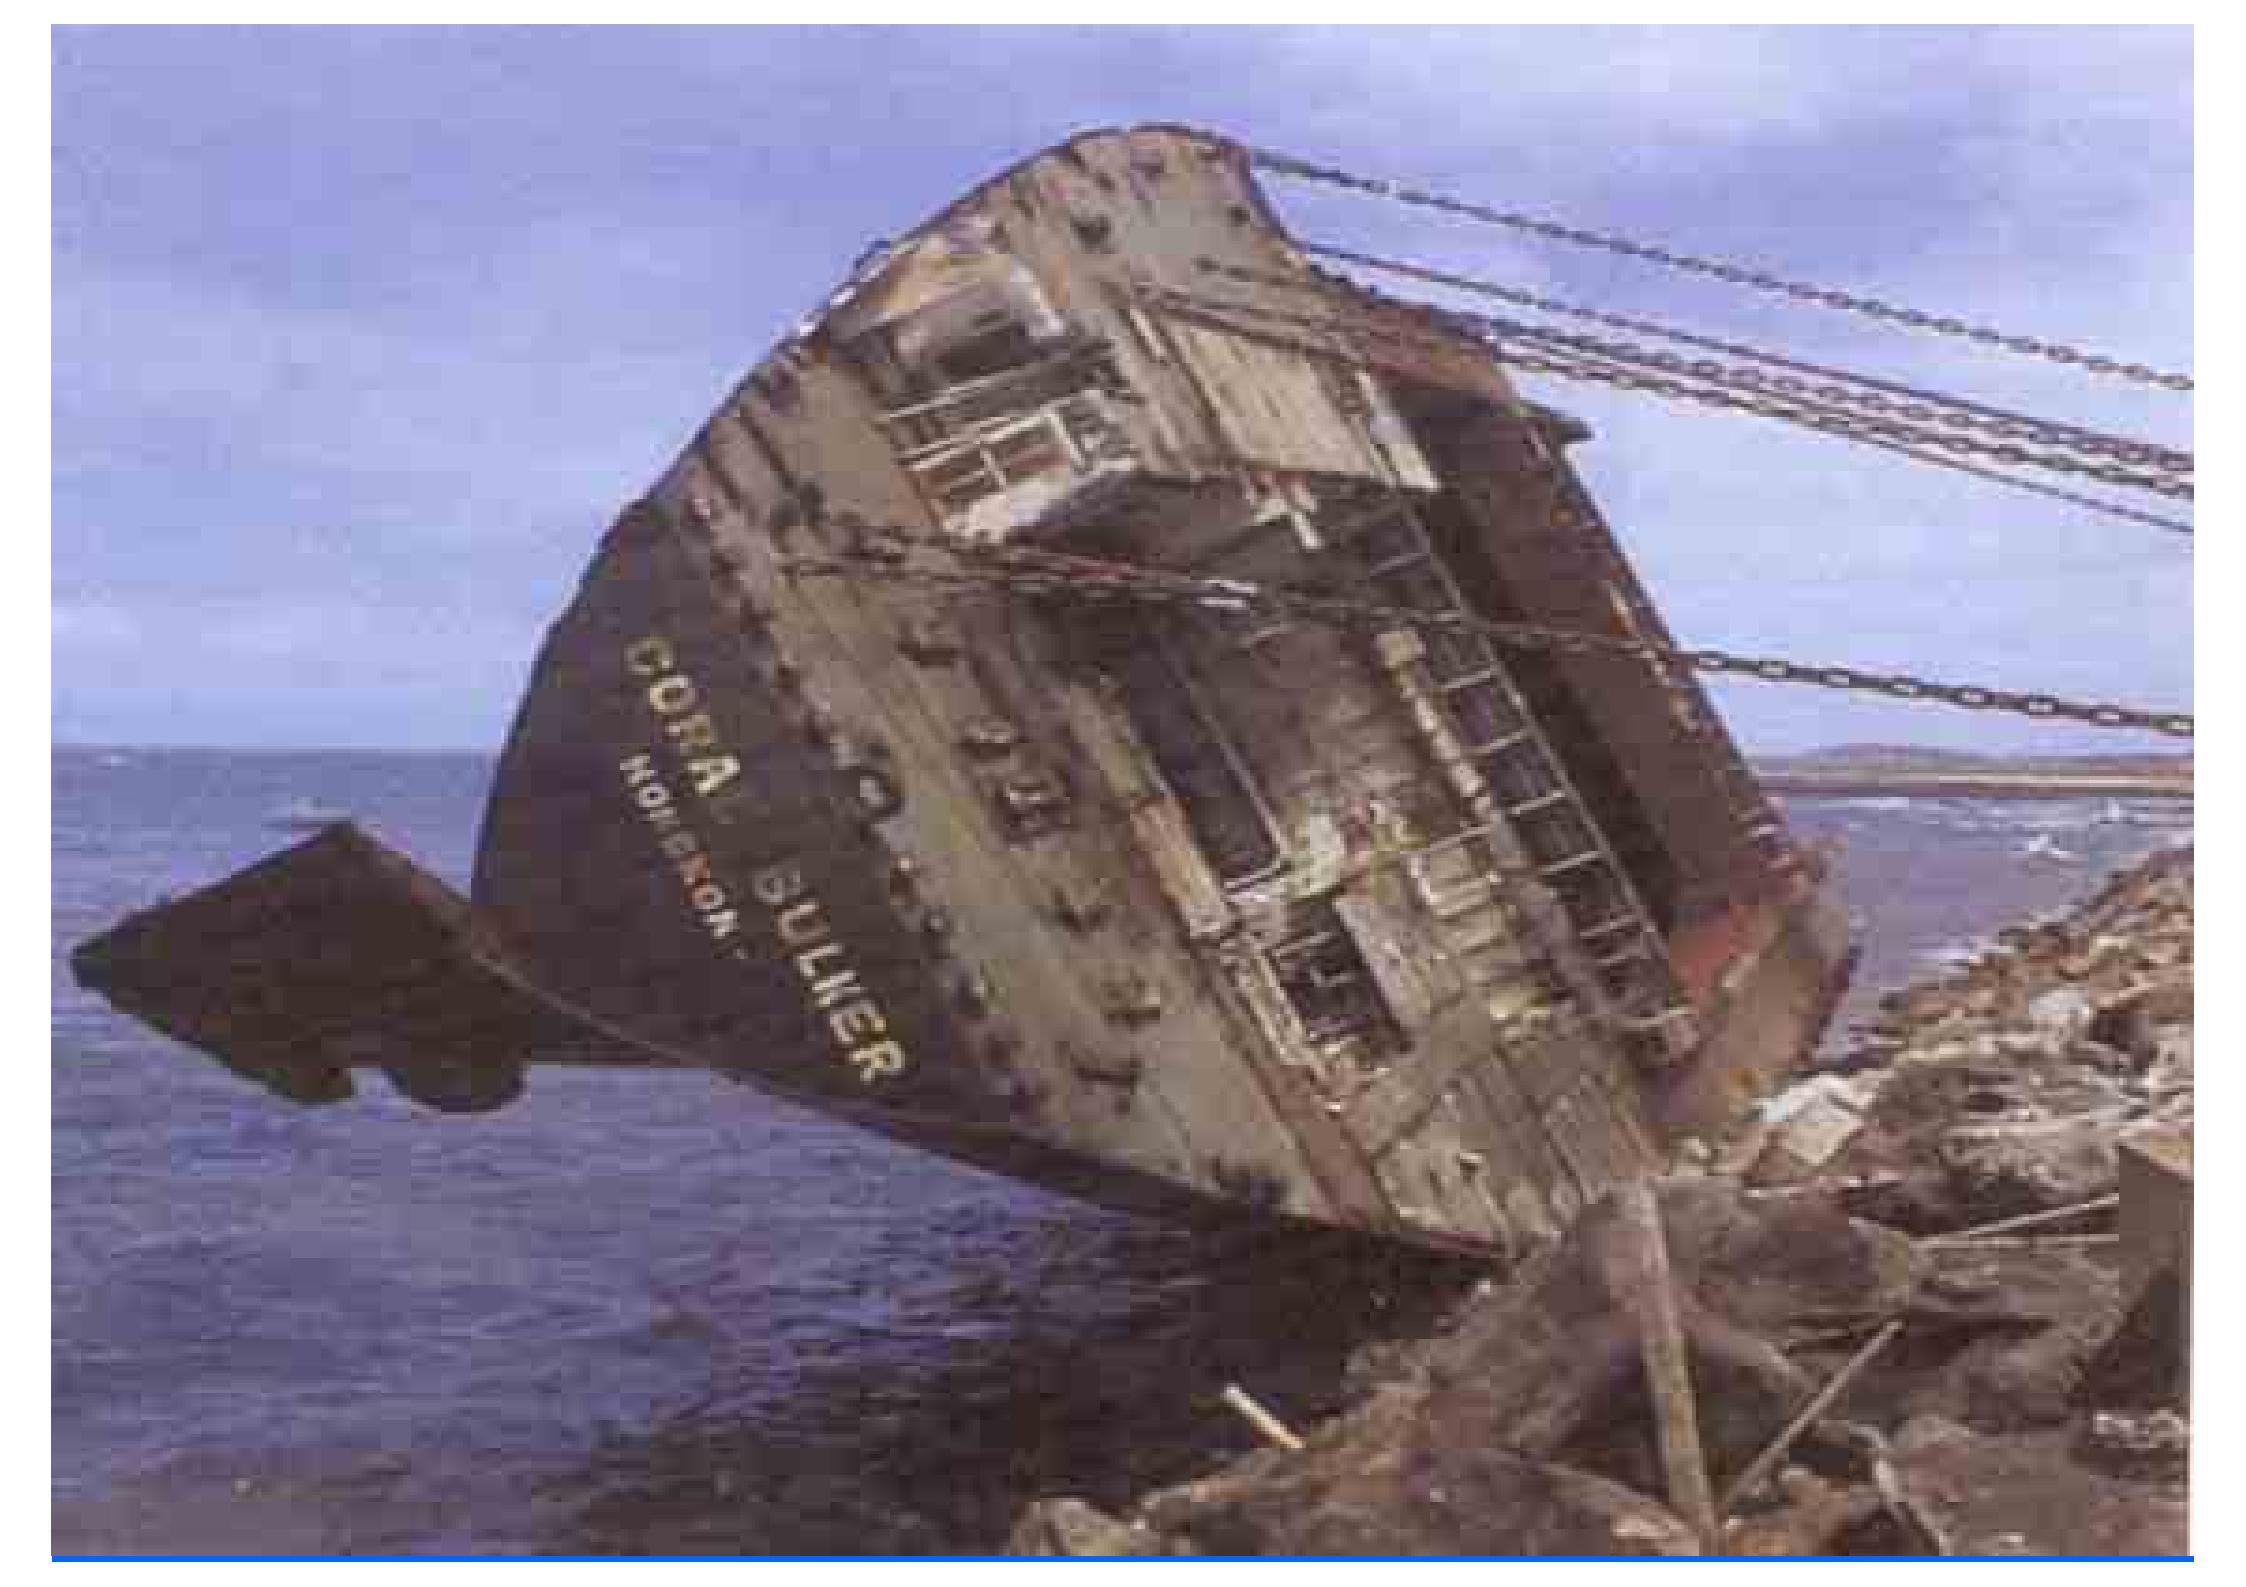
CORAL GULF

In this phase all the cargo spread along the beaches was recovered. [Slide 11](#)

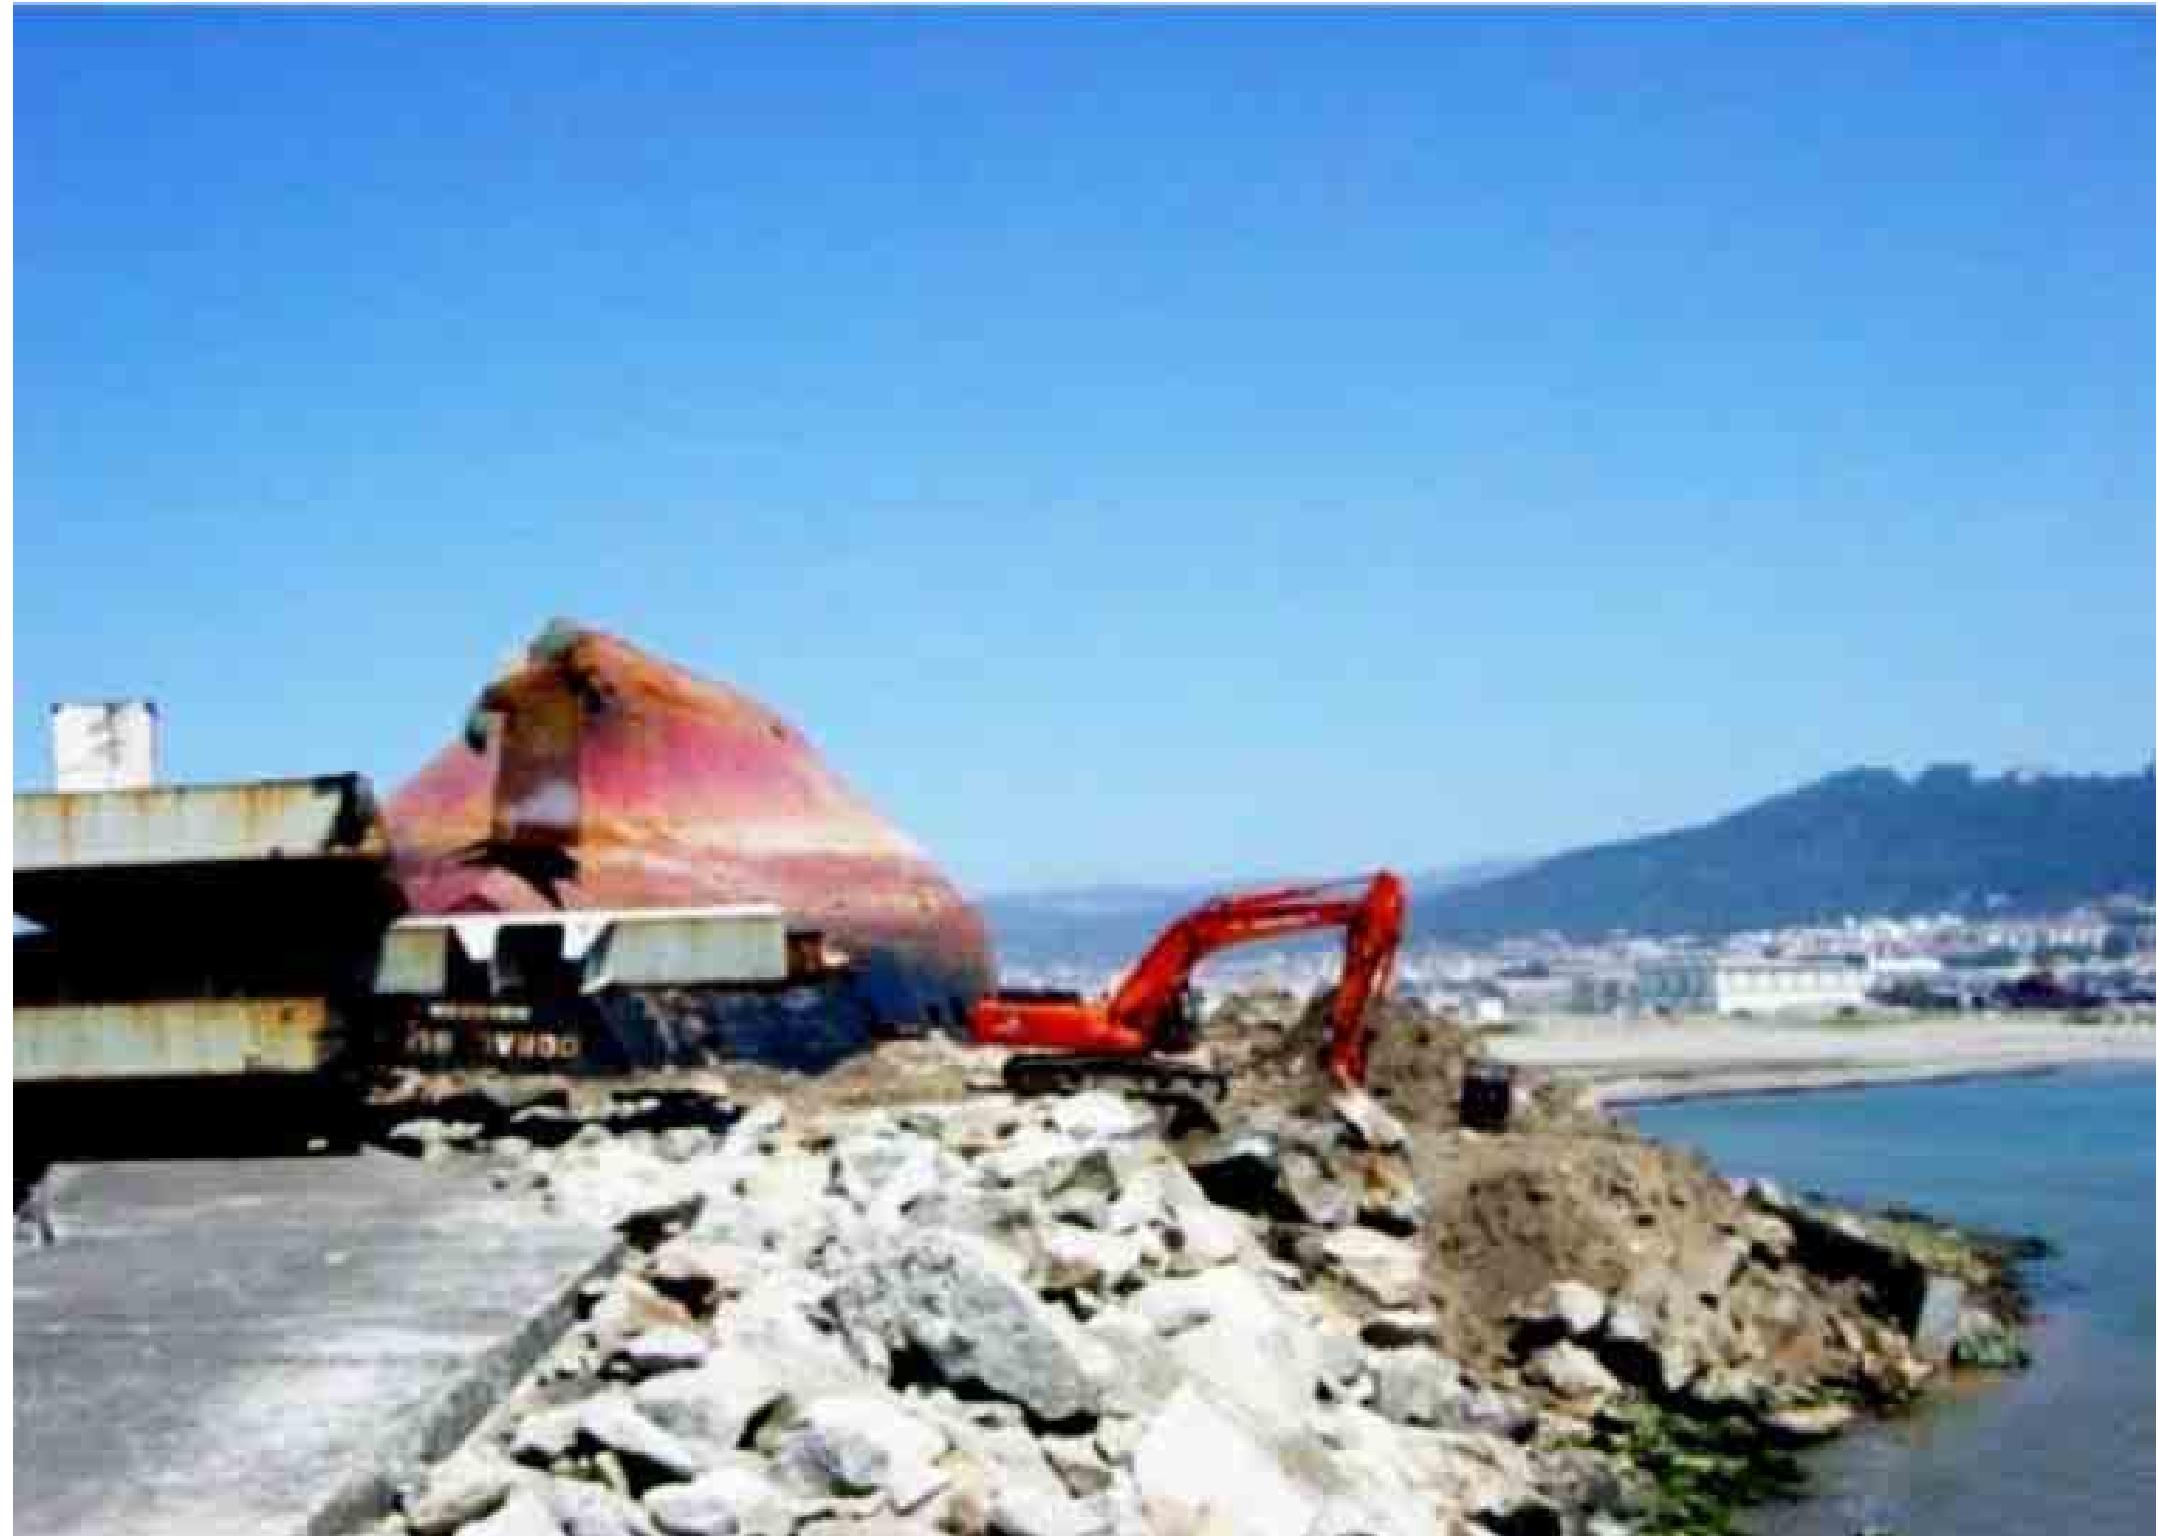
The 3<sup>rd</sup> phase began. It was the most amazing phase of all. The ship was cut in two parts and removed ashore. [Slide 12](#)
