MV "CORAL BULKER"

**DEALING WITH A WRECK STRANDED ON A PORT
BREAKWATER**

**LES JOURNÉES D'INFORMATION DU CEDRE
INSTITUT OCÉANOGRAPHIQUE - PARIS
6 OCTOBRE 2003**

**Eng. Alvaro Guidotti
TITAN MARITIME LLC**

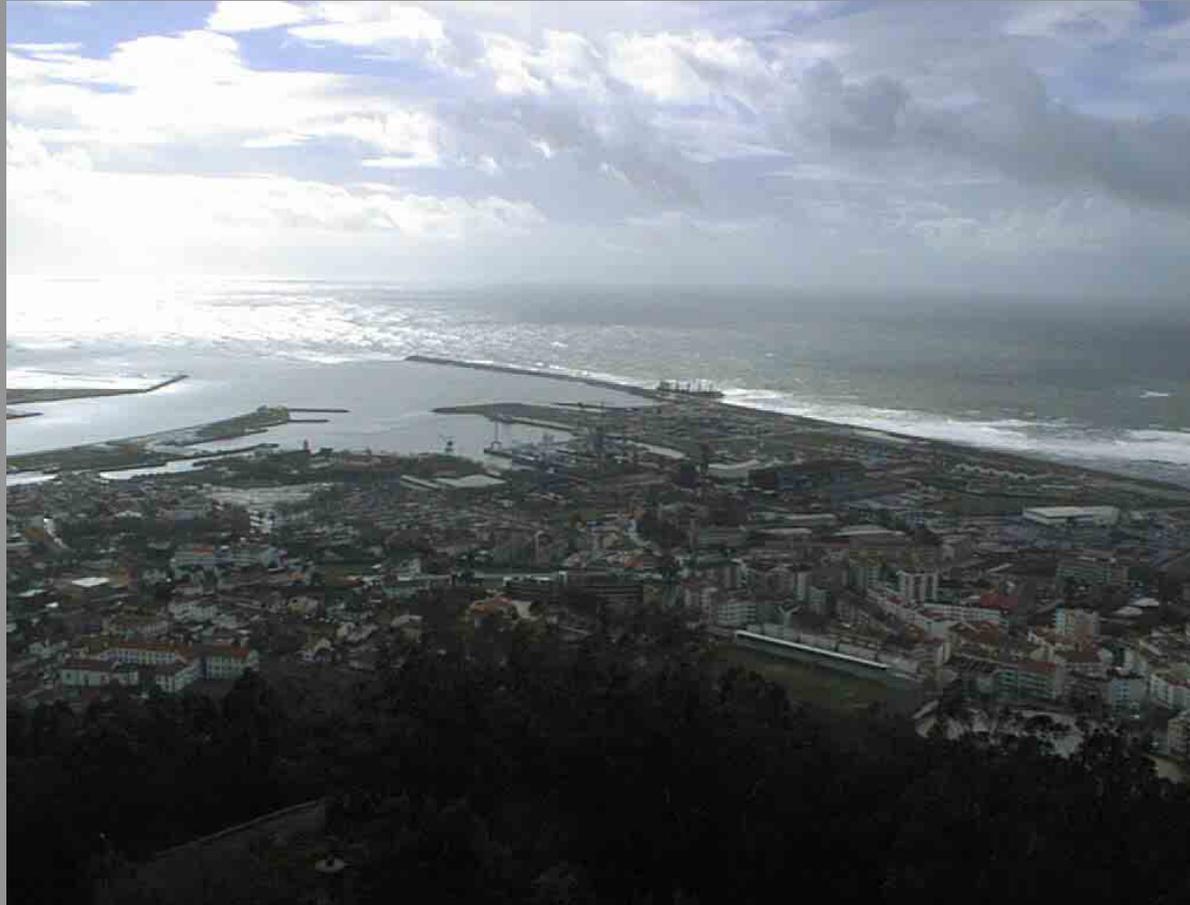
**CORAL BULKER AGROUND ALONGSIDE THE NORTH
BREAKWATER, VIANA DO CASTELO**

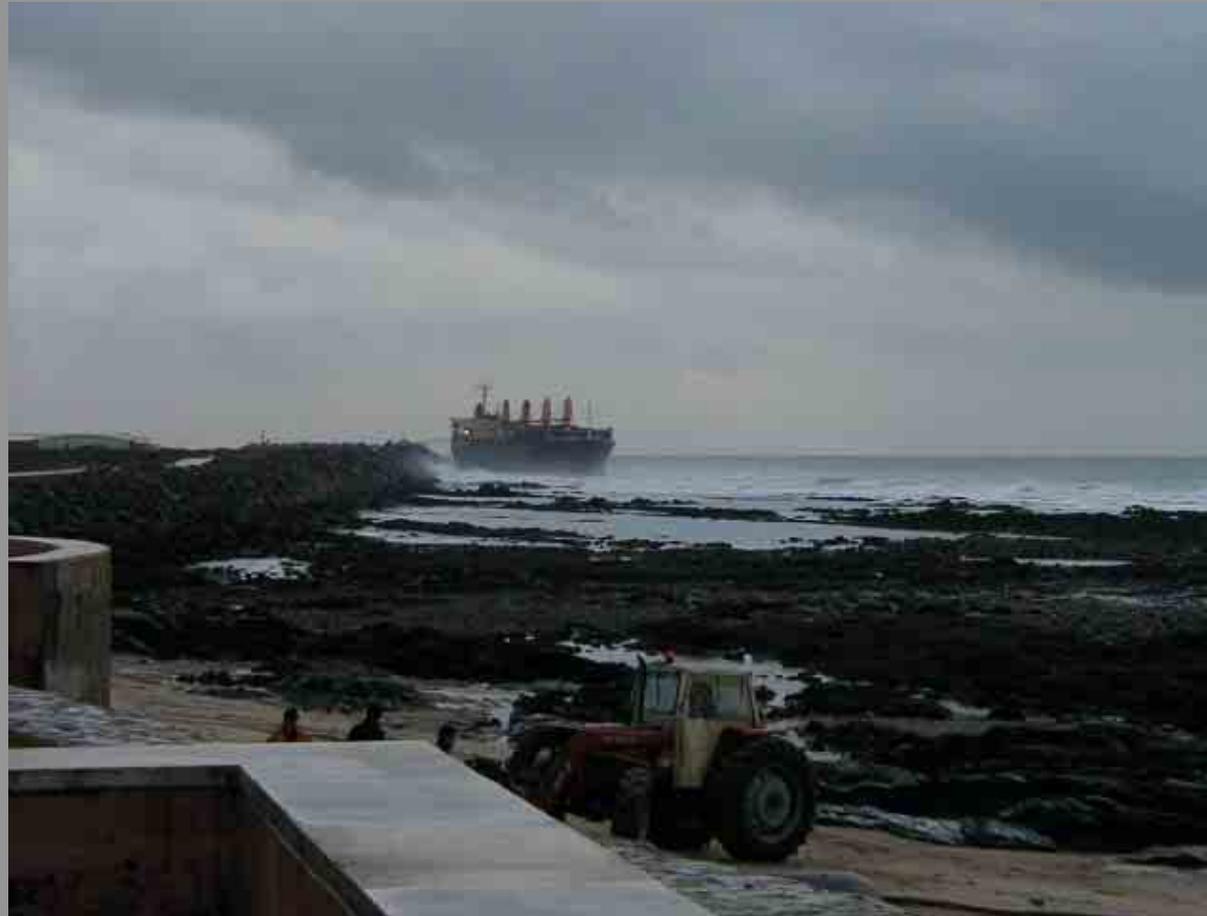
**CORAL BULKER AGROUND ALONGSIDE THE NORTH
BREAKWATER, VIANA DO CASTELO**

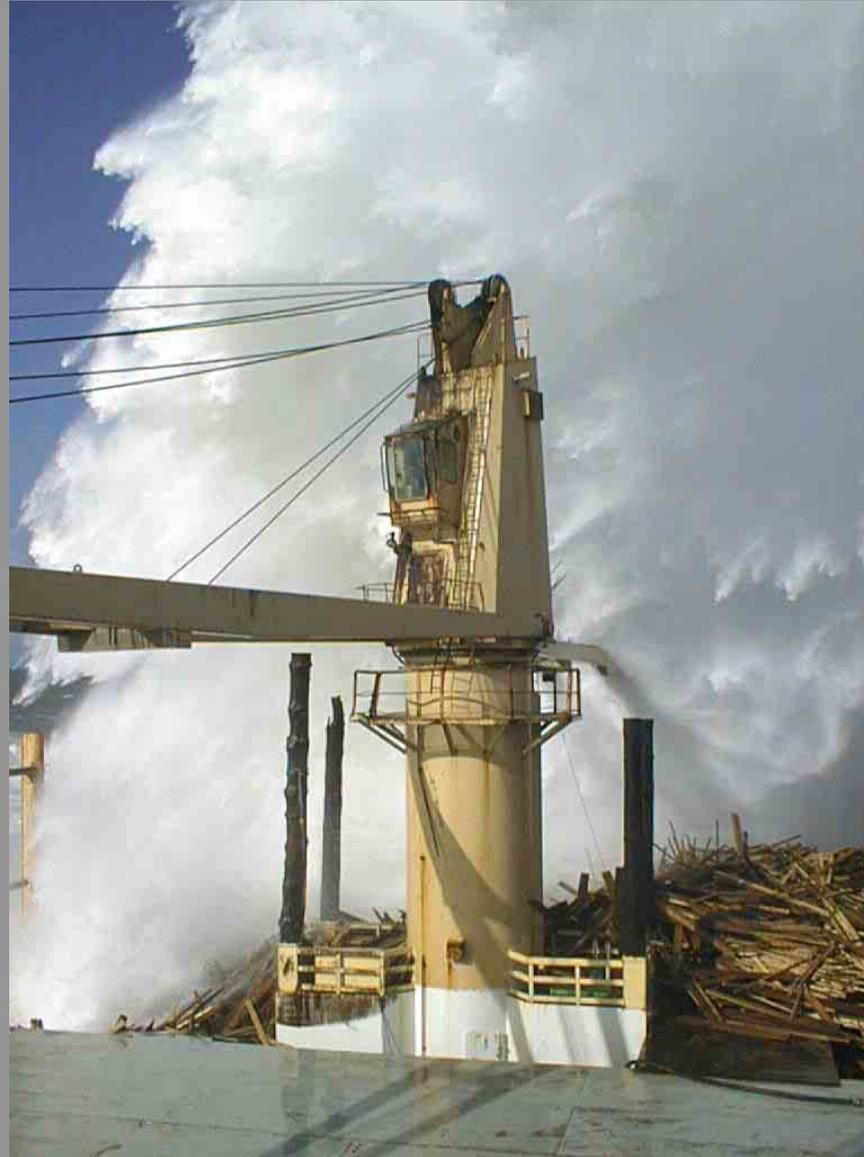
**STRONG SOUTH WESTERLY
WINDS AND HEAVY SWELLS
PREVENTED EARLY DISCHARGE
OF TIMBER DECK CARGO.**

**AT TIMES CONDITIONS WERE SO
SEVERE AS TO MAKE BOARDING
THE CASUALTY UNSAFE.**

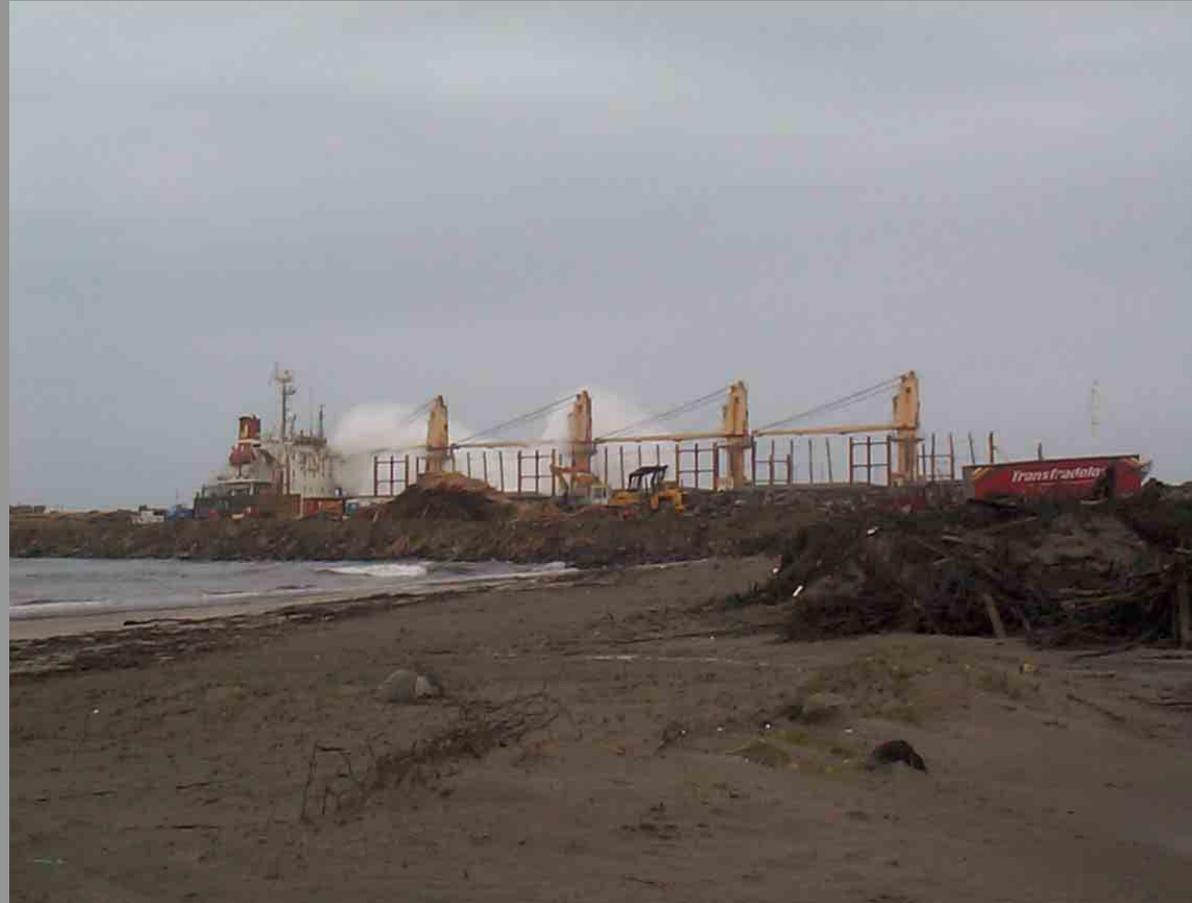
HEAVY SEAS AND SWELLS BREAKING OVER CORAL BULKER

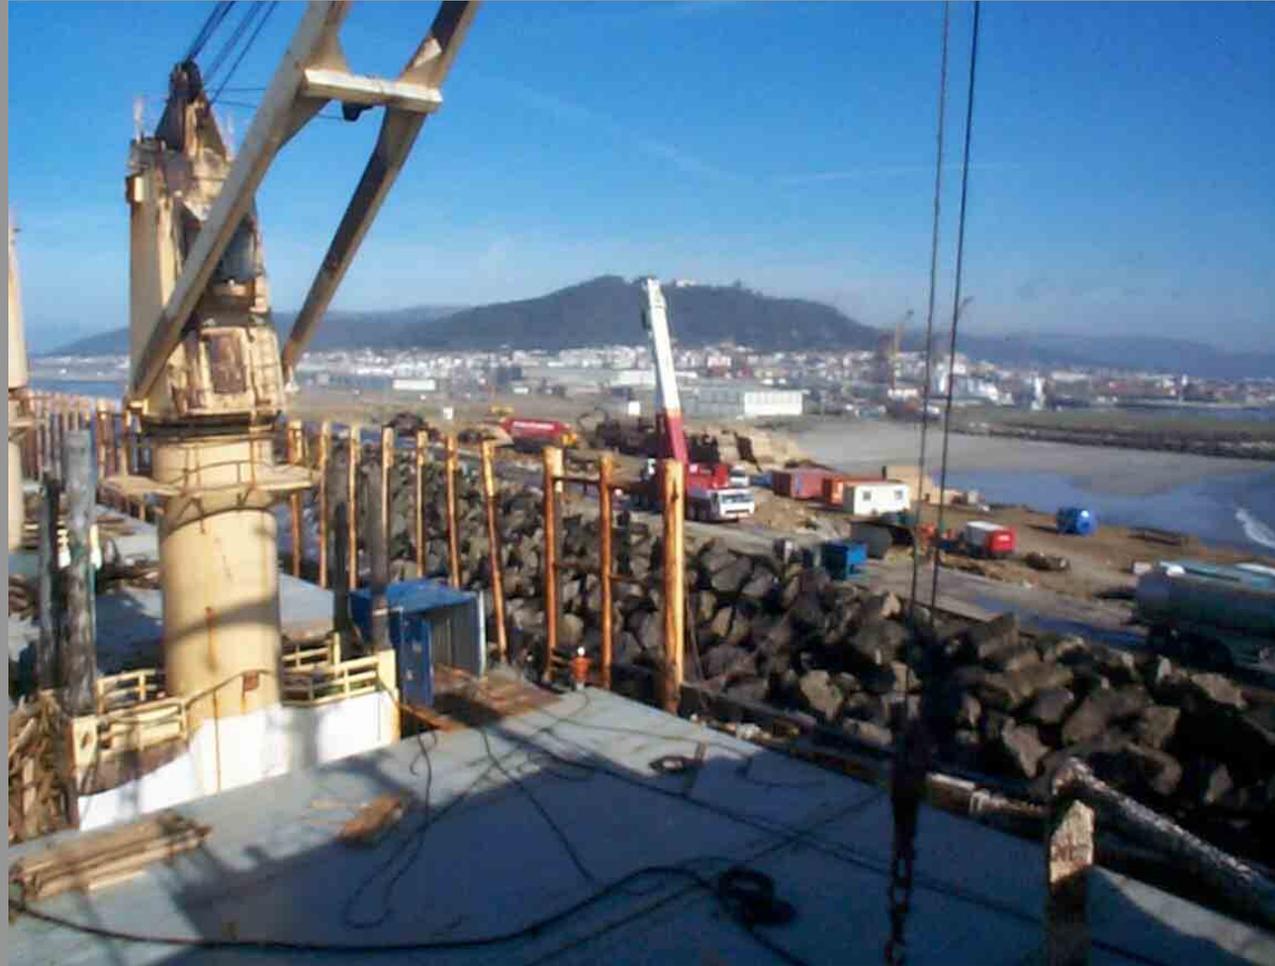
OIL REMOVAL OPERATION

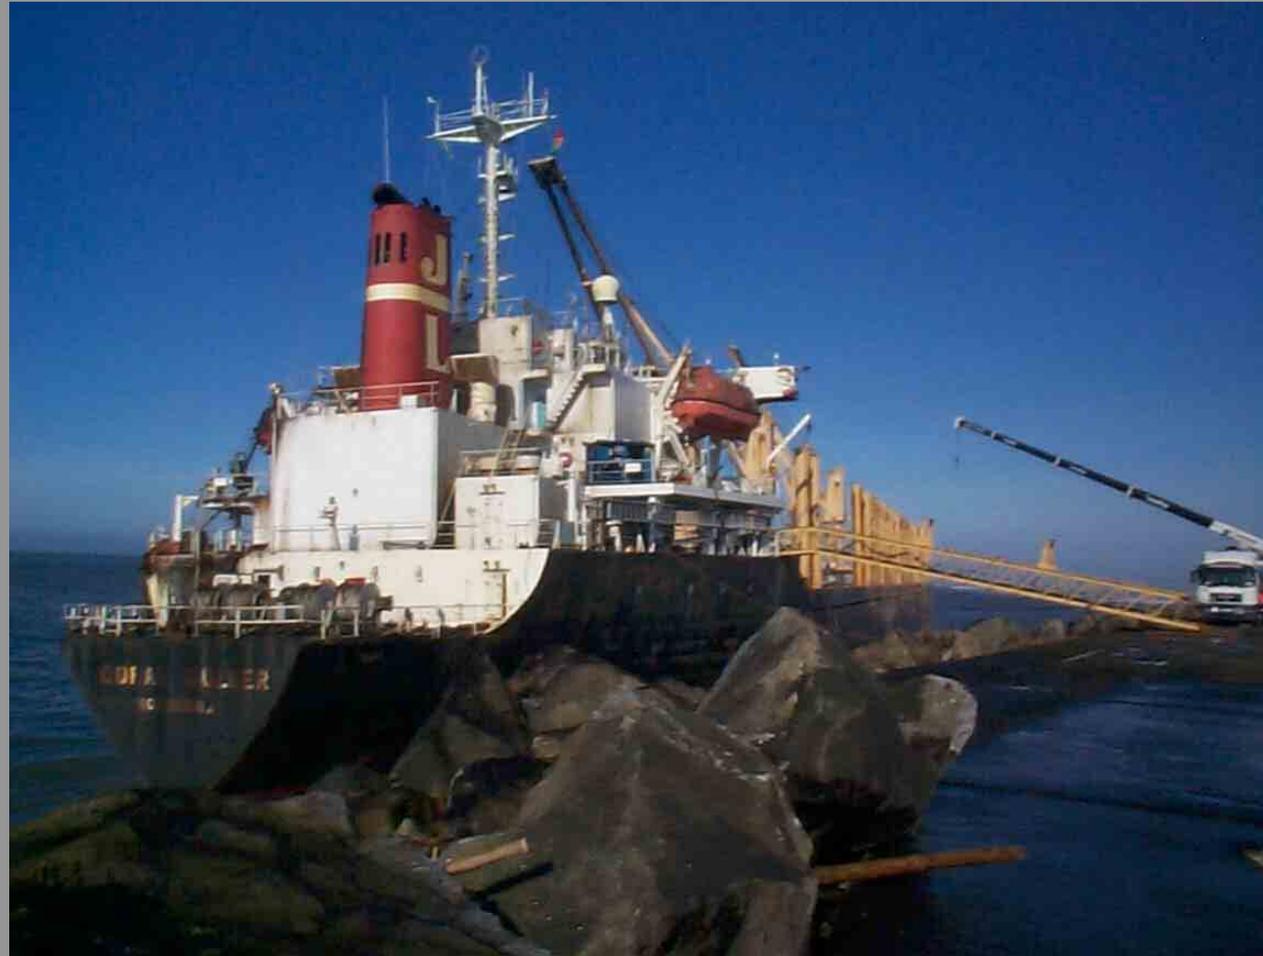
CORAL BULKER FROM SOUTH DURING OIL REMOVAL

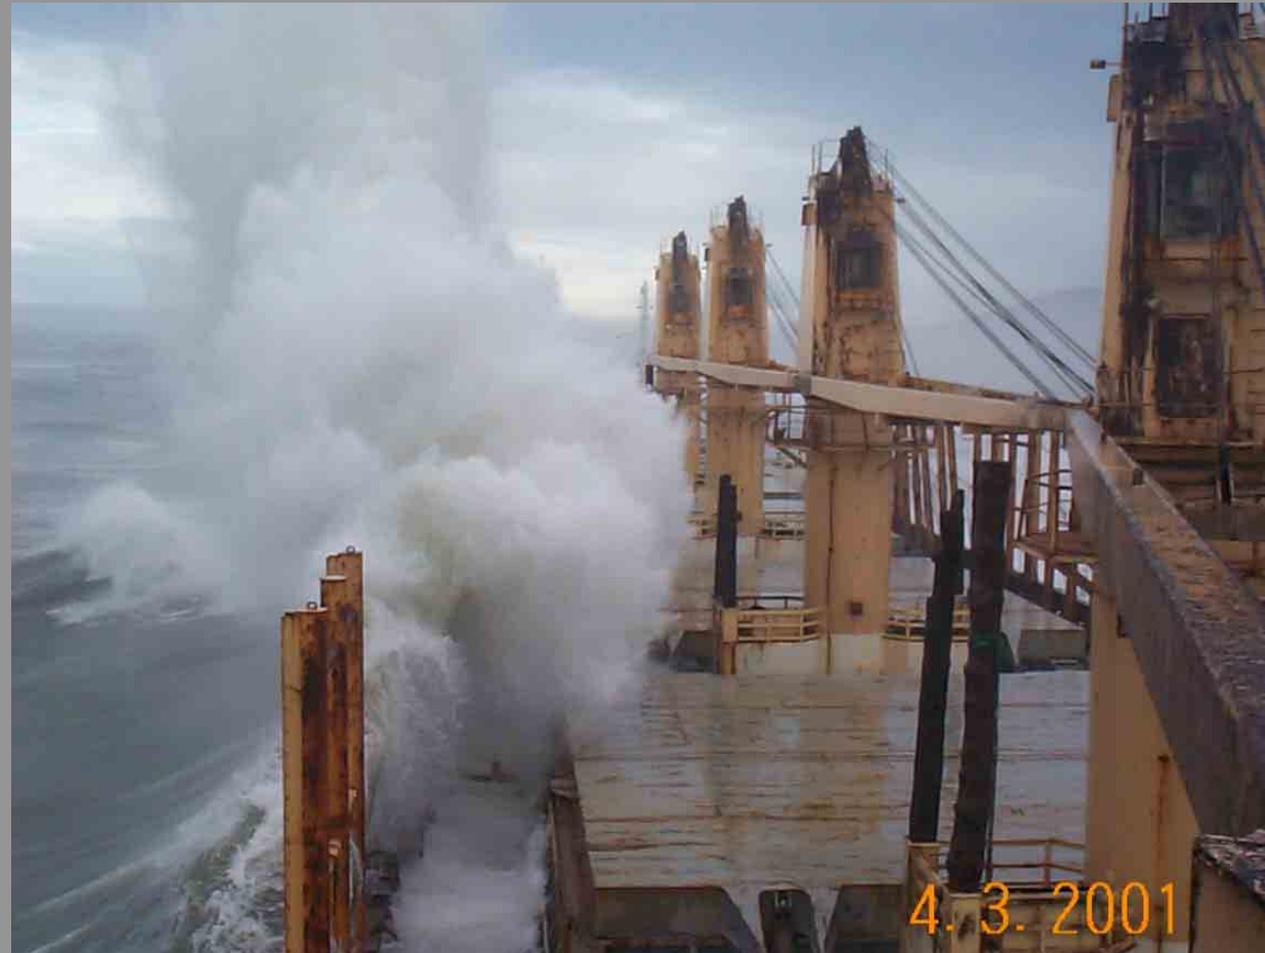
**CONTINUED BAD WEATHER PREVENTING DISCHARGE OF
UNDER DECK CARGO**

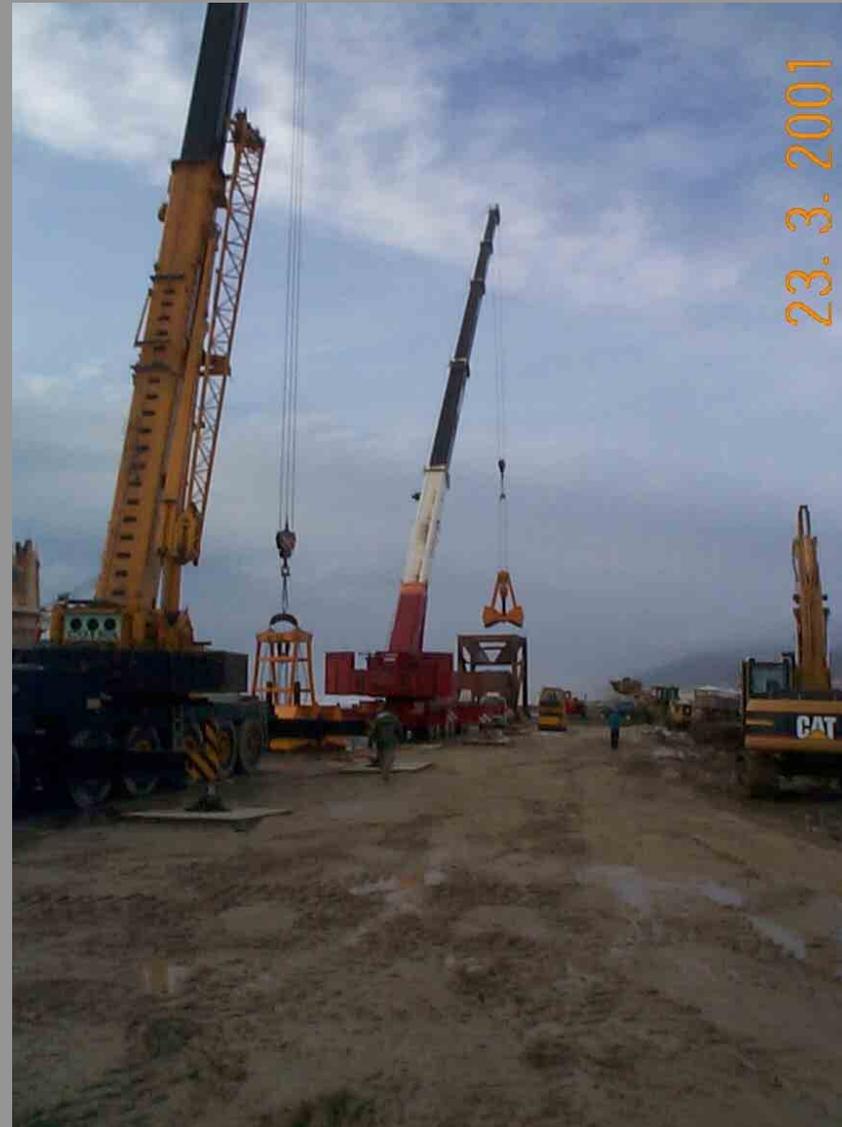
**TWO CRANES DISCHARGING
UNDER DECK CARGO USING
REMOTELY CONTROLLED GRAB
BUCKETS.**

Discharge of the underdeck cargo would be undertaken using the ship's cranes and two long reach stick cranes fitted with remotely operated grabs. The cargo would be discharged to shore using hoppers positioned on the deck and conveyors to transfer the cargo ashore. Engineering work was started on the construction of a bridge to support the conveyor from the vessel to the shore. However, due to continued bad weather and subsequent damage to the vessel the method of discharge was revised. To expedite discharge the decision was taken to discharge the cargo directly to the shore using grabs.

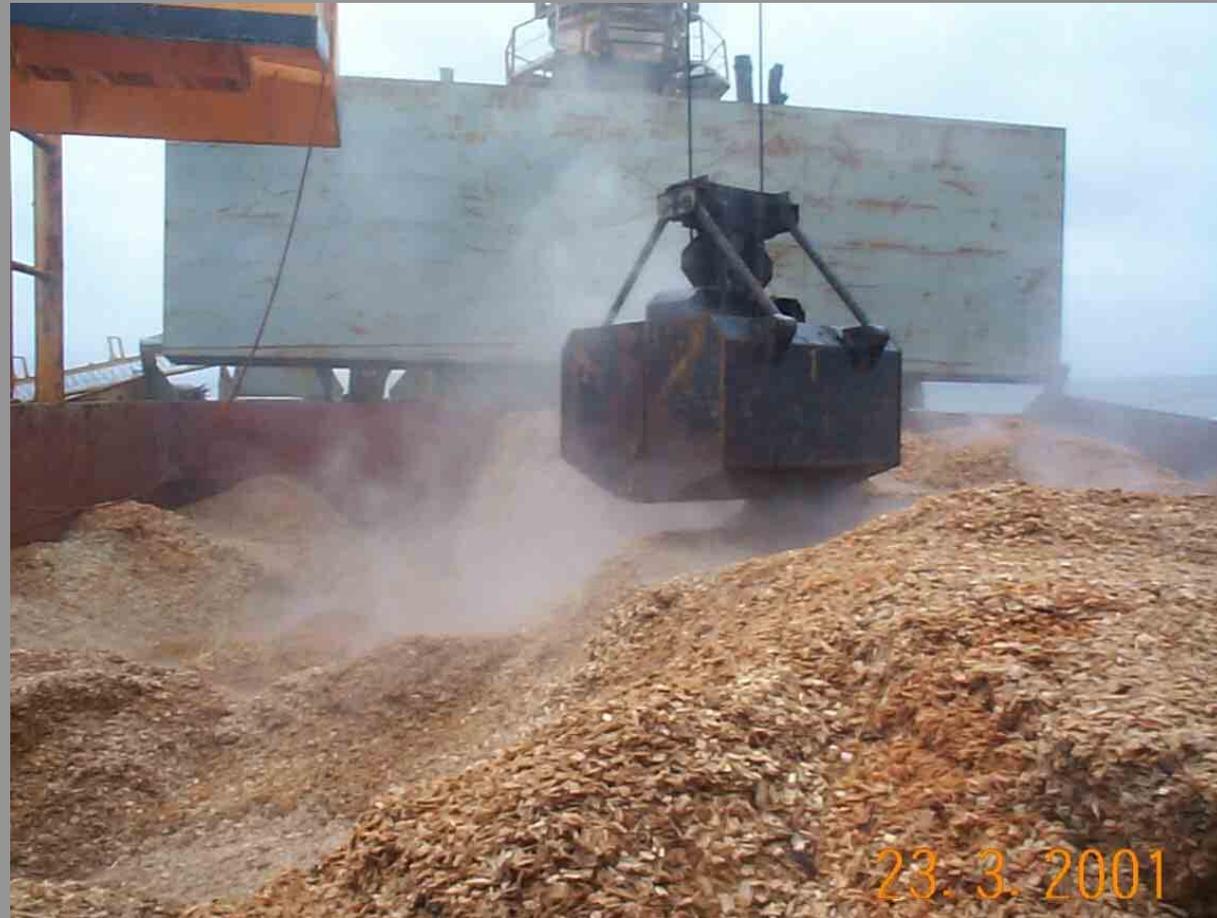
DISCHARGE OF WOODCHIPS FROM #4 CARGO HOLD

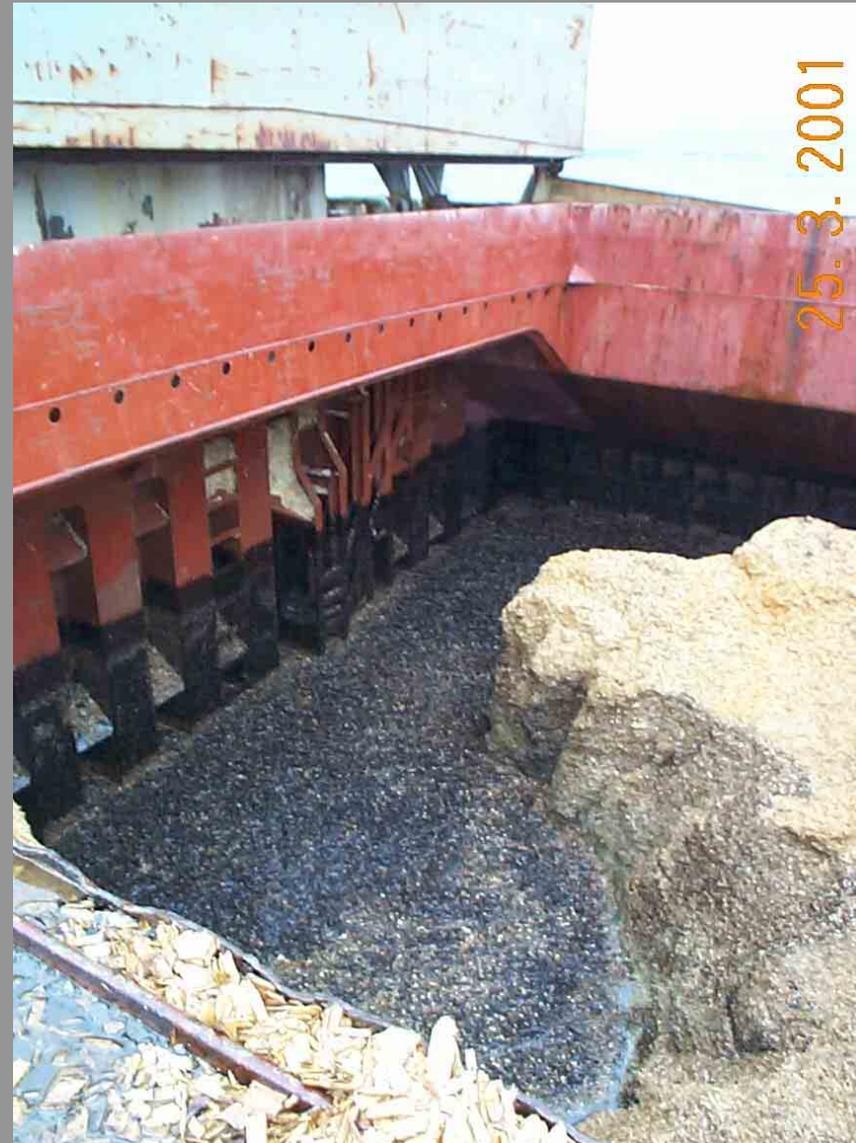
**CONTAMINATED WOOD CHIP
CARGO IN #4 HOLD.**

**CONTAMINATED CARGO WAS
DISCHARGED BY GRABS INTO
THE LOADING HOPPER AND
INTO CLOSED SIDED TRAILERS
FOR ONWARD
TRANSPORTATION TO DISPOSAL
SITE.**

After close liaison with the Customs, they agreed free movement with no importation fees for the underdeck cargo. The contaminated cargo was discharged ashore and was disposed of in boilers at local paper factories.

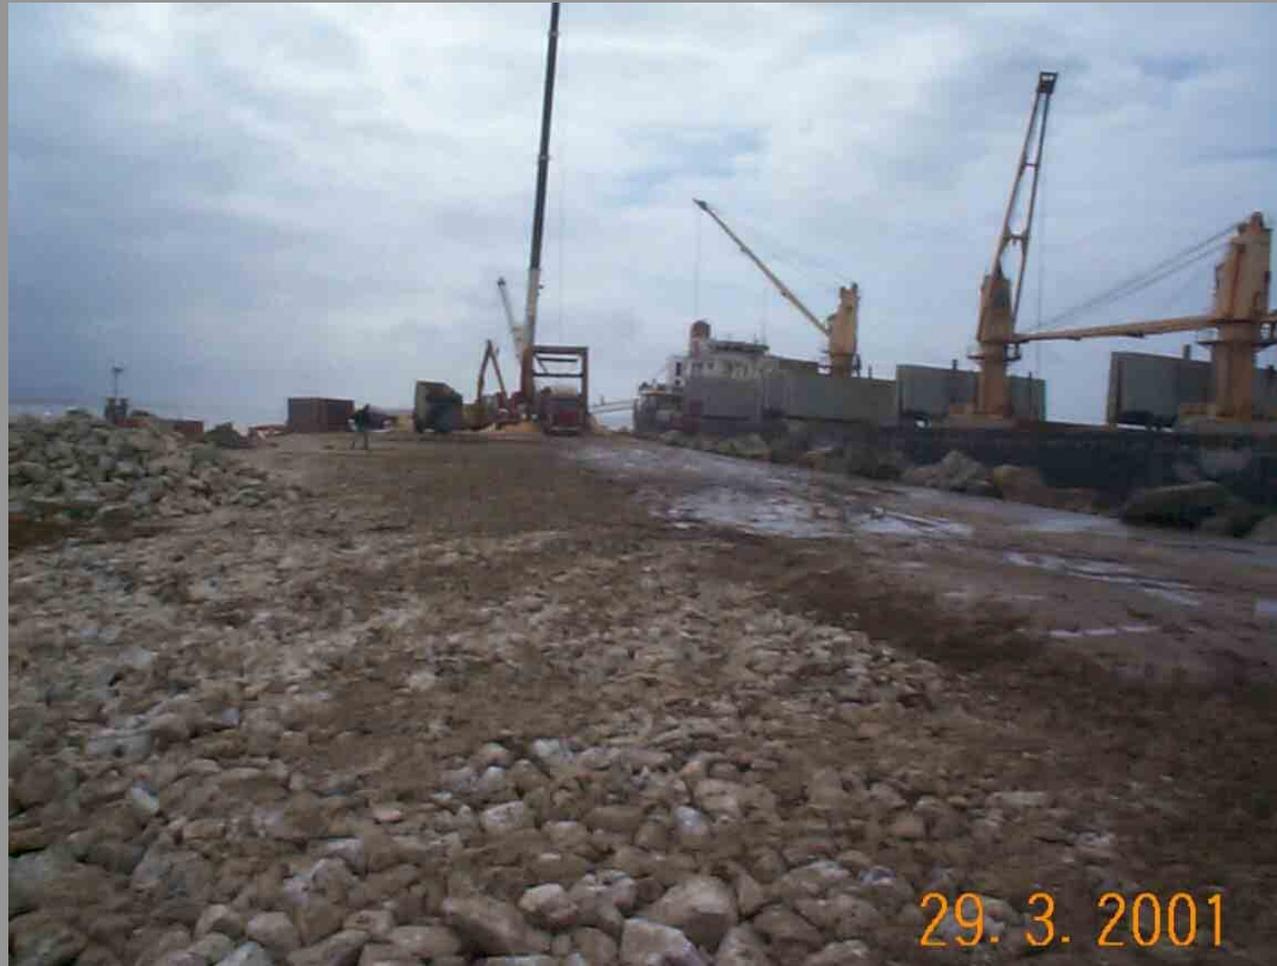
**EXTENSION TO BREAKWATER TO PROVIDE FIRM FOUNDATION
FOR HEAVY LIFT CRANES**

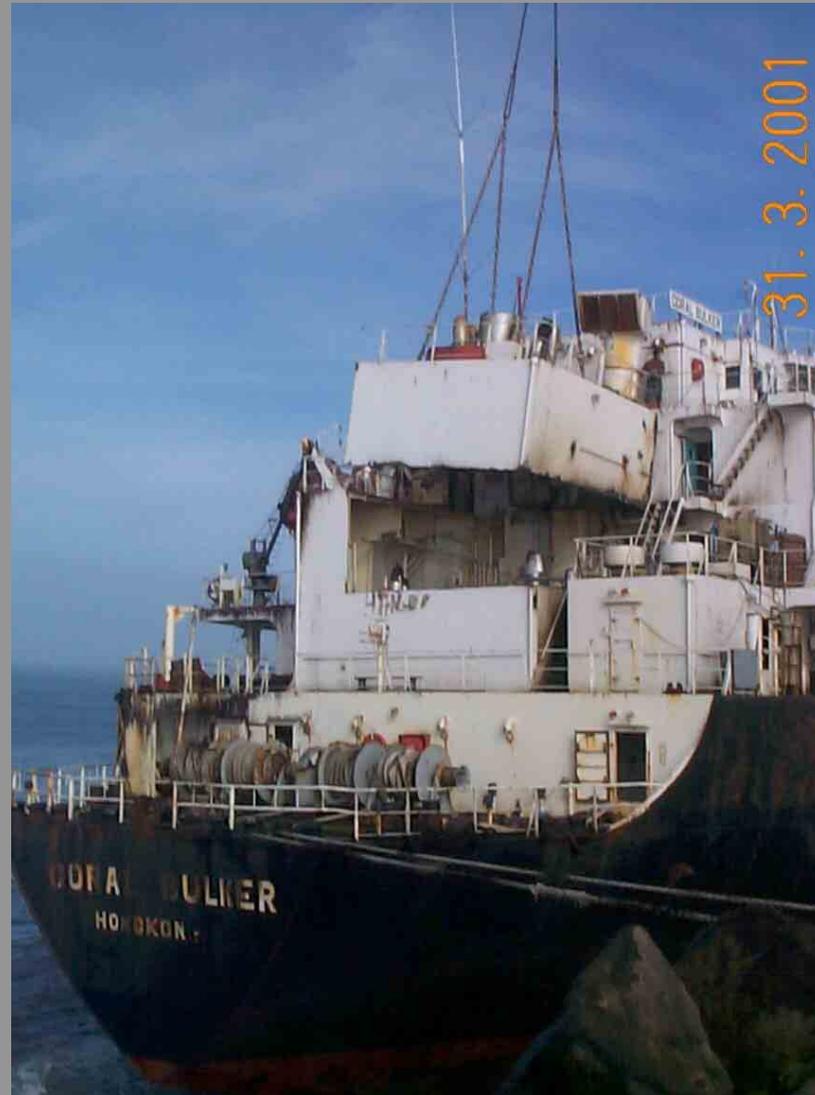
**ACCOMMODATION REMOVAL
CONCURRENT WITH
UNDERDECK CARGO
DISCHARGE.**

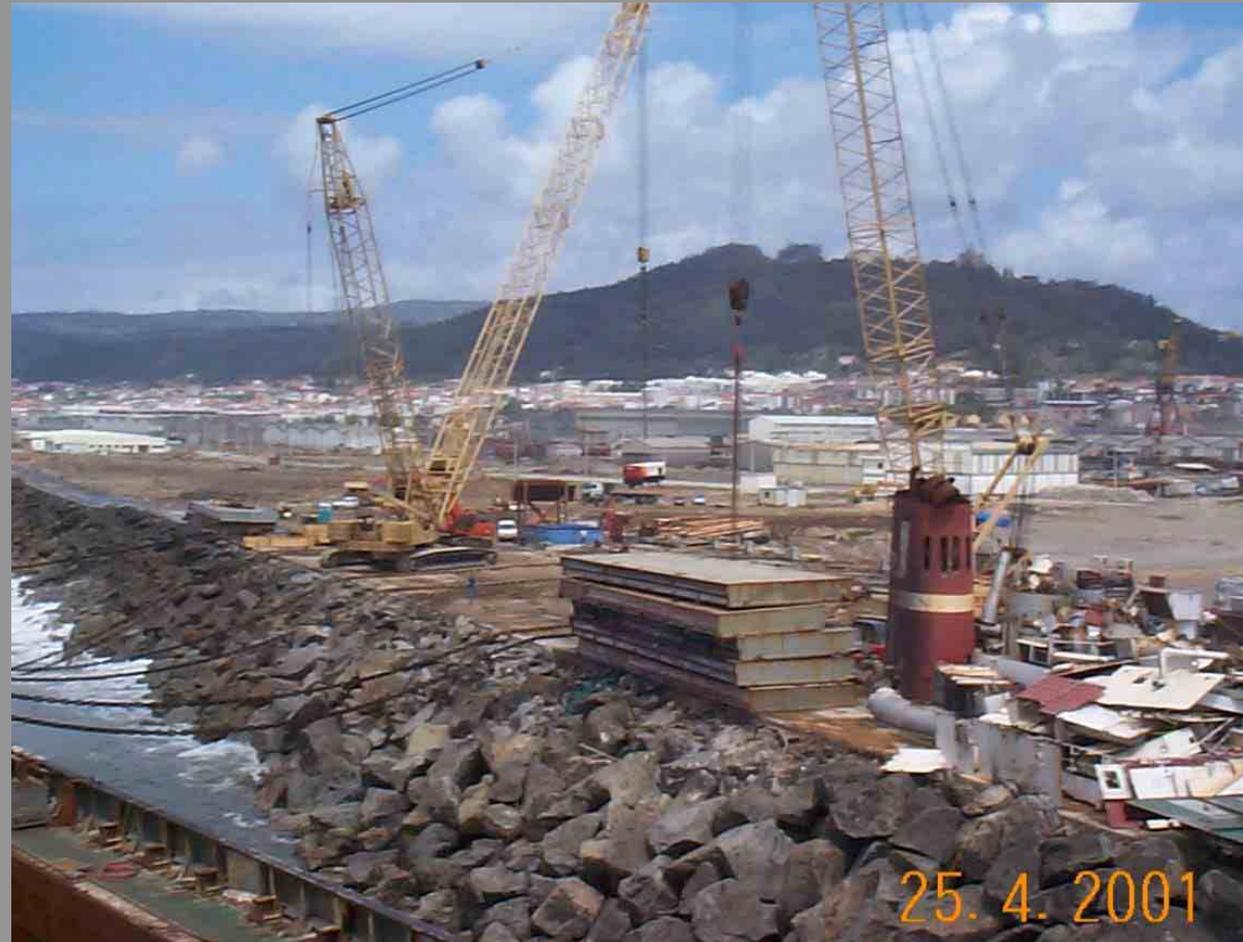
**EXTENDED BREAKWATER SITE, SHOWING TWO HEAVY LIFT CRANES
IMPORTED FROM UK.**

Two heavy lift, latticed, long reach cranes were shipped from the UK to Viana Do Castelo on a chartered barge. The initial plan was to ground the barge to the East of the breakwater and use this as a foundation/anchorage for the hydraulic pullers, this plan was however modified and the barge was later towed back to Northern Europe. The two cranes would be used during the demolition of the vessel. Concurrent with the underdeck cargo discharge the demolition of the accommodation commenced. The accommodation was demolished using traditional gas cutting methods.

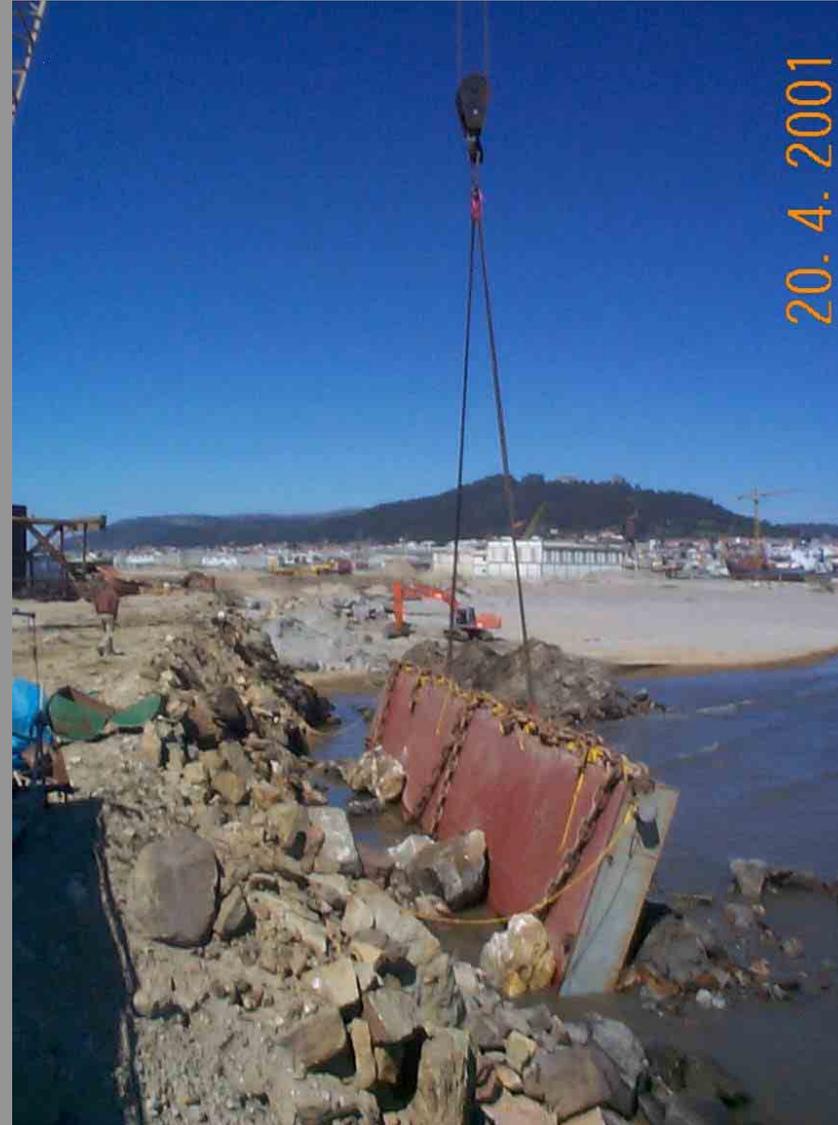
**BURYING HATCH COVER DEADMEN
TO THE EAST OF THE EXTENDED
BREAKWATER SITE. DEADMEN
USED AS ANCHOR FOUNDATION
FOR HYDRAULIC PULLERS.**

During the cargo discharge and the lightening of the hull, part of the TITAN team had modified a number of the cargo hatch covers and these were to be used as deadmen ashore. The deadmen were buried vertically against the eastern extremity of the extended breakwater and would act as a solid foundation for the hydraulic pullers to act against.

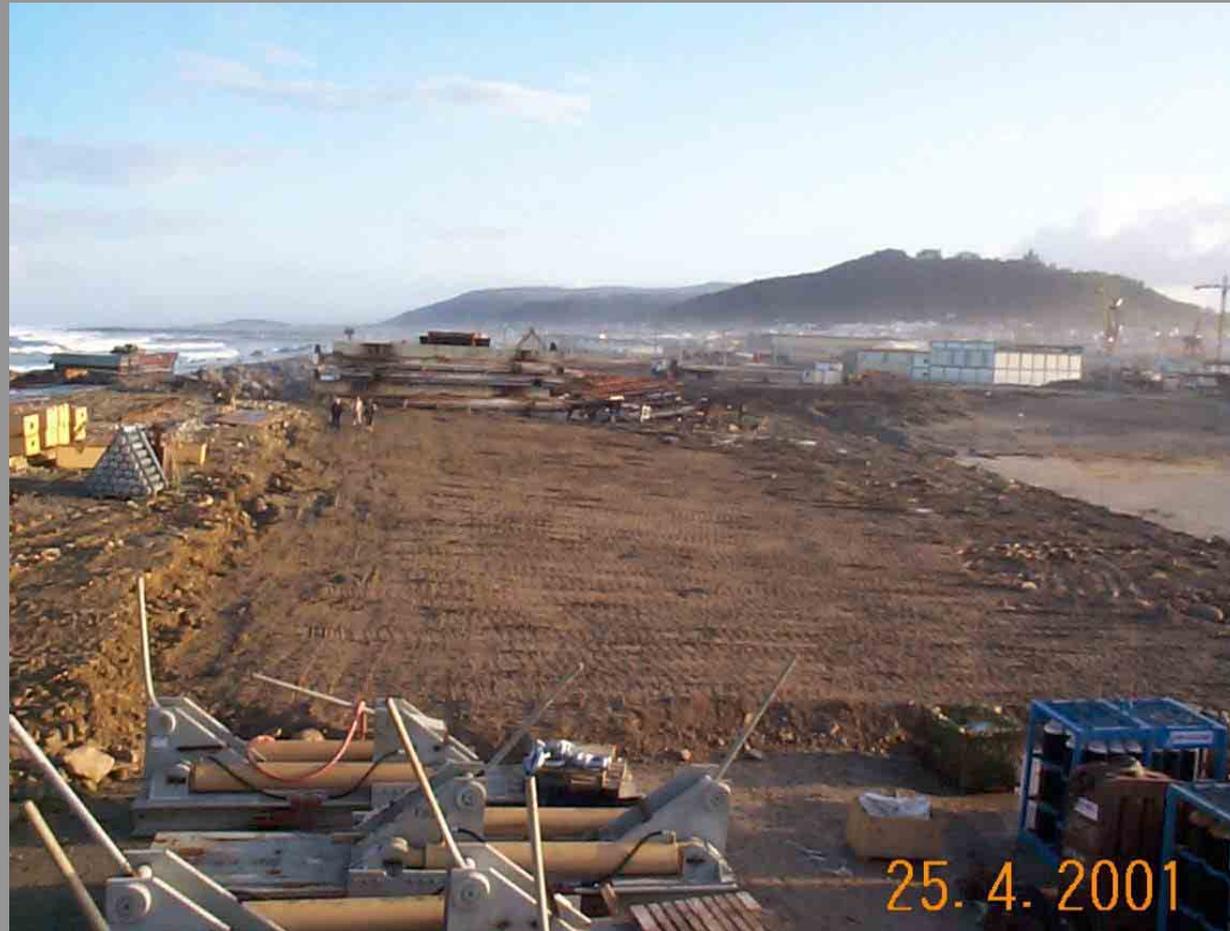
**LOOKING NORTH ALONG EXTENDED AND GRADED AREA TO BE USED FOR
HYDRAULIC PULLERS/BASES**

A large area was levelled and backfilled to the East of the breakwater. As can be seen from the slide the condition of the area was greatly improved.

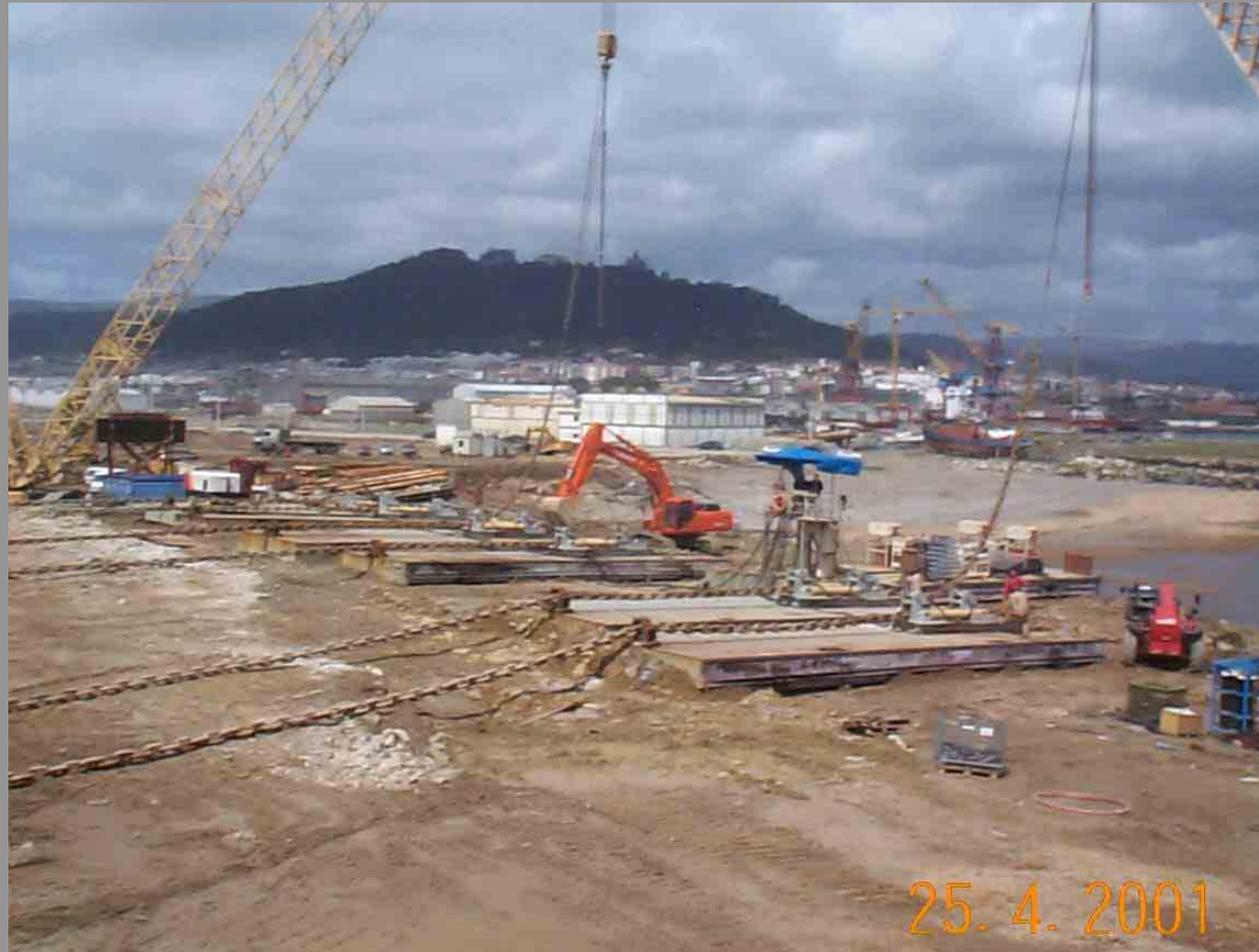
PULLERS IN USE, POSITIONED AT PREPARED AREA TO EAST OF WRECK

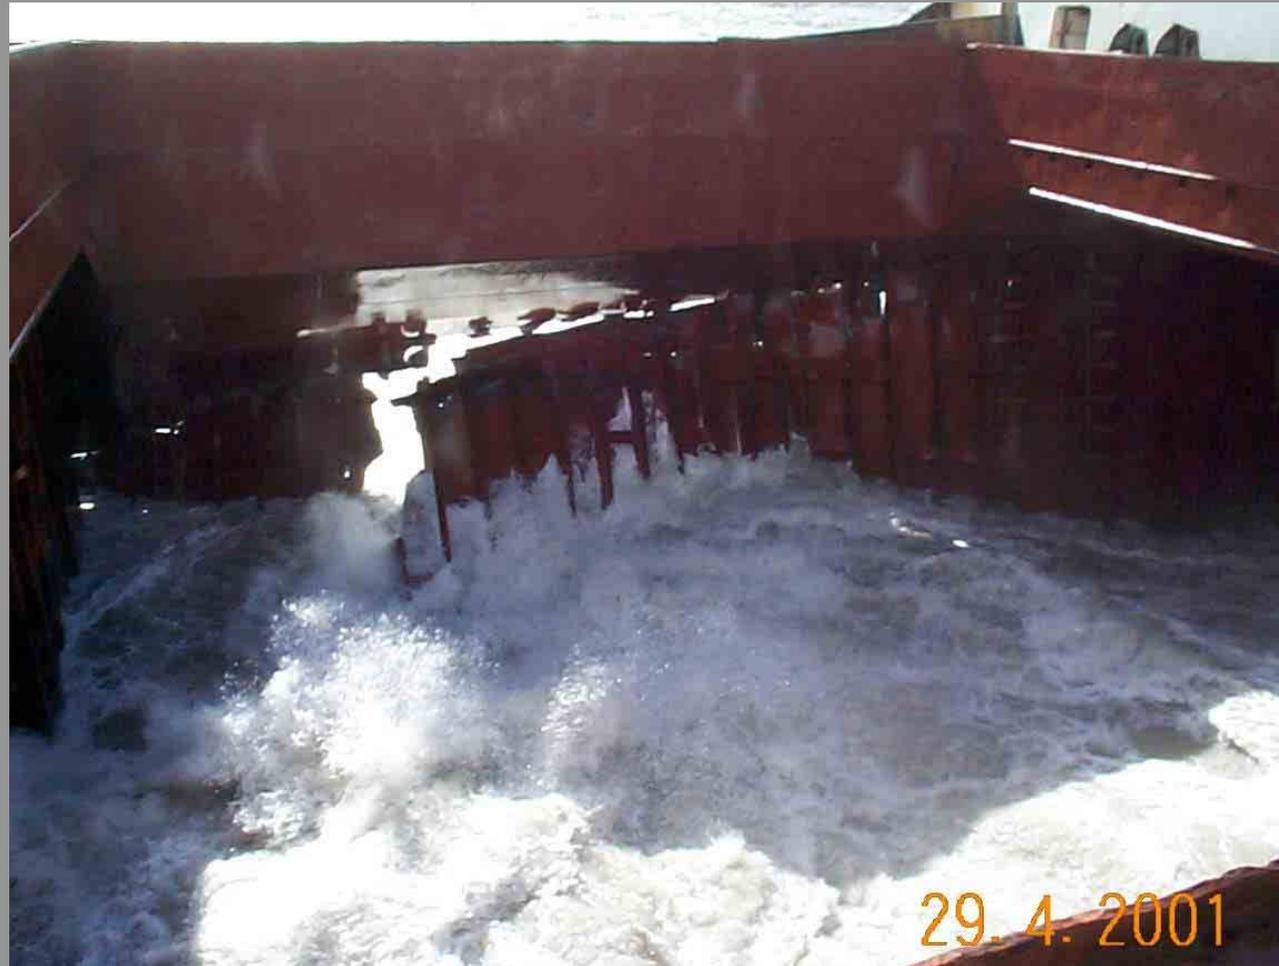
CONTINUOUS WAVE ACTION TAKES ITS TOLL ON THE SHELL PLATING.

Continued bad weather began to have an impact on the already damaged hull. The hull plating on the outboard side of the cargo holds already discharged became detached and quantities of the remaining woodchips and sawdust were lost to sea.

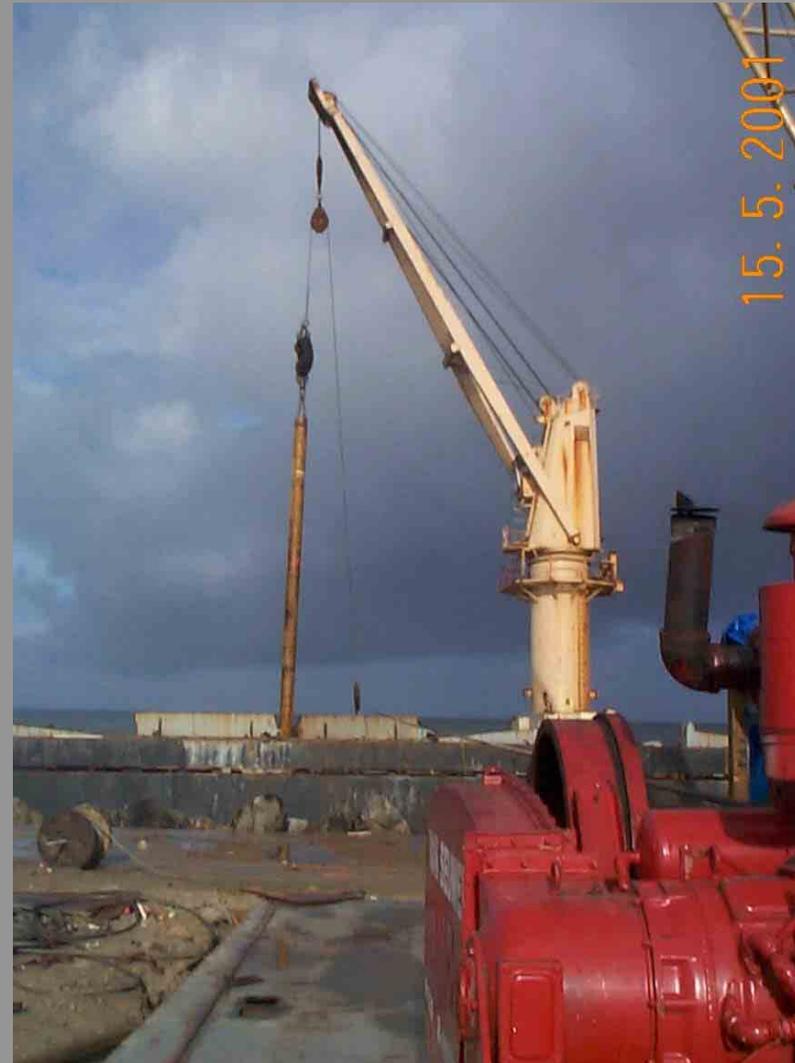
**TITAN DEMOLITION CHISEL IN
USE.**

**CASUALTY WAS CUT INTO TWO
SECTIONS IN WAY OF #4 CARGO
HOLD USING BOTH THE
DEMOLITION CHISEL AND
TRADITIONAL GAS CUTTING
TECHNIQUES.**

TITAN used a 13 tonnes demolition chisel which was rigged from number 3 crane, a winch was fitted to a firm foundation ashore and a wire reaved from the winch through tackles to the top of the demolition chisel. The winch was then used to raise and then drop the chisel through guides fitted to the cargo hatch, thus cutting the ship's bottom plating. When it was apparent that the underwater section had been successfully cut the upper wing tanks either side of the hatch and the remaining shell plating was cut using traditional gas cutting methods. The hull was now in two sections and ready for the parbuckling operation.

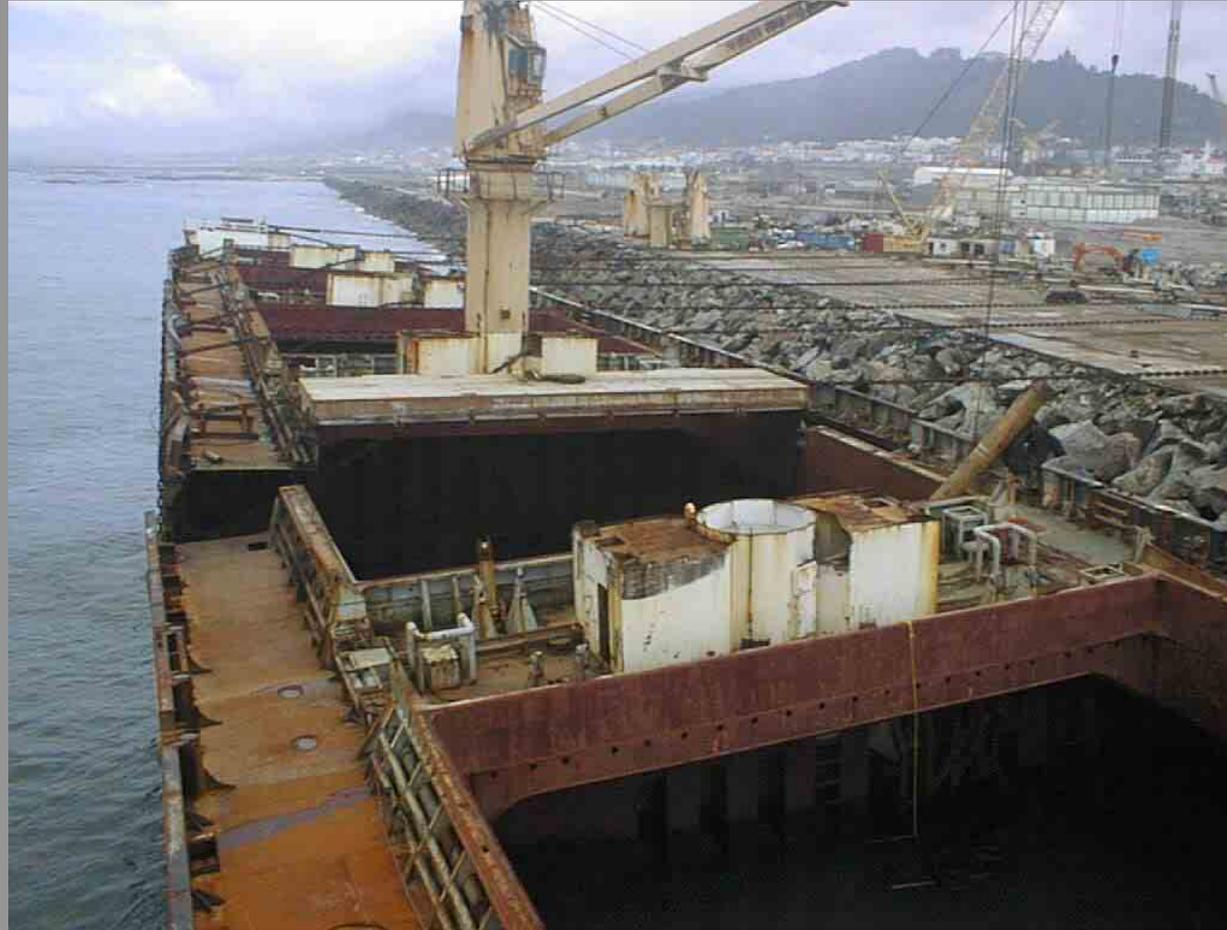
TEST PULLING FORWARD SECTION WITH 9 CHAINS/PULLERS.

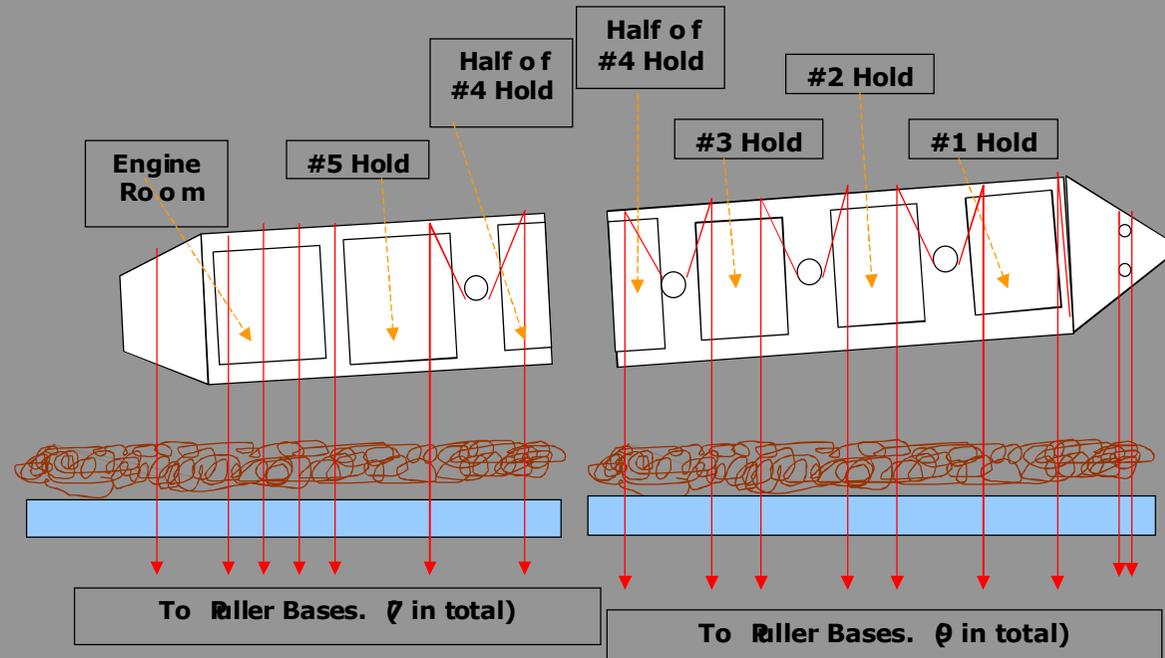
SKETCH SHOWING LAYOUT OF PULLERS/BASES FOR BOTH FORWARD AND AFT SECTIONS

As stated previously a number of the hatch covers were modified to act as deadmen for the hydraulic pullers. The pullers themselves were fitted to individual hatchcovers, these acted as a firm foundation for the pullers. There was insufficient room to fit 5 deadmen for the forward section so the two forward most pullers were secured using traditional anchors embedded in the beach to the East of the breakwater. By 17th May, TITAN were ready for a test pull of the forward section, the test proved effective and the section was seen to roll approximately 10° to starboard.
