MV "CORAL BULKER"

**DEALING WITH A WRECK STRANDED ON A PORT
BREAKWATER**

**LES JOURNÉES D'INFORMATION DU CEDRE
INSTITUT OCÉANOGRAPHIQUE - PARIS
6 OCTOBRE 2003**

**Eng. Alvaro Guidotti
TITAN MARITIME LLC**

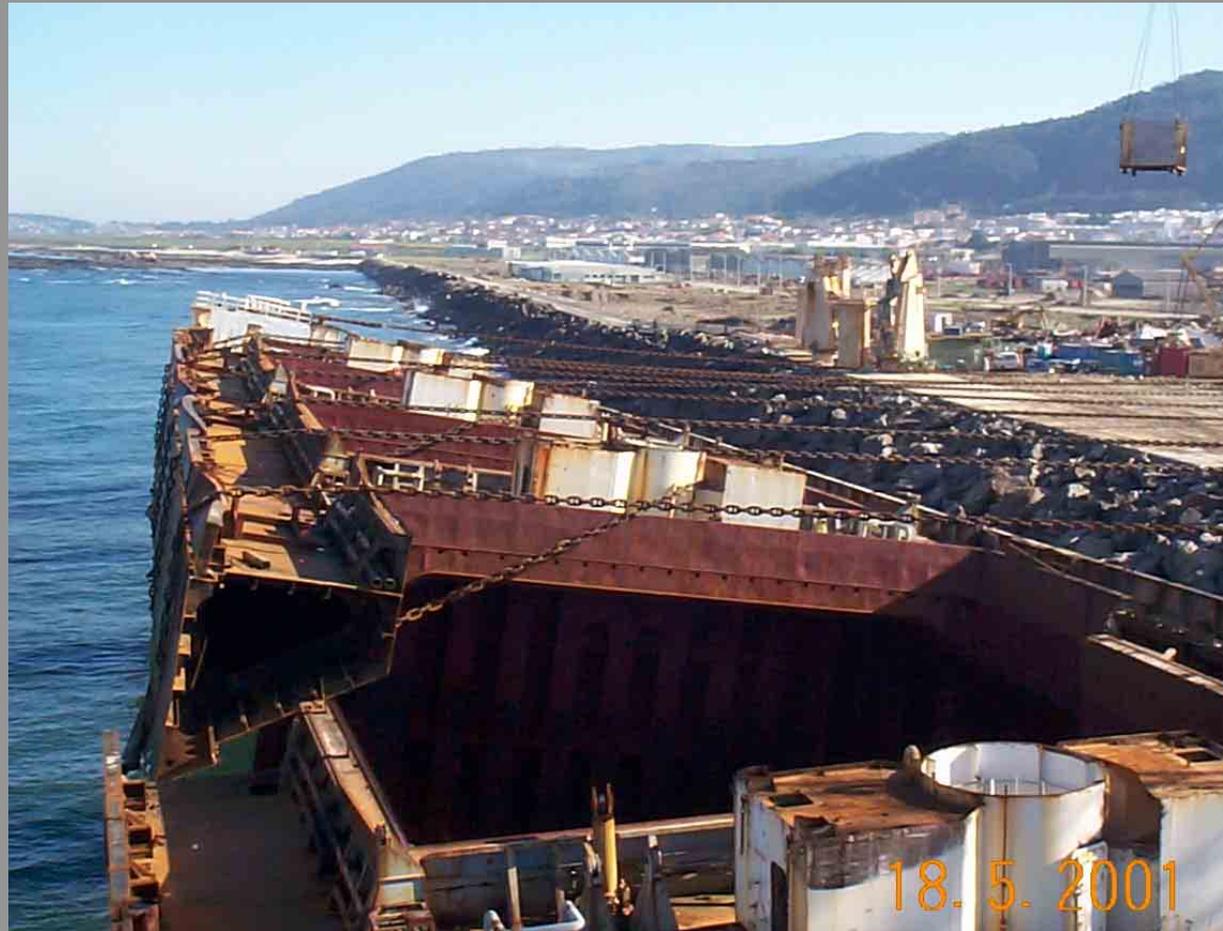
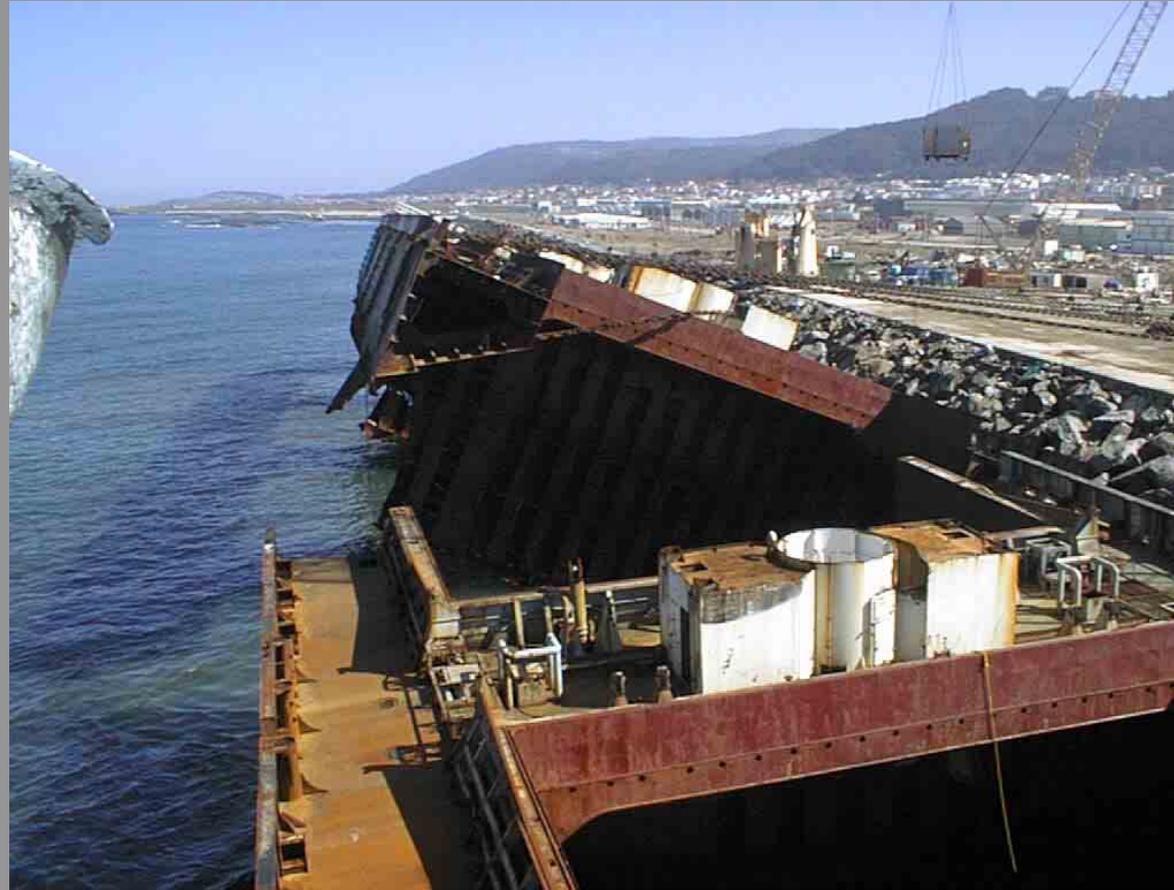
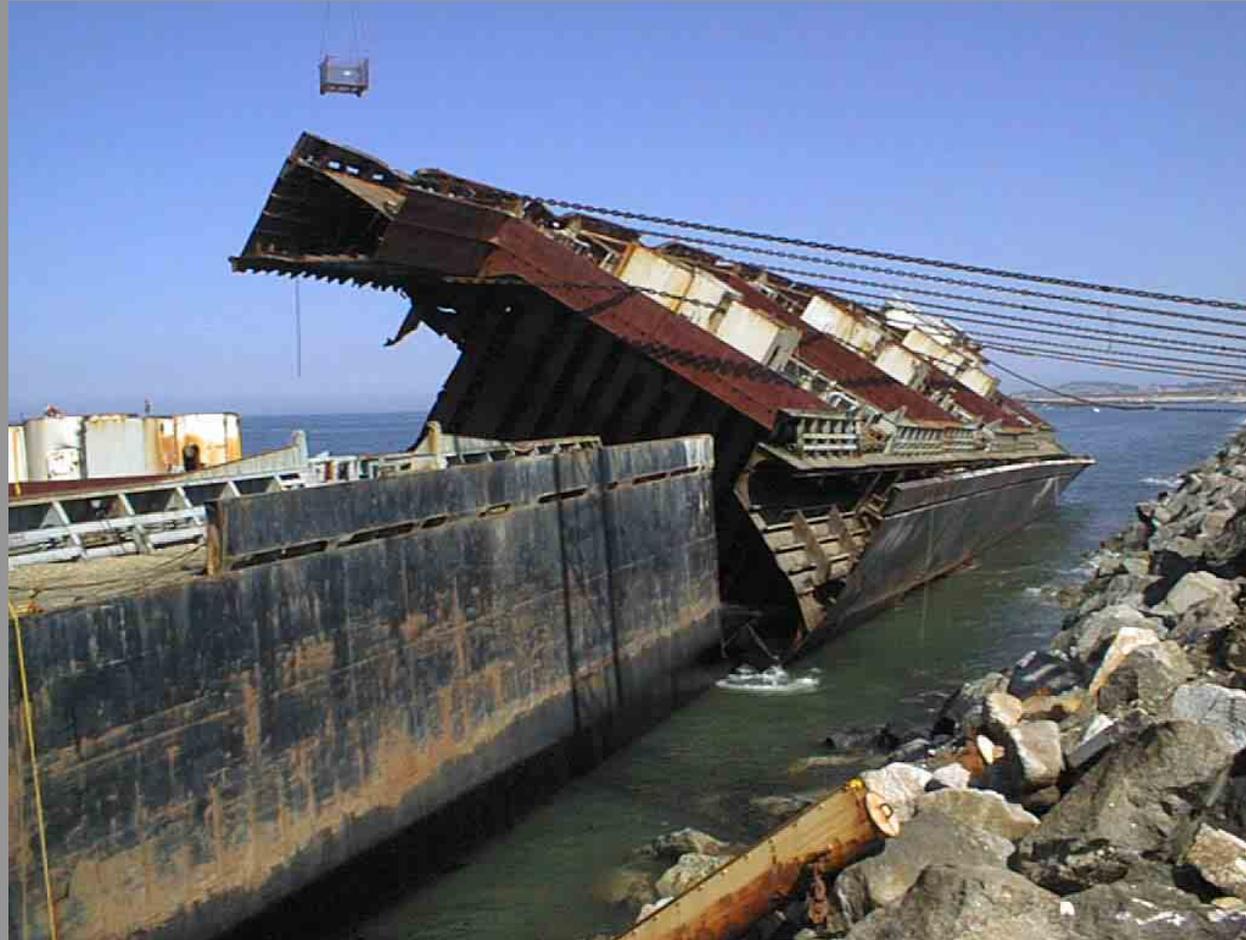
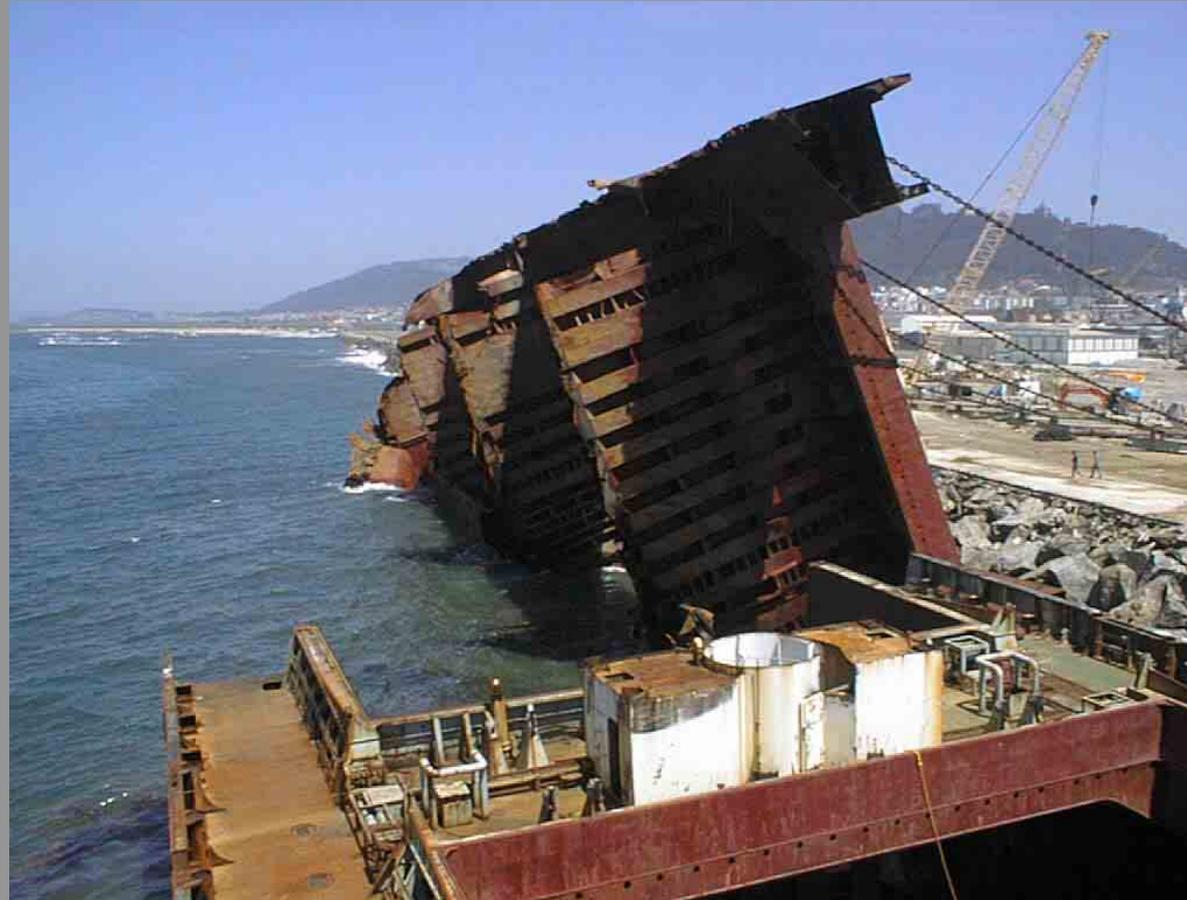
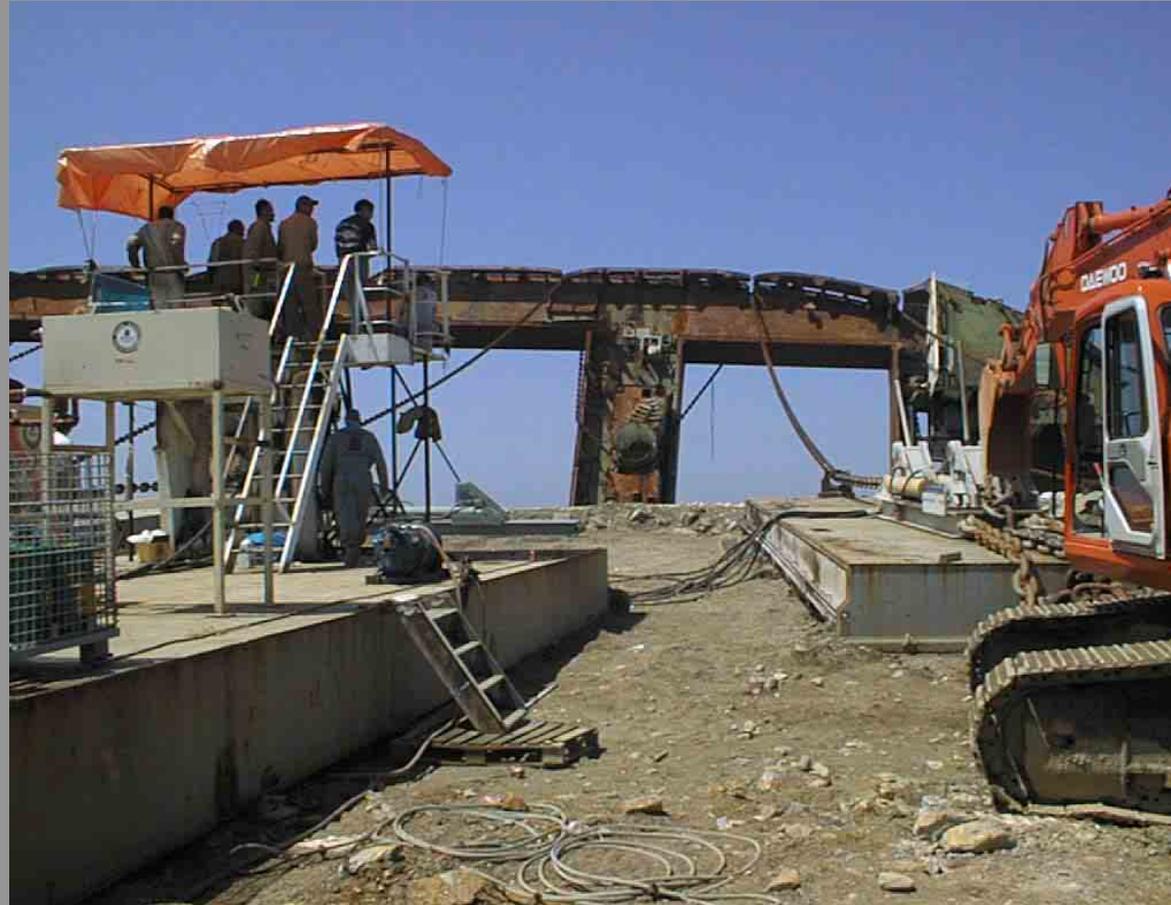
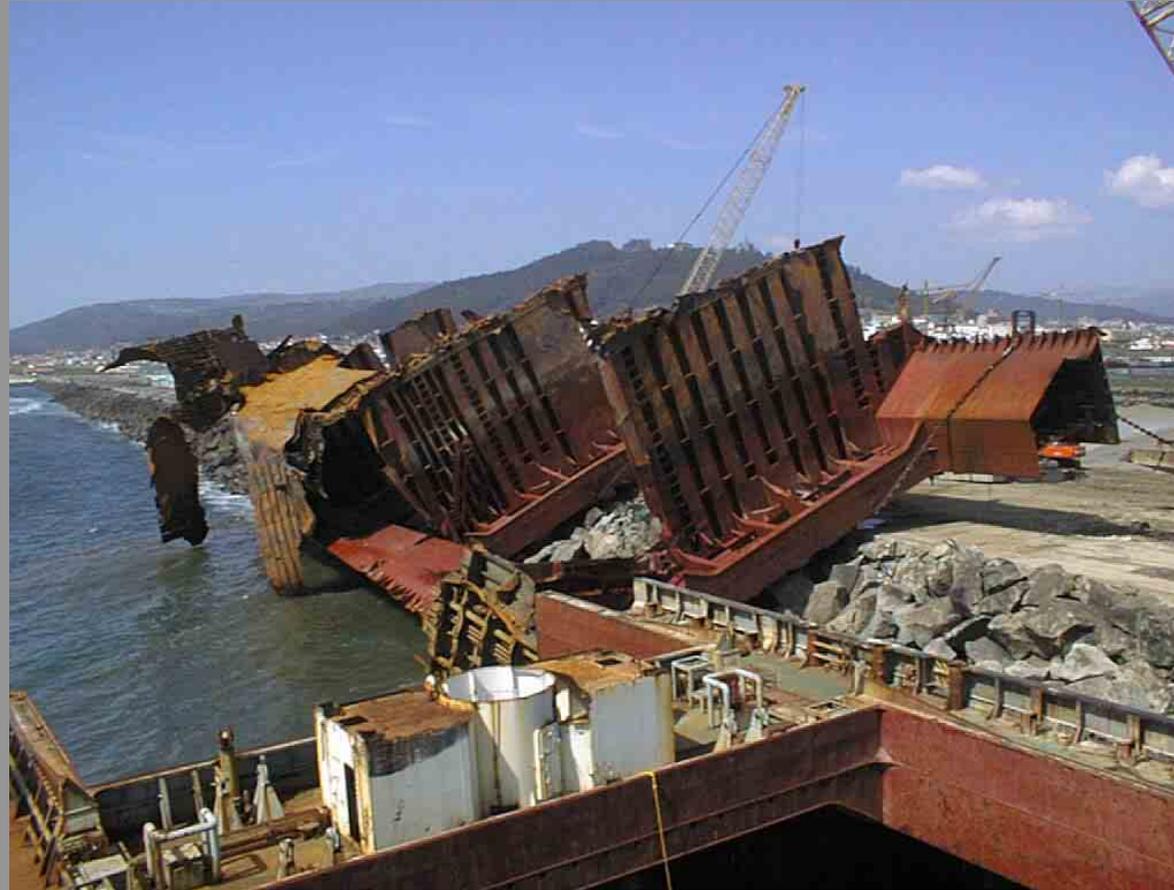
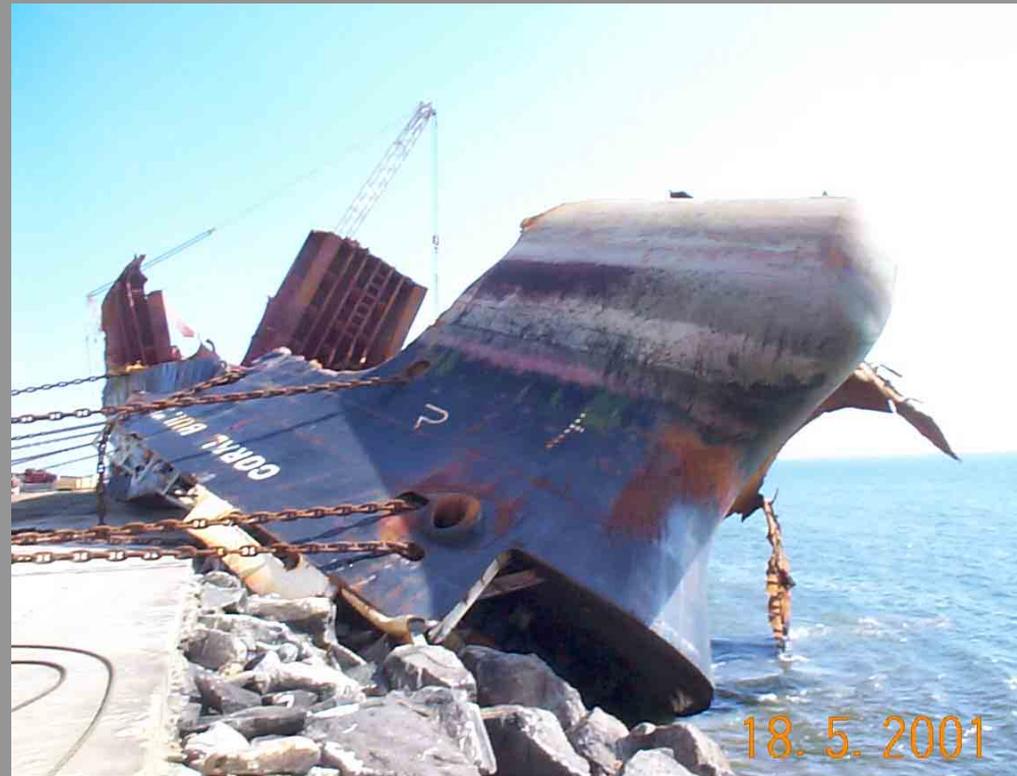
PULLING FORWARD SECTION WITH 9 CHAINS/PULLERS.

The forward section was rolled through approximately 140-150° and remained under control throughout.

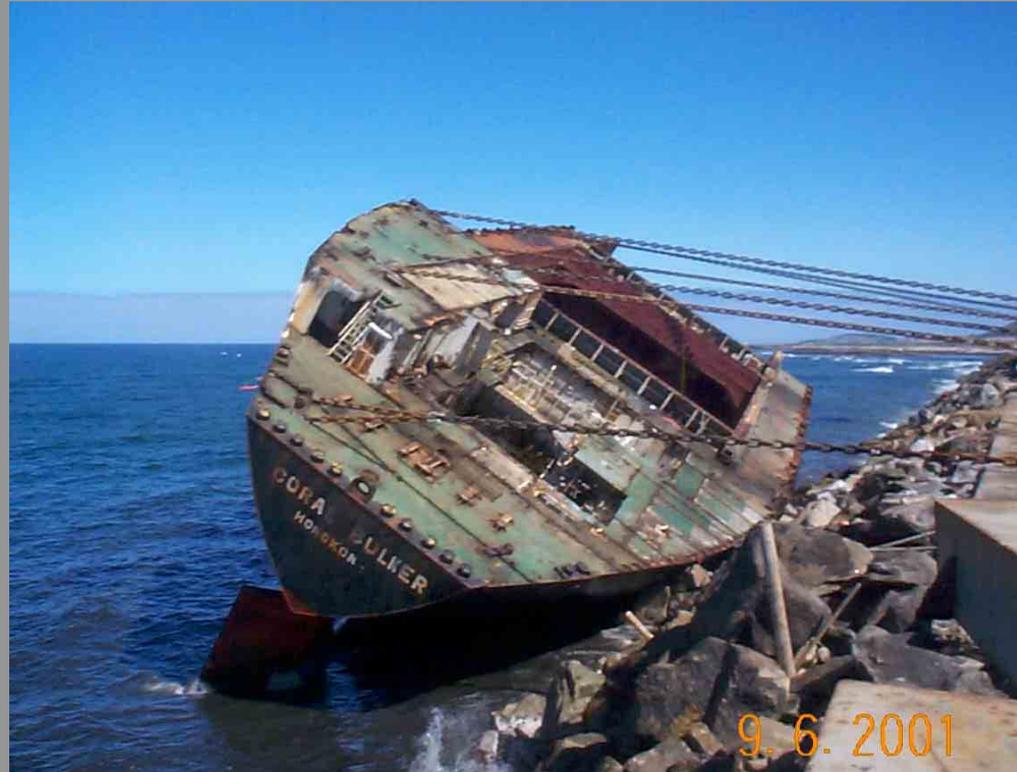
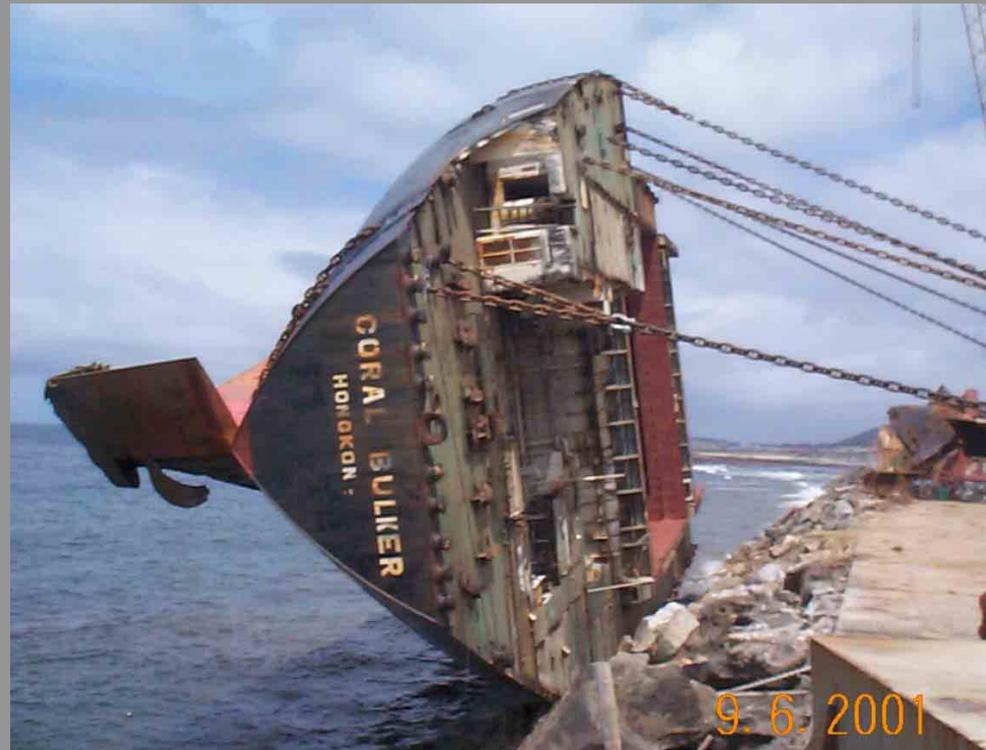
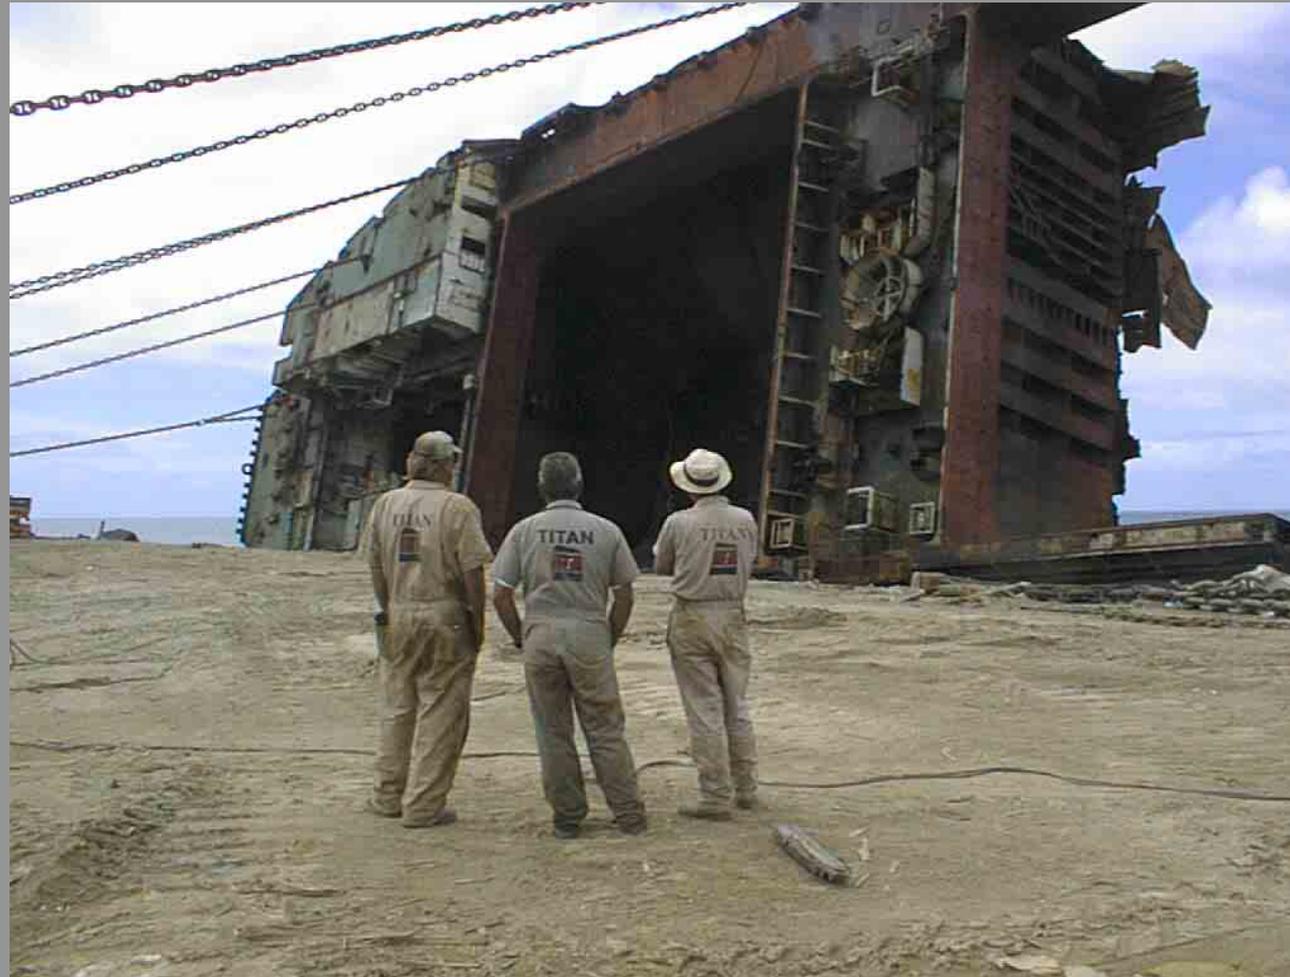
PULLING STERN SECTION WITH 7 CHAINS/PULLERS.

PULLING STERN SECTION WITH 7 CHAINS/PULLERS. SECTION AT 85 Degrees

The stern section parbuckle was again a successful operation and went according to TITAN's calculations and plans. The section was rolled over to approximately 135° before falling onto the breakwater.

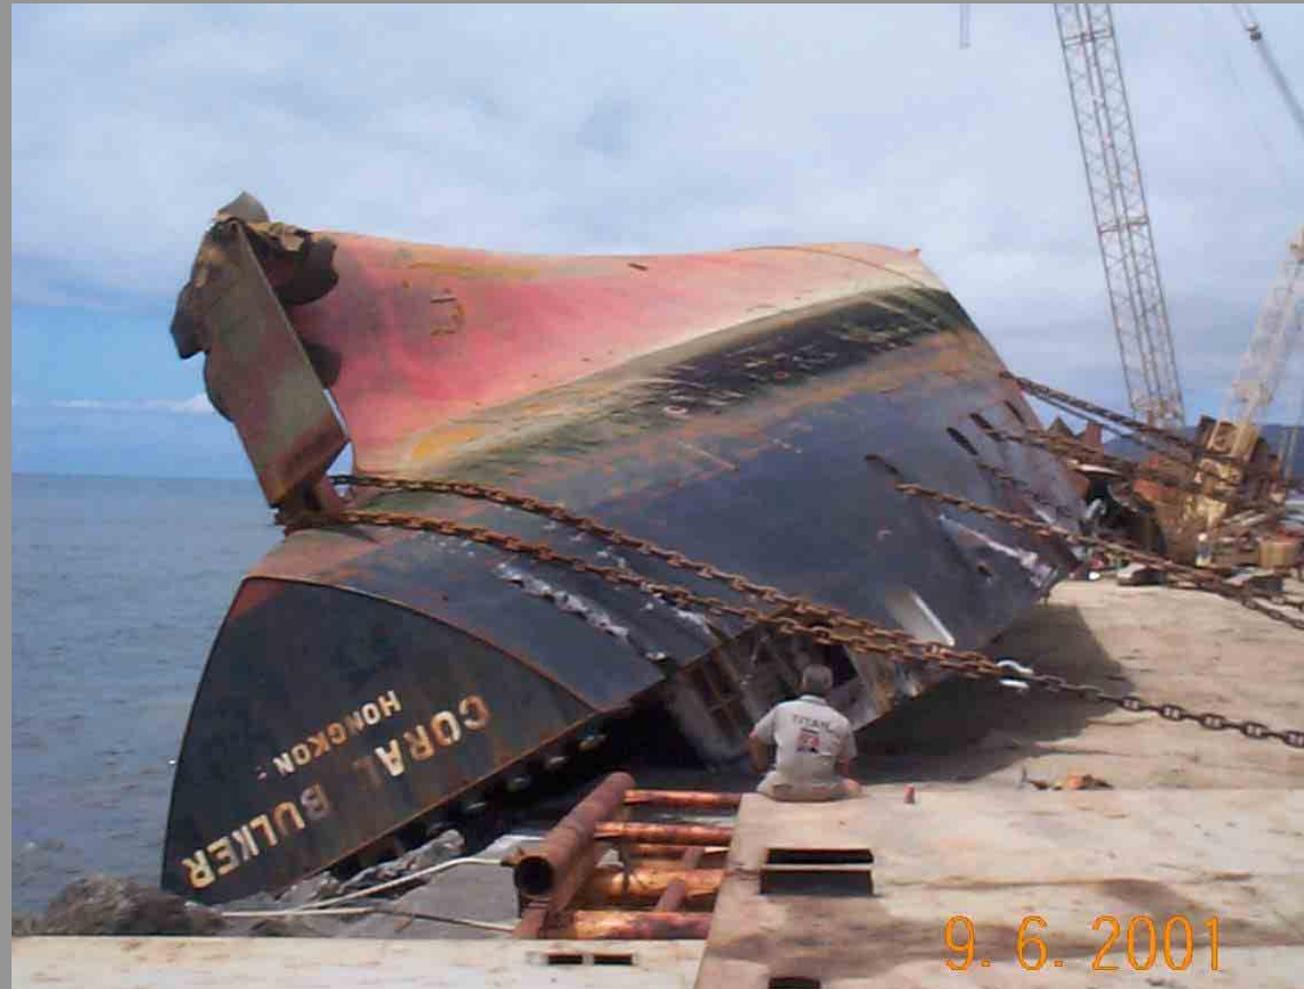
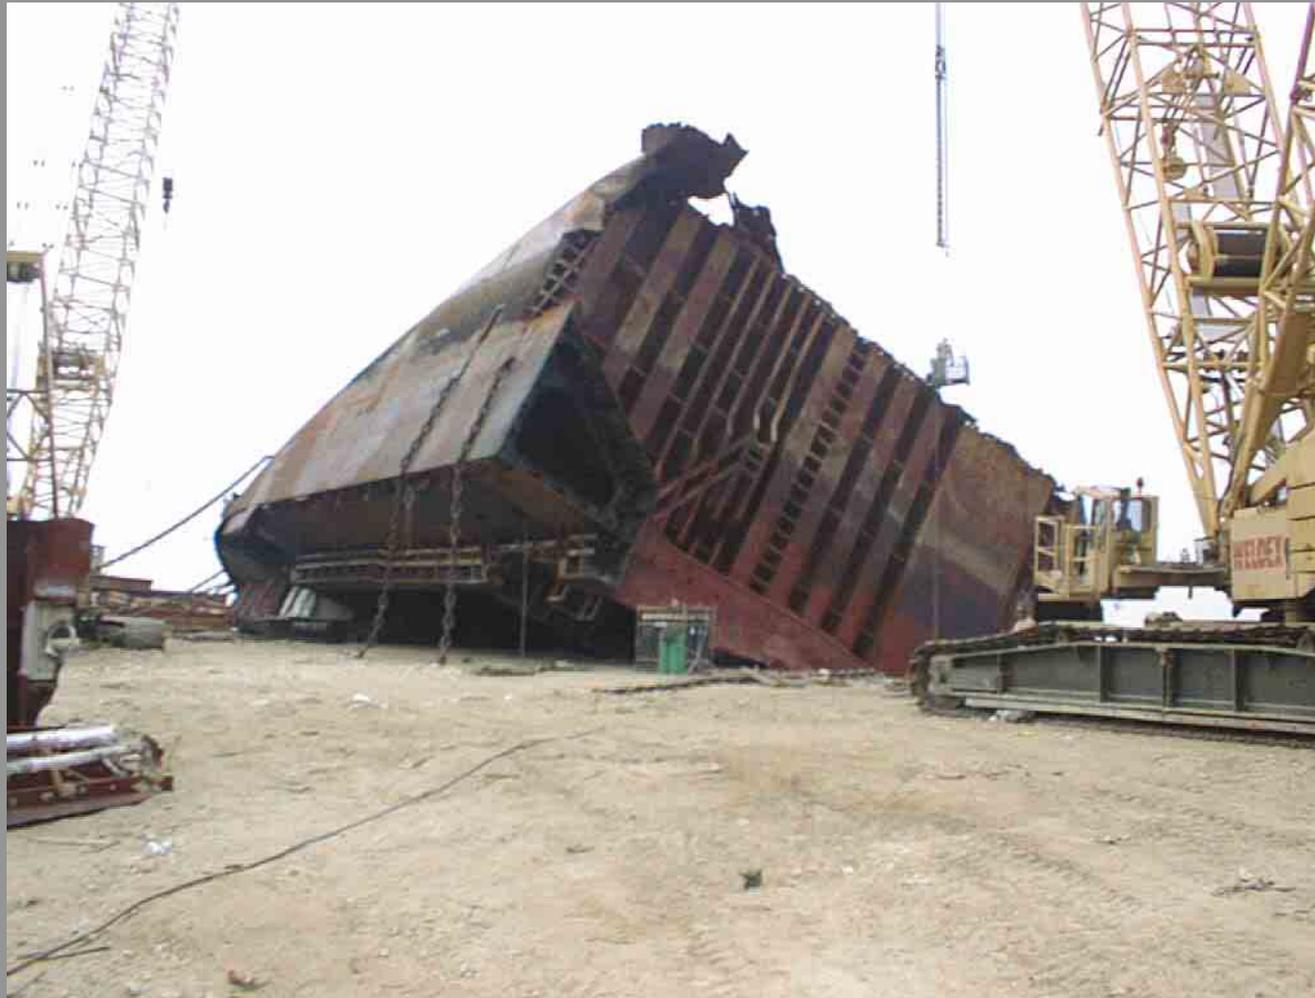
STERN SECTION ROLLED ONTO BREAKWATER

TITAN continued to pull the section but the pulling chains were observed to be cutting into the hull plating. The chains were re-rigged and over the next few days the section was further lightened by cutting and removing areas of the double bottom, the stern section was eventually pulled completely onto the breakwater.

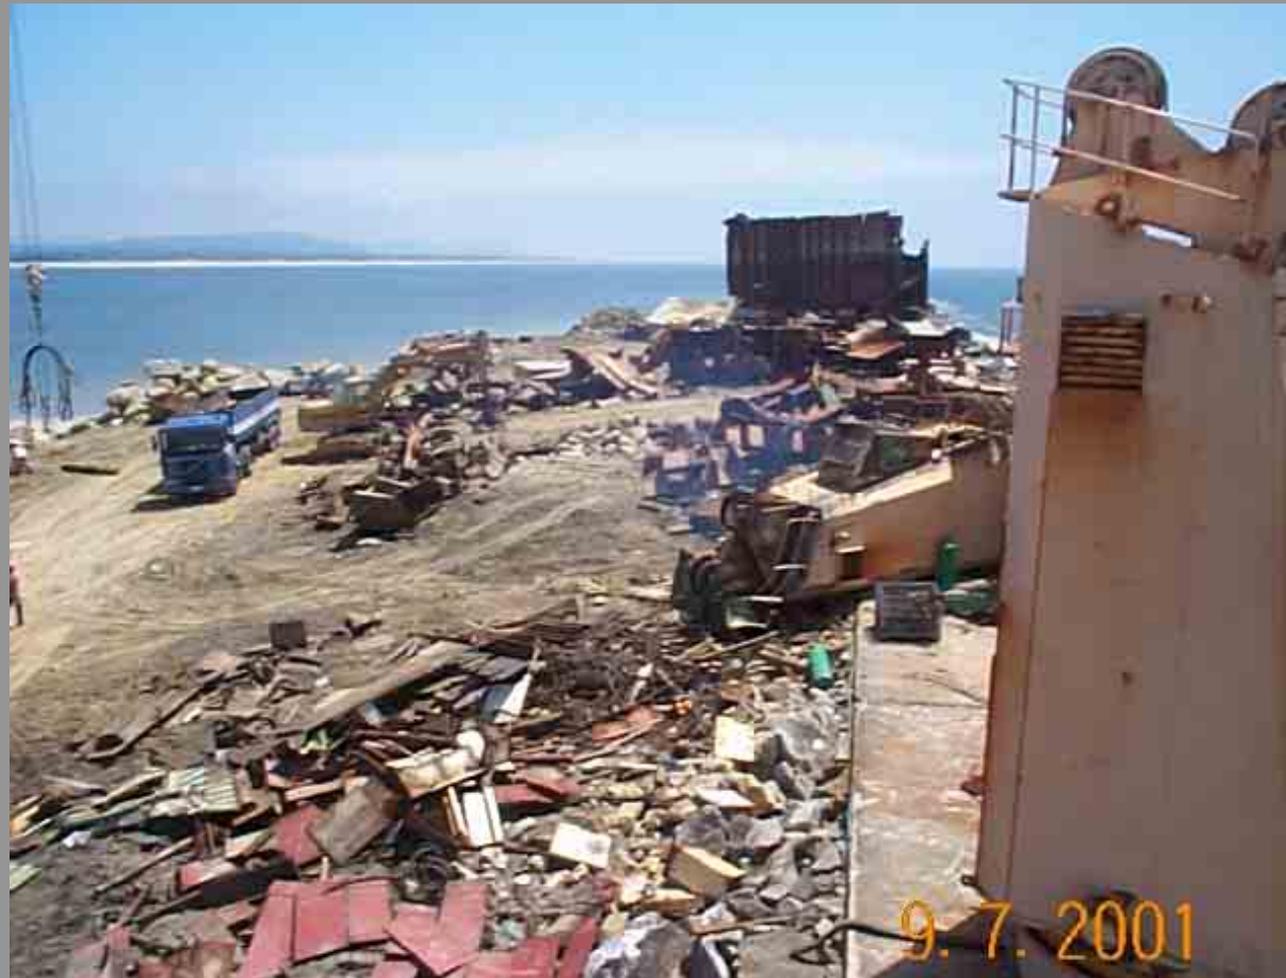
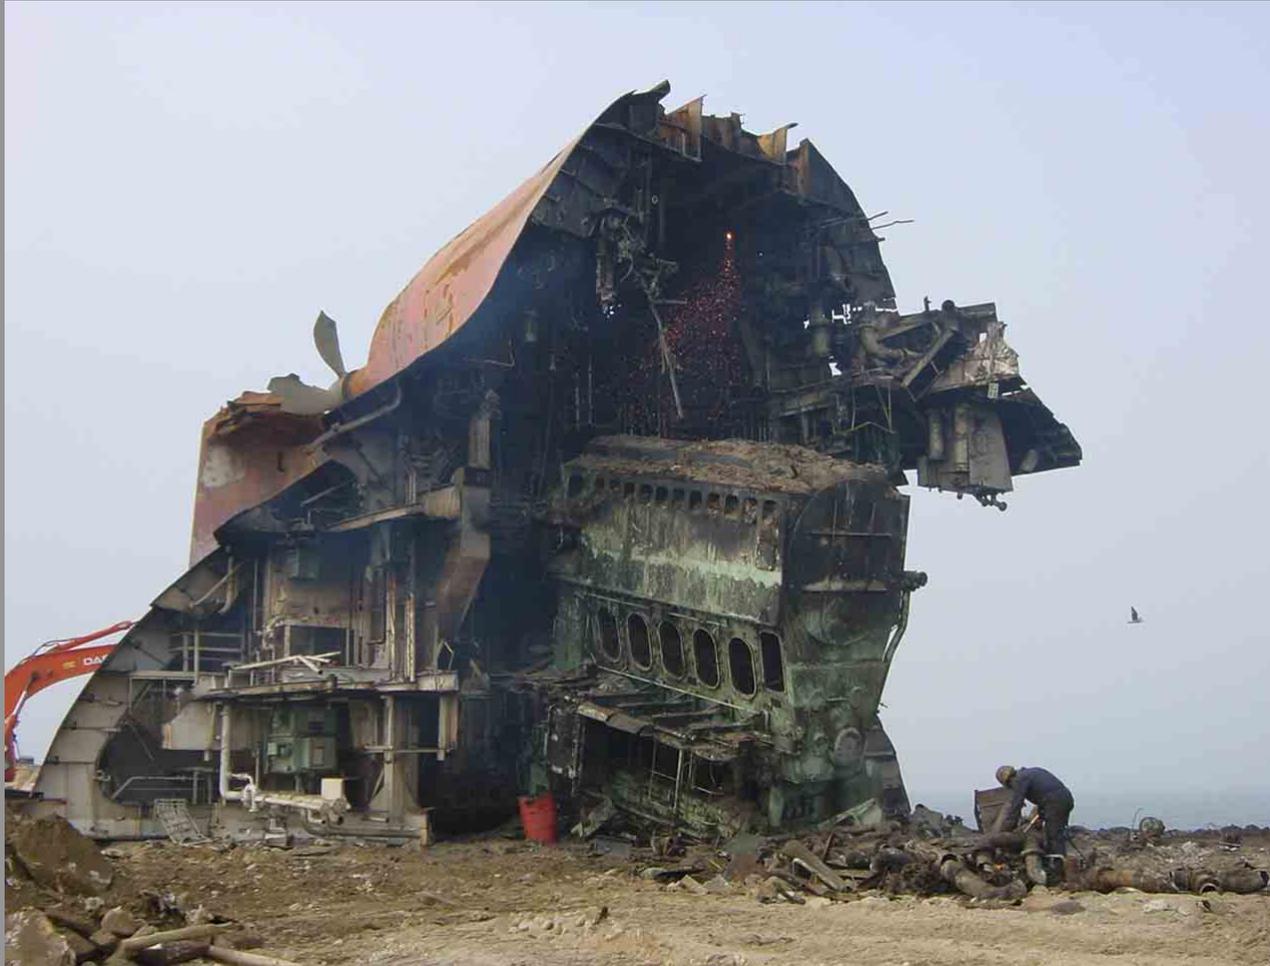
SCRAPPING OPERATION

SCRAPPING REMAINS OF STERN SECTION AT BREAKWATER SITE

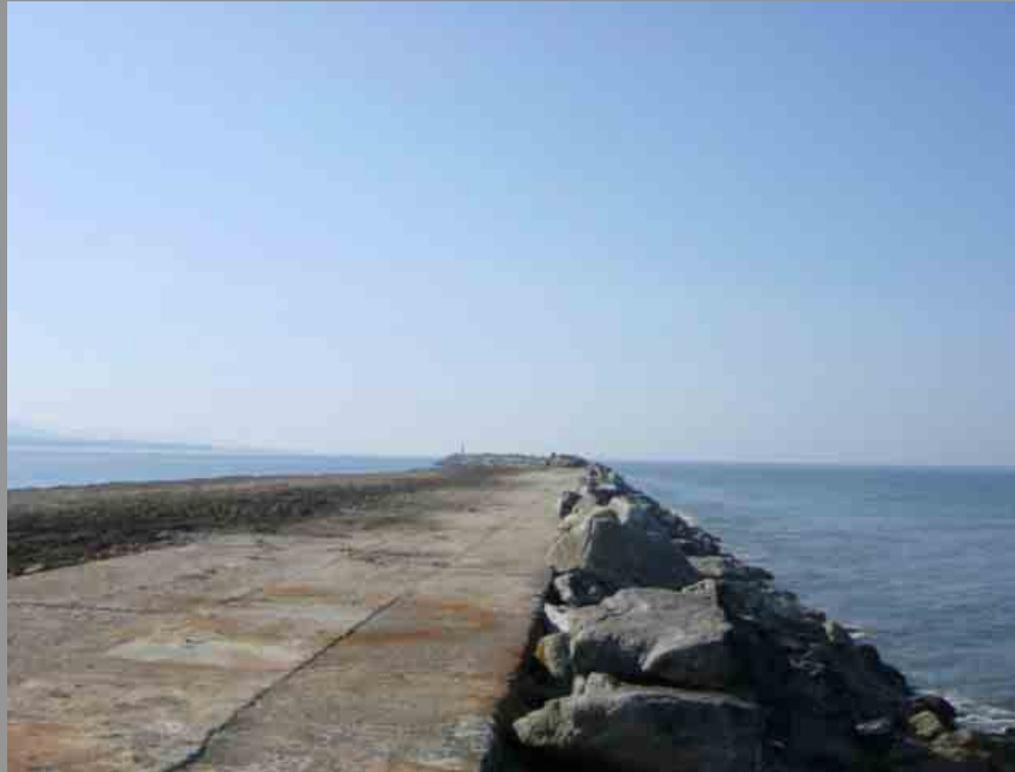
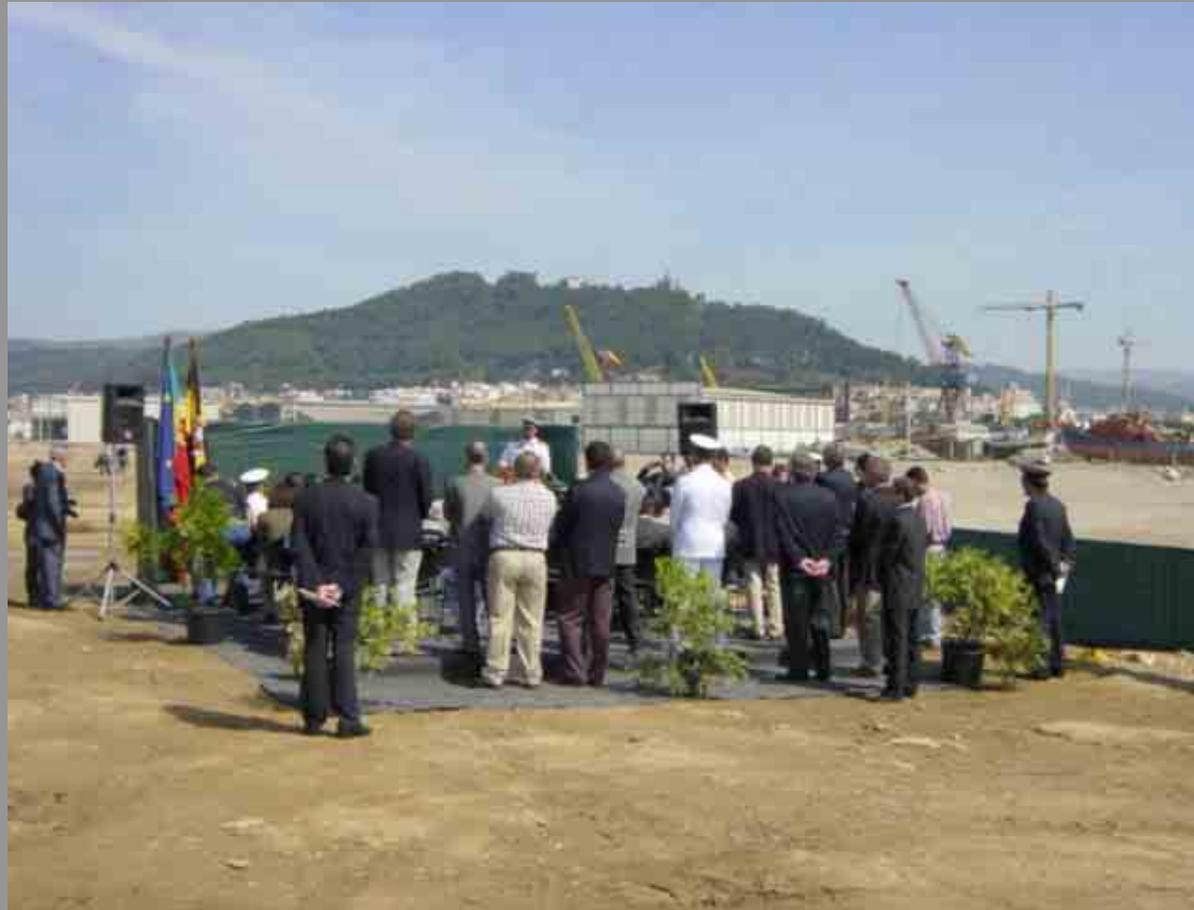
BREAKWATER SITE RE-INSTATED UPON COMPLETION OF SCRAPPING OPERATION

By mid-July the site had been cleared of all scrap and the site was finally levelled and cleaned before redelivery to the local Port Authority and the final signing off of the wreck removal by the Port Captain.
