The Symposium of the information days of CEDRE  
"The environmental impact of an accidental  
pollution of water".

*Environmental Restoration of the Guadiamar  
River basin affected by the accident of  
the mine in Aznalcollar, Spain.*

# "The environmental impact of an accidental pollution of water"

*Environmental restoration of the Guadiamar river basin affected by the mining accident in Aznalcollar (Seville).*

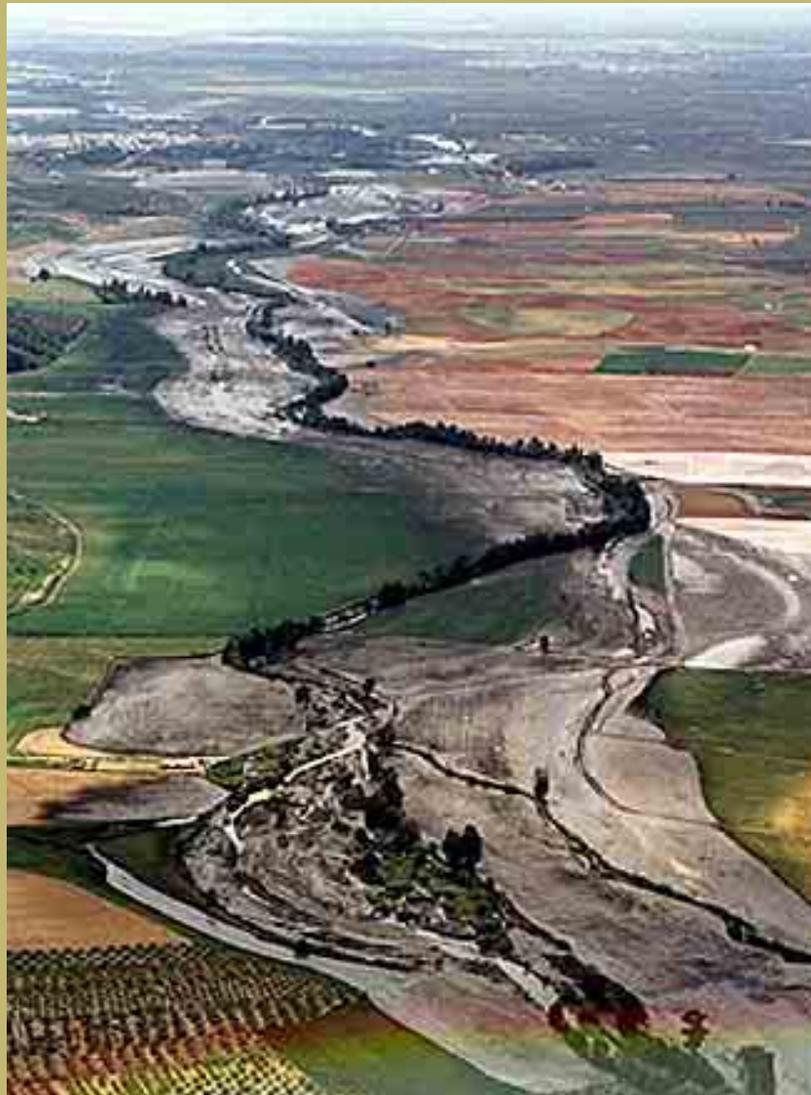
- The mining residue came from the process of pyrite floatation to obtain Pb, Cu and Zn concentrates.

- The original material, having come from the Frailes hole, was made up of the dissemination of sulphades such as galena, chalcopryrite and esphaleryte included in a pyrite matrix.

- After being triturerated and finely ground, sizes smaller than 8 microns, the specimens carrying the metals of interest are freed thus obtaining an individual, sequential concentration of each of them.

- The resulting residue, practically 90% of the processed mineral, was confined in the tank which was damaged.

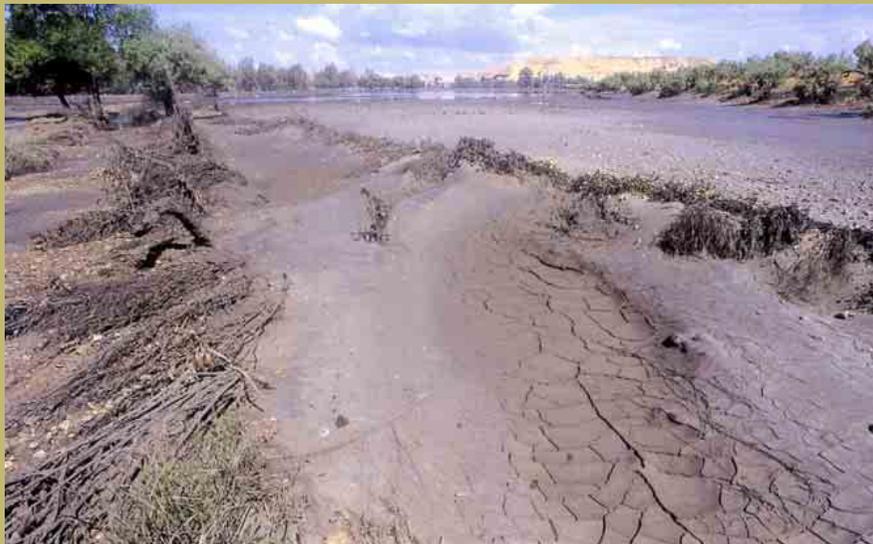
Element/Concentration of the pyrite sludge: grams/tonne

Zn	8,000
Pb	8,000
As	5,000
Cu	2,000
Co	90
Tl	55
Bi	70
Cd	28
Hg	15

- High pyrite purity 68-78%
- Very fine granulometry, 50% of the particles are smaller than 8 microns. (Particles smaller than 10 microns can be inhaled).

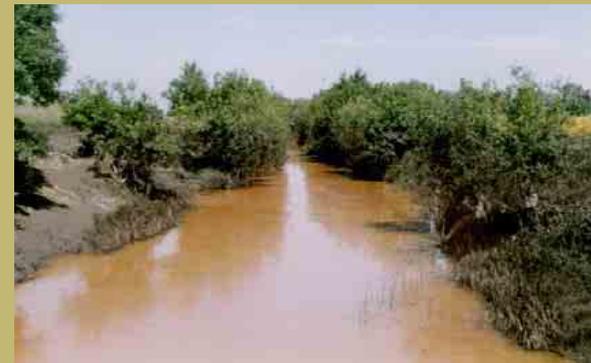
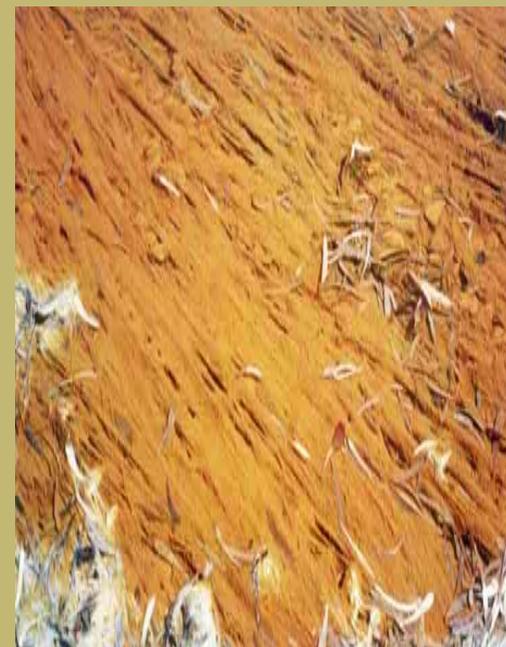
The water quality worsened drastically starting on the day of the spill, taking one month to recover the initial levels:

Zn from 450 to 5 mg/l

pH from 4 to 7.9

A follow-up and vigilance programme was designed. To begin with, 70 sampling points were installed that controlled zones from the rupture point in the tank to the mouth of the Guadalquivir River. As time passed, the control point network was modified according to two criteria: the evolution of the analytic data and the evolution of the relevant variables.

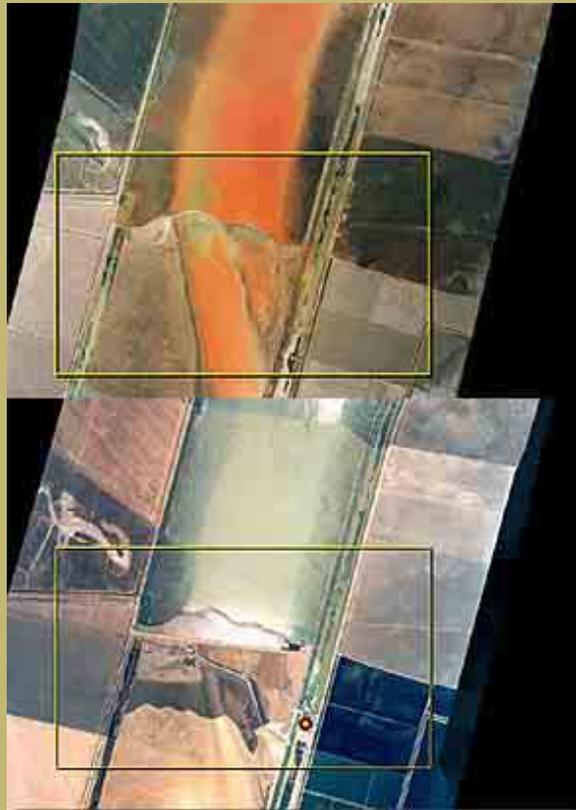
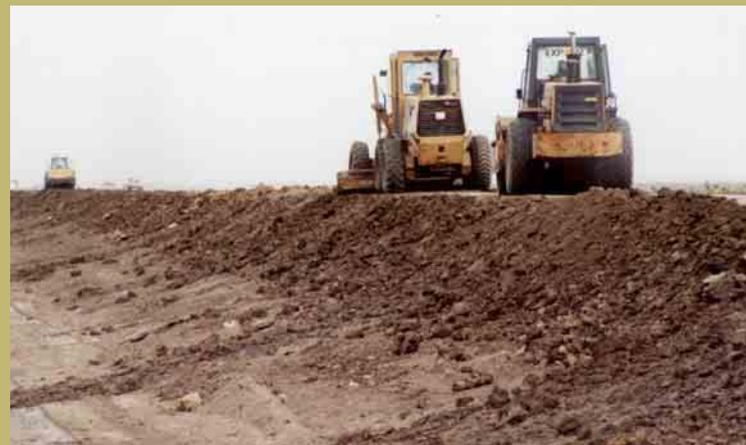
## Construction of the containment walls

At Entremuros, during the rupture the following were registered:

Zn	300 mg/l.
Mn	80 mg/l.
pH	4

- The **construction of a transversal containment wall** to prevent the contaminated waters from entering into areas of greater ecological interest.
- Removal of contaminated sludge.**

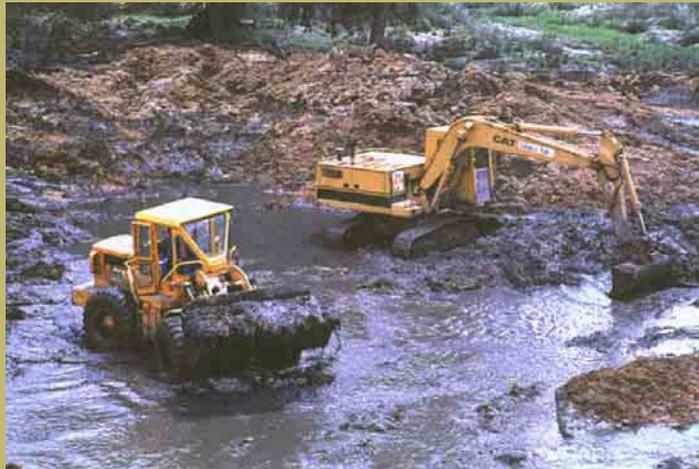
## Sludge removal

- The deposit of the sludge along 62 km of fluvial area affected each zone differently, registering levels of 4 metres nearer to the tank and around 10 cm in the southern section.

- In the cleaning works the resources employed were numerous, being simultaneously almost 500 lorries and more than 150 machines among diggers and loading machines, to remove 7 million of m<sup>3</sup> of sludge and countermined water.

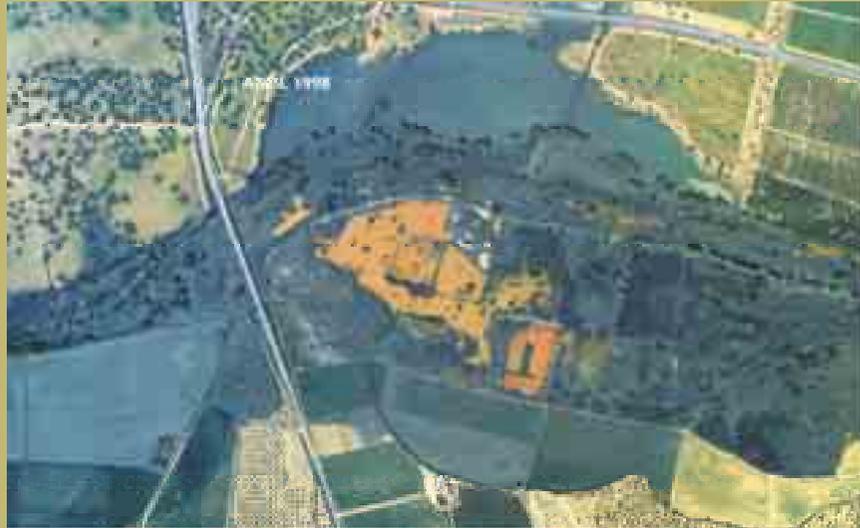
## Sludge Removal

- A total of 7 million m<sup>3</sup> were removed .

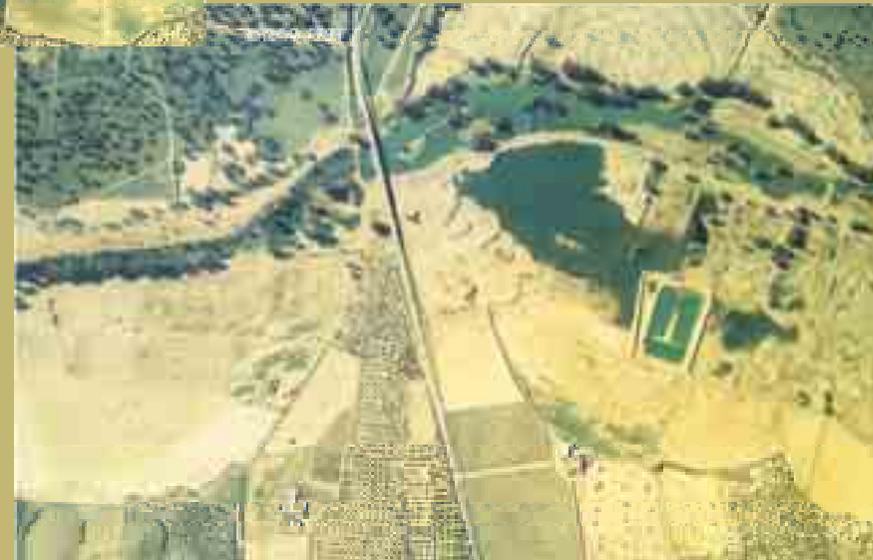
• Given the importance of a greater or lesser presence of S-pyrites in the soils, a system of quality control of the cleaning was implanted, establishing as an indicator the % of this compound in the soils. The norm said that it always had to be lesser than 1.5 % in the first 20 cm of soil.

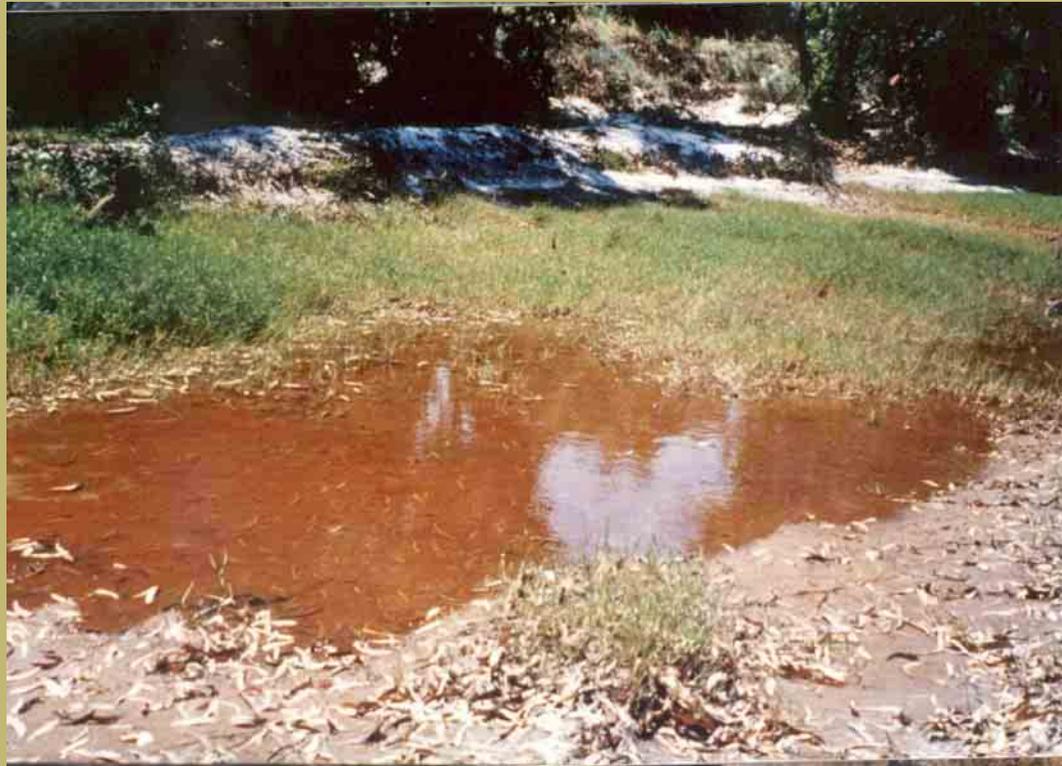
Identification of the main problems:

- Potential acidity
- High As concentrations
- High Zn concentrations.
- Low fertility level of the soils.

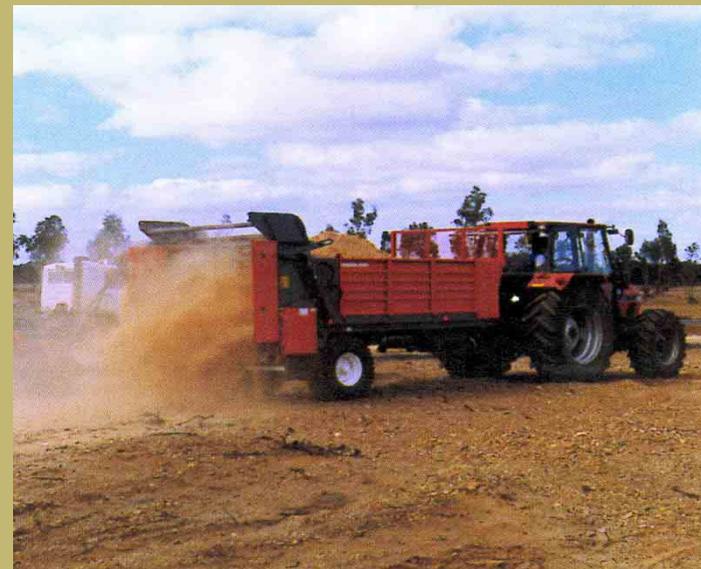
### Acidity correction

- The elevation of the pH of the soil not only makes the re-vegetation of the affected area possible, but at the same time causes a descent in the mobility of the metals, especially starting at pH 6, preventing lixiviation phenomena.
- With regards to As, it shows a minimal concentration in the interval pH 5 to 6, augmenting its solubility above these values. This circumstance demonstrates the scant effectiveness of this treatment when it comes to immobilising As.
- The material selected for the lime treatment was an industrial sugar subproduct. This material has an elevated capacity of neutralisation, rapid reaction and very low cost.
