**CENTRE OF DOCUMENTATION, RESEARCH AND EXPERIMENTATION ON
ACCIDENTAL WATER POLLUTION**

Sea & Shore Technical Newsletter n°33

2011-1

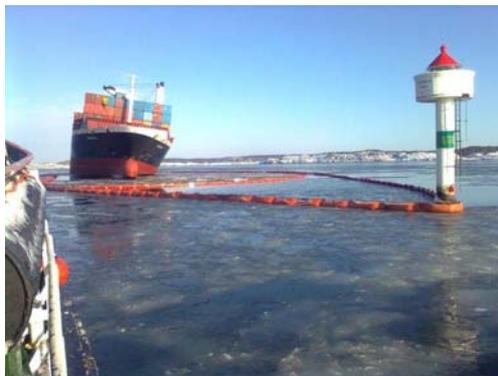
Containment booms deployed around the grounded Godafoss (Source: Kystverket)

Two rows of floating boom were immediately placed around the *Godafoss* to contain as much of the oil as possible. Assessment teams identified the leak points and the day after the incident the leaks were plugged. Operations to secure and salvage the vessel were rapidly initiated, starting with the removal of the remaining bunker fuel, the first attempts at which resulted in the recovery of a limited volume (123 tonnes) of fuel oil, which had become highly viscous as the heating system had broken down. It was also estimated that 112 tonnes of IFO 380 were spilt during the first hours.

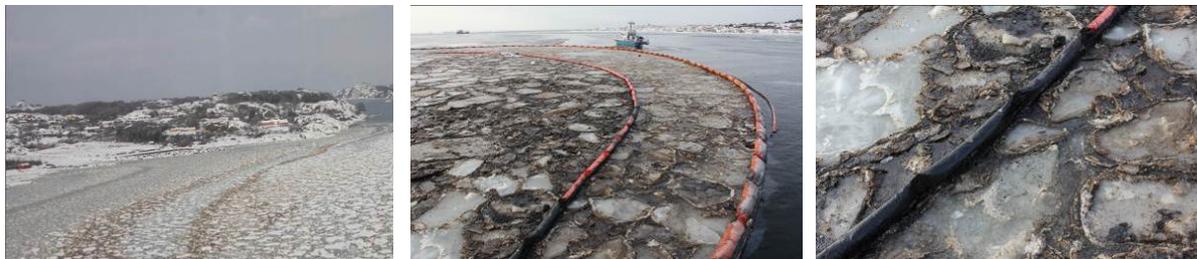
Aerial view of trails of heavy fuel oil spilled in ice-infested waters (left); deployment of a double row of floating boom (middle); "density" of blocks of ice in containment pockets (right) (source: Kystverket)

At sea, the efficiency of containment operations was dependent on the resistance of the available booms to the heavy strain exerted by the blocks of ice, liable to cause them to rip and/or be submerged.

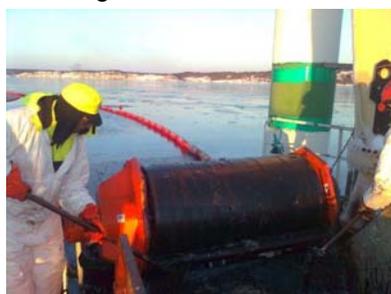
Sandvik industrial steel belt oil skimmer (source: Kystverket)

Fuel recovery itself was also complicated by the presence of ice, which penalised the skimmers' performance; the very low atmospheric temperatures (-20°C), by "congealing" the IFO 380 (already viscous by nature), were a challenge for the pumps used. Within this context, various types of skimmers were deployed (including steel belt skimmers, designed for more industrial purposes). The oleophilic brush skimmers equipped with spray systems which, by causing the ice to melt and decreasing the oil's viscosity, showed the best performance.

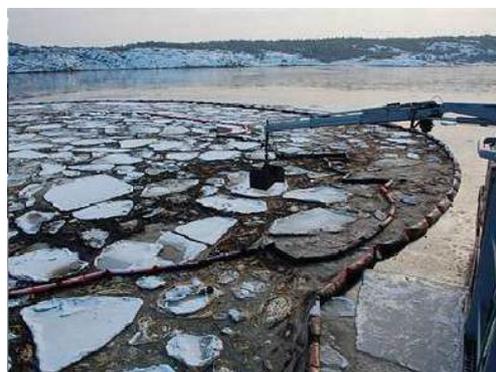
Recovery using a grab (source: Kystverket)

Another original aspect involved clusters of weathered fuel oil, mixed with large quantities of ice and contained using floating booms or sweeping arms fitted to vessels, often being recovered using grabs before being stored in temporary storage tanks on the decks of the recovery vessels.

While this overcame the above-mentioned weather-related constraints, limiting skimming and pumping options, this method proved to be of moderate selectivity (large amounts of ice recovered) and raised difficulties related to the management of the volumes recovered: availability of temporary storage capacities, increased settling time due to the time required for the ice to melt³.

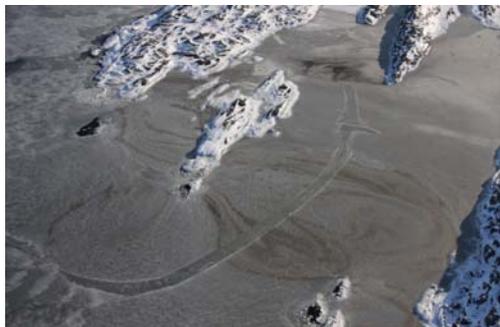
Inshore area: IFO 380 frozen into the ice (source: Kystverket)

In the case of the second scenario, while visual surveys initially led teams to suspect that large quantities of oil had been trapped in the newly formed ice, tests showed that the oil content was in fact minor (according to the NCA, the equivalent of 1 litre of fuel oil in a volume of 250 m³ of ice⁶), and its recovery was therefore not considered appropriate. On the other hand, clusters of fuel oil mixed with ice or snow were collected using excavators placed on barges, and the mixtures recovered contained 3 to 5 % oil.

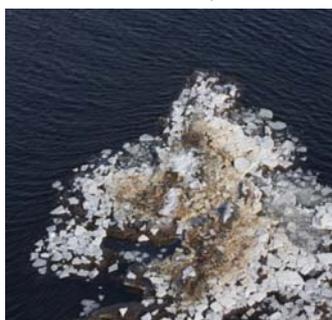
Aerial view of fuel oil, mixed with ice, being pushed towards a jagged, rocky coastline (left); Fragmentation (tar balls) of the shoreline pollution (middle); Manual collection of unpumpable clusters of heavy fuel oil (right) (source: Kystverket)

From this point of view, the low winter temperatures and the oil's high viscosity facilitated its collection by preventing its penetration into cracks and crevices on the characteristic rocky coasts in the region affected.

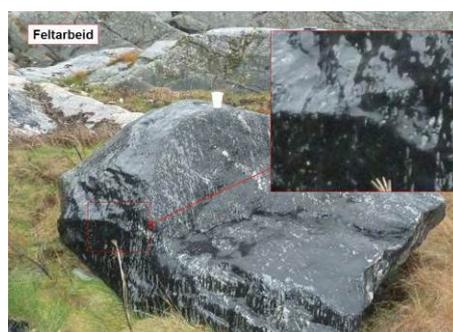
Spring 2011: surveying localised oiled areas (note the fluidification of the heavy fuel oil) (source: Kystverket)

Most of the shoreline operations, which resulted in the recovery of around 15 m³ of heavy fuel oil (Cf. figure below), were finished in the spring, followed by a few clean-up operations in late autumn 2011 (or even spring 2012 for one popular beach).

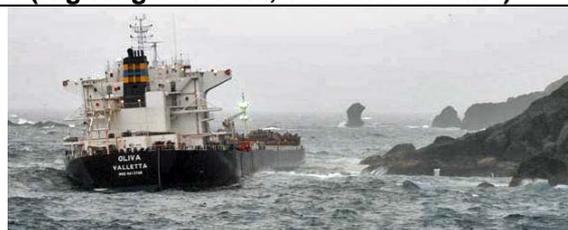
16th March: the *Oliva* grounded at Spinners Point
(source: www.tristandc.com)

On 17th March, the 22 crew members were safely evacuated⁸ from the grounded vessel, which broke in two the following day, due to violent swell, to soon release its cargo of 65,000 tonnes of soybeans and the contents of its bunker tanks, i.e. around 1,400 m³ of IFO 320 and 70 m³ of diesel.

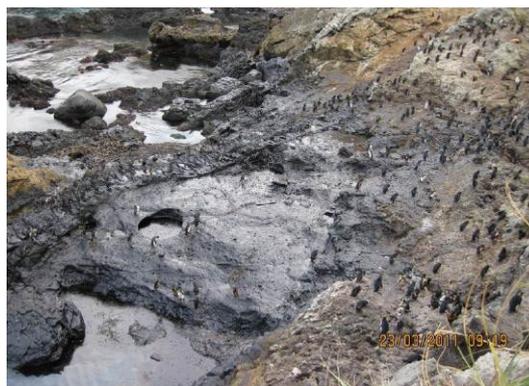
23rd March: oiled site frequented by bird populations
(source: ITOPF)

Restricted by the inaccessibility of sites, shoreline clean-up efforts focused – initially according to photographs – on relatively sheltered, localised areas of fuel oil accumulation, identified as moulting areas for penguin populations.

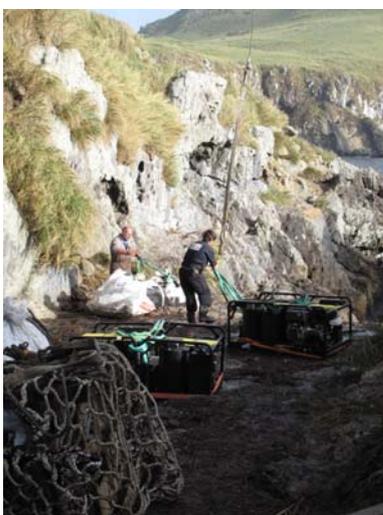
Delivery of equipment by helicopter (source: ITOPF)

We note that the presence of a helicopter on board the icebreaker *Ivan Papanin* proved to be a determining factor for conducting aerial surveys, transporting response teams and equipment to shores often inaccessible by sea and evacuating waste (liquid and solid oiled waste transported to South Africa by the icebreaker – in plastic bags placed in a specially prepared area on board – for treatment).

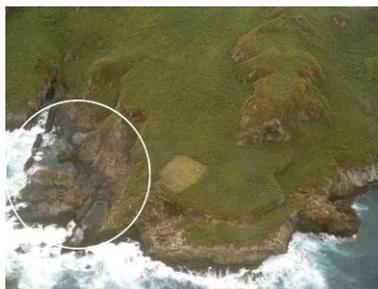
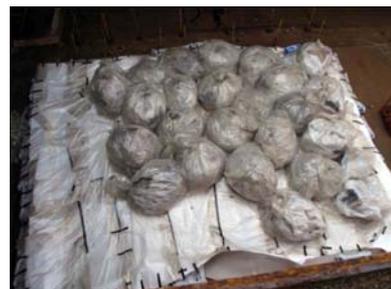
*Left: Inaccessibility of a polluted site (circled); Right: storage area for bags of waste on board the *Ivan Papanin* (source: ITOPF)*

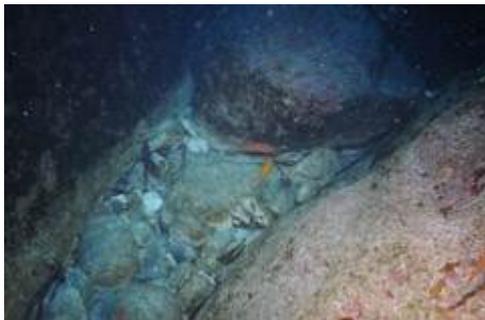
Local accumulation of soybeans decomposing at depths of 20 m (source: www.tristandc.com)

- a few dredging operations to recover accumulations of soybeans were conducted in areas where lobster pots were used (south-west coast of Nightingale Island), where its decomposition generated a potential risk of hypoxia¹³. The possible impact of the soybeans on crustacean populations around the island was being studied in late 2011, with catches appearing to be lower than normal in areas where decomposing residues were observed on the pots. Lobster fishing was reopened in certain areas (Inaccessible Island), but with a preventively lower quota for the 2011/2012 season, and remains to be banned around Nightingale Island, until further results relating to the potential impact of the pollution on the youngest age groups are obtained.

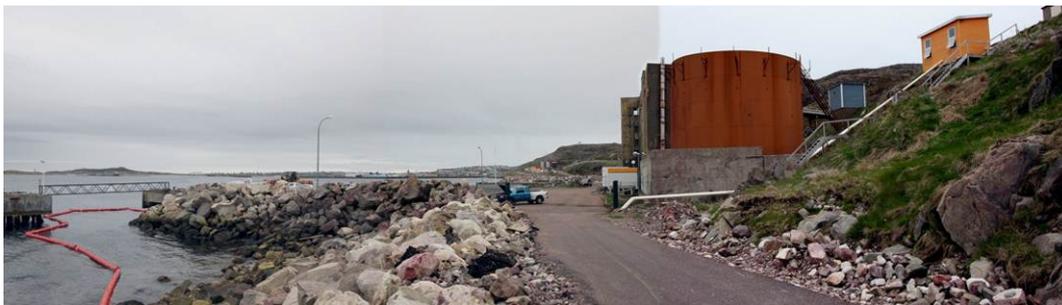
Site layout: right (orange) hut where the valves and pipes for filling tanker trucks are located. The heating oil ran down the slope, under the road, then through the riprap (source: DTAM 975)

On 30th May 2011, in the Port of Saint-Pierre (Saint-Pierre-et-Miquelon archipelago, French overseas territory), a handling error at the island's oil depot led to the release, from tanker truck filling valves, of around 100 m³ of heating oil. The leak occurred in a closed hut (also containing the valves feeding into the storage tanks); the hut was filled with oil, which overflowed out of the door and windows, and ran down the slope and into the sea at the port's deep-water dock.

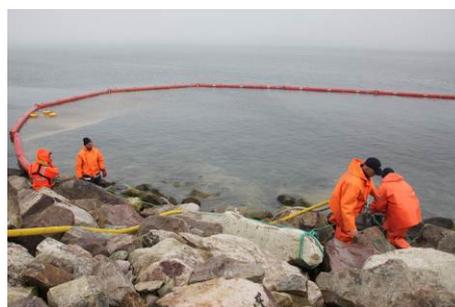
Containment and recovery at the foot of riprap (source: DTAM 975)

The first boom was laid 2 hours after the alert, and pumping began in the afternoon, once containment had proved efficient. The equipment and personnel involved were from the Polmar stockpile and the lights and beacons department; the company responsible for the spill organised waste management, and accepted to reimburse the costs of response by State services and of the supplies used.

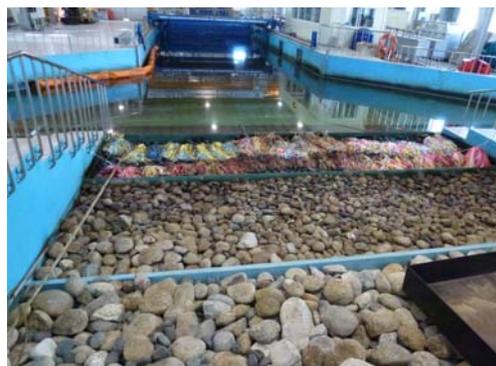
Man-made beach (pebbles) within MERTI's facilities (source: Cedre)

MERTI, which, in addition to classrooms, has at its disposal man-made beaches and closed water basins (with tidal and current generators) enabling real oil spills, plans to provide oil spill response training courses in compliance with the international standard recommended by IMO (levels 1-3). More widely, this institute is perceived as a tool which should help to significantly reinforce international cooperation: both between East Asian countries and with international organisations and experts (e.g. implementation of the OPRC-HNS Protocol).
