**CENTRE OF DOCUMENTATION, RESEARCH AND EXPERIMENTATION ON
ACCIDENTAL WATER POLLUTION**

Sea & Shore Technical Newsletter n°37

2013-1

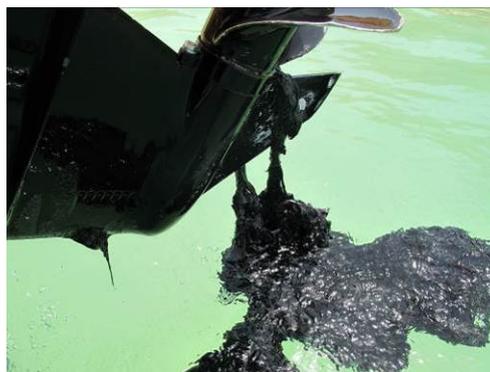
24 June 2013: viscous, cohesive texture of 60/70 grade bitumen (fragmented pollution) (Source: MECA)

The substance spilt was grade 60/70 bitumen², which is a viscous pollutant, heated for transport (122°C), with a density close to (if not higher than) that of seawater (between 1.01 and 1.06 compared to 1.025). When the substance came into contact with the seawater, the immediate cooling caused it to solidify into relatively cohesive patches. These patches, which were large and thick in places during the first few days, tended to be partially submerged and drift towards the coast, or even to sink, and to break up into tarballs. Given this specific behaviour of the pollutant, and due to the lack of ad hoc resources available, no recovery operations at sea were implemented.

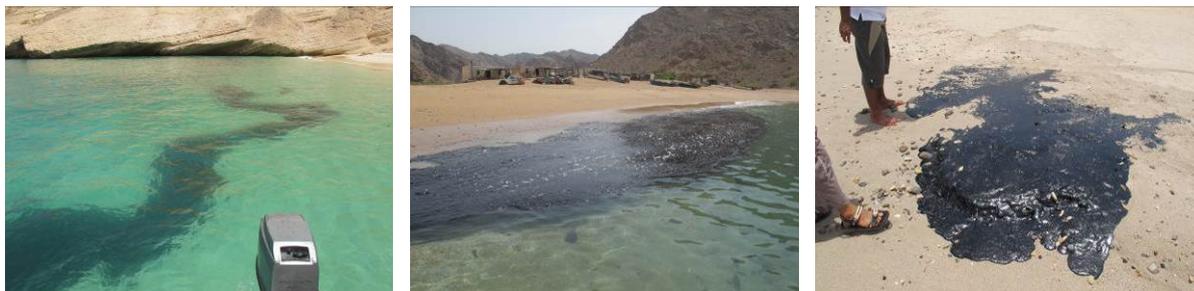
D₊₅: Submerged bitumen in front of a beach (left); Free slicks (centre); Partially buried patch (right) (photos: MECA)

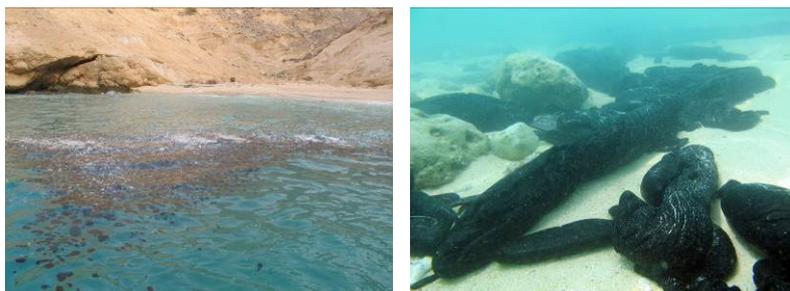
D₊₁₁: Fragmented free pollution (left); Sunken and persistent bands of bitumen (right) (photos: MECA)

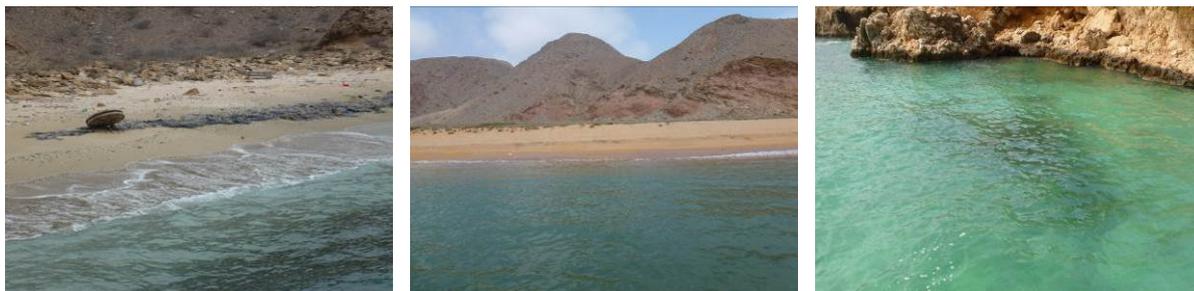
09/09/2013: Remote uncleaned beaches, with accumulations of buried and submerged bitumen (left); buried bitumen partially unearthed/eroded by waves (centre). Submerged slick on a cleaned shore (right) (Source: Cedre)

- of site surveys, indicating:
 - o the presence of bitumen on certain very remote and uncleaned sites, mainly in the form of thick patches either submerged in front of the beaches (generally around one metre long, sometimes a few metres), or stranded and sometimes buried,
 - o residual pollution on certain treated sites, with deposits of bitumen, at the surface or buried, or submerged clusters and slicks.
- of interviews with those in charge of the ministries responsible for establishing compensation records, relating to clean-up costs, any economic damages suffered (fishing and tourism) and expected ecological impacts (in particular on coral).

In terms of shoreline response, Cedre's recommendations focused mainly on the need to recover major accumulations of submerged bitumen and bitumen stranded/buried on the beaches, while highlighting the importance – for a reliable and detailed compensation claim established by the NCC – of rigorously recording the data relating to clean-up site management and the waste produced.

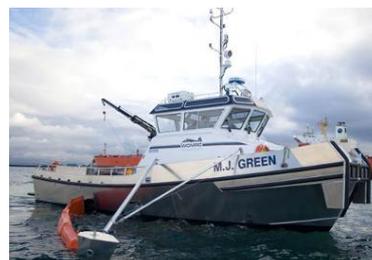
Outrigger and sweep boom of the *Rozema 47* (Source: Elastec)

An outrigger and 10-m sweep boom are fitted to each side of the 14 m vessel in order to concentrate the oil and channel it towards an X30 skimmer embedded in the hull.

The X30 has 2 grooved discs and is a smaller version of the X150 (which has 10 discs) with a recovery rate of 30 m³/h according to the manufacturer (giving the OSRV a total recovery rate of 60 m³/h).

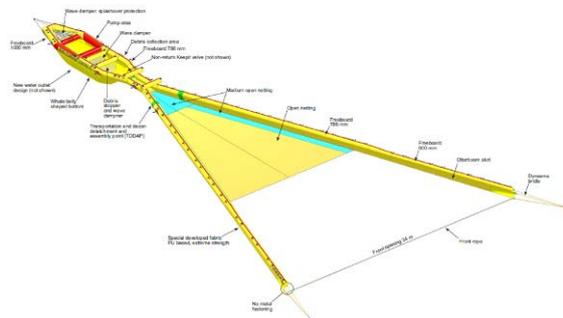
Diagram of the Current Buster 6 (source: NOFI)

- the alteration of the rear section of the device to give it a more hydrodynamic shape to improve its performance in wave conditions, facilitate manoeuvres and reduce drag (and therefore the required strength and size of vessels required for its deployment).

The Current Buster 6 can be deployed by a single vessel with support from a Standard Boom Vane (whereas the Current Buster 8 requires an Ocean Boom Vane). The inclusion of 4 additional water drainage valves in the floor of the separator improves the performance of the water/oil separator, which can store approximately 35 m³ of pollutant. The maximum current speed at which the device can operate is identical to that of the Current Buster 8, i.e. 5 knots.

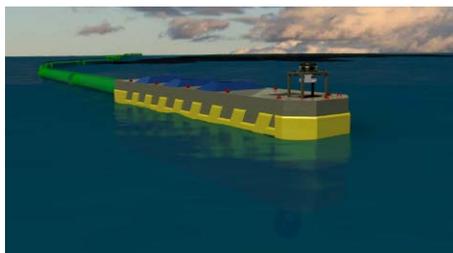
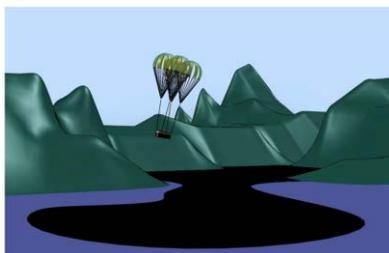
*Illustrations of the IDS Containment System prototype as deployed on water (left) and airdropped on site (right)
(Source: Scout Exploration, Inc.)*

In 2013, the Canadian firm Scout Exploration Inc. (SXCN) acquired the rights for a project developed by IDS Offshore Inc., consisting in a containment system prototype for floating oil in marine or inshore waters. The originality of this concept (currently known as the IDS Containment System), the result of collaboration between industry and Canadian public entities, lies in its method of transport to the spill site: the system is designed for aerial delivery and deployment on site. The prototype is an upshot of a search for technical solutions to significantly reduce response times at sea (and hence to minimise the potential impact on the coast).
