**CENTRE OF DOCUMENTATION, RESEARCH AND EXPERIMENTATION ON  
ACCIDENTAL WATER POLLUTION**

**Inland Waters Technical Newsletter n°21**

**LTEI 2013 - 2**

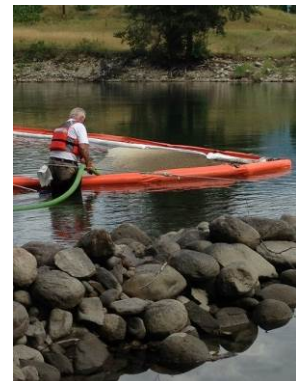
*Containment by floating and sorbent booms and recovery by pumping (vacuum truck) (Source: Lemoncreekresponse.ca)*

The emergency response was implemented by firefighters, together with a Vancouver Hazmat Team. Surveys were carried out on land and by boat to assess the spread of the spill. Containment booms were set up and lined with sorbent booms to contain the oil within the Slocan and Kootenay Rivers. The responsible party rapidly contracted a specialised company to continue to clean up the oiled areas. At the height of operations, the contractor mobilised over 50 responders to conduct operations both on the water (where the product was recovered manually using sorbents and nets/scoop nets, or by pumping with vacuum trucks) and on the shoreline.

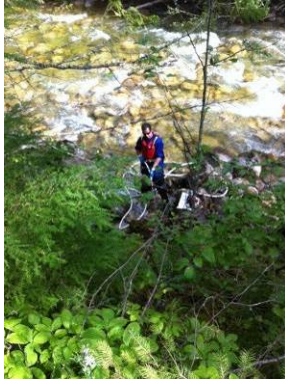
Flushing on vegetated streambanks (Source: Lemoncreekresponse.ca)

Shoreline surveys indicated that the product was rapidly evaporating<sup>1</sup>. Six days after the incident, a specialised consultant (Polaris Applied Science) was contracted to carry out more detailed surveys using the North American Shoreline Cleanup Assessment Technique (SCAT), in order to assess the level of contamination over a 200 km stretch downstream of the incident, and to concentrate clean-up efforts in the most contaminated areas (Lemon Creek and certain sites on the Slocan River showed residual pollution). As recommended by the Ministry of Environment, final clean-up operations were implemented (by flushing to release the oil and recovery using sorbents).

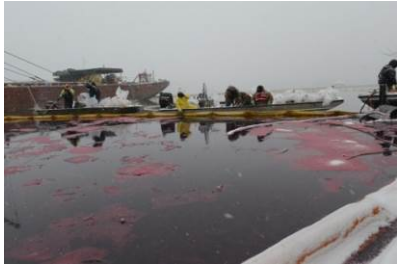
Recovering diesel-soaked sorbents (red colour) (Source: USCG)

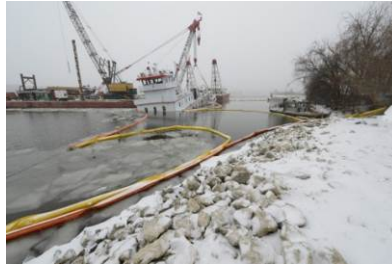
View of booms in the icy waters of the Mississippi (Source: USCG)

The presence of ice also reduced the efficiency of fuel containment around the wreck and made it difficult to deploy additional lengths of boom.

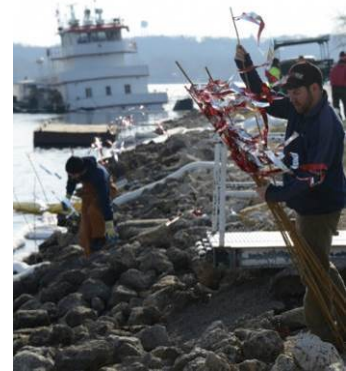
Setting up coloured tape as bird deterrent devices (Source: USGC)

Finally, as the incident occurred during the migratory season of 2 species of waterfowl, visual bird deterrent devices (coloured tape) were set up on the river banks.

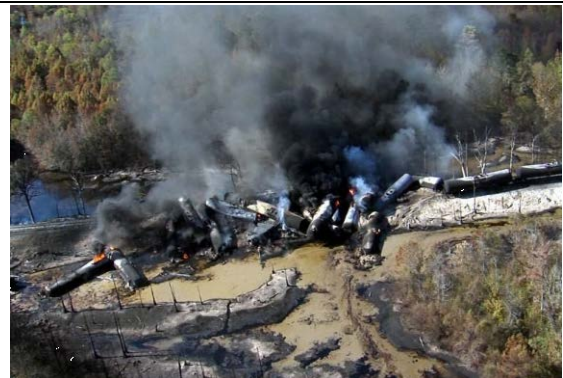
26 cars overturned, 3 of which exploded and caused a fire which spread to the fuel tanks, as well as to the leaking oil. Some of the oil spread across the ground and into the adjacent marsh, while the flames burnt the vegetation cover and trees across a 0.8 ha area. A large cloud of smoke comprising particulates and combustion gases, as well as volatile organic compounds (VOCs), were thus released into the atmosphere.

Aerial view of the derailment site (Source: EPA)

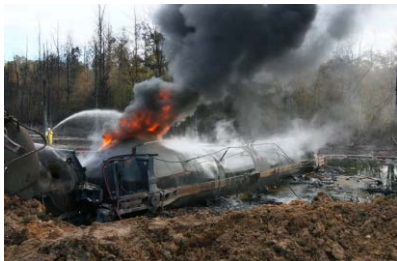
Firefighting (Source: EPA)

The intensity of the blaze was such that the content of the damaged tanks was left to burn, while the surrounding area was secured and undamaged cars were moved away. The remaining fires were extinguished by cooling the cars with water and by spraying foam (AFFF)<sup>6</sup> onto the fuel.

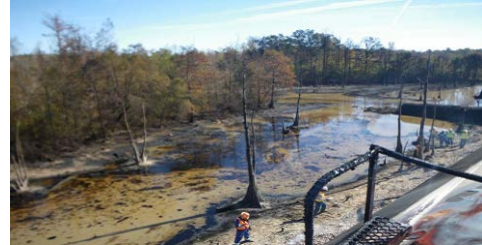
Site overview. Note the burnt vegetation next to the railway track (Source: US EPA).

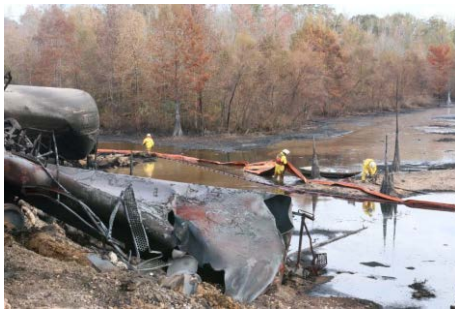
Containment and recovery on a marshy site: laying containment booms next to the damaged tanks (Source: US EPA)

Containment booms and sorbents (booms, mops, rolls attached vertically to piles in a barrier configuration) were deployed around and near to the cars. Downstream, site surveys were carried out and, locally, protective systems were put in place.

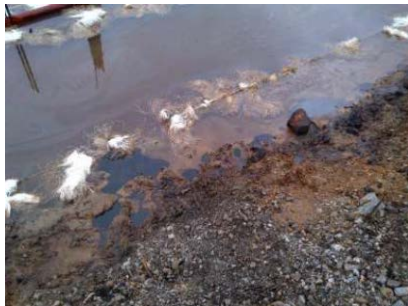
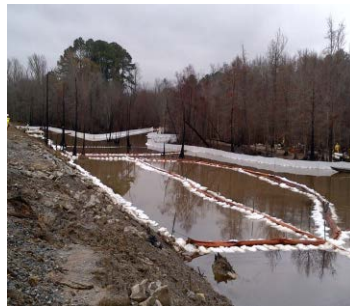
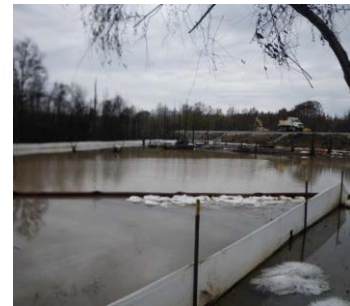
Sorbent mops on ropes, and viscous, sticky, weathered oil on the banks (left); containment booms lined with sorbent mops (middle); sorbent rolls taut between piles (right) (Source: US EPA)

The contained oil was recovered by pumping, with or without skimmers, and manually using various sorbents (oleophilic/hydrophobic sorbent pads, booms, mops, etc., including Opflex products). Around 350 people were mobilised in the field at the height of firefighting and spill response operations.

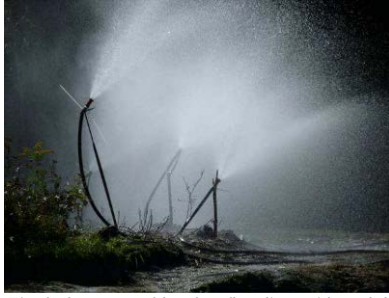
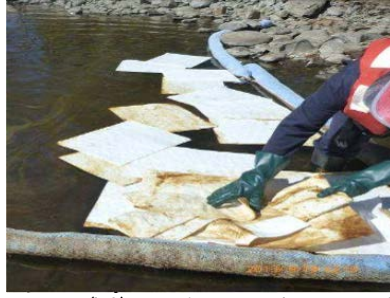
*Final clean-up of banks: flooding with a deluge system (left); containment and recovery of released oil using sorbents (source: MDDELCC)*

Bank clean-up, initiated just over a fortnight after the incident, included an initial manual recovery phase for accumulations of oil on substrates and oiled vegetation (scything). At the height of these operations (22nd July-17th August 2013), over 100 responders were mobilised. The second phase lasted around 3 months (10th August to 28th October) and aimed to remobilise residual pollution trapped in/on sediment, followed by recovery on the water using sorbents. These operations were carried out (i) by flooding the banks (deluge system, using pierced pipes on fine sediment or fire hoses on coarse sediment, set up on the upper section of the bank) and (ii) in the river bed, by manual agitation using tools (rakes, shovels, etc.) or by injecting a mixture of water and air.

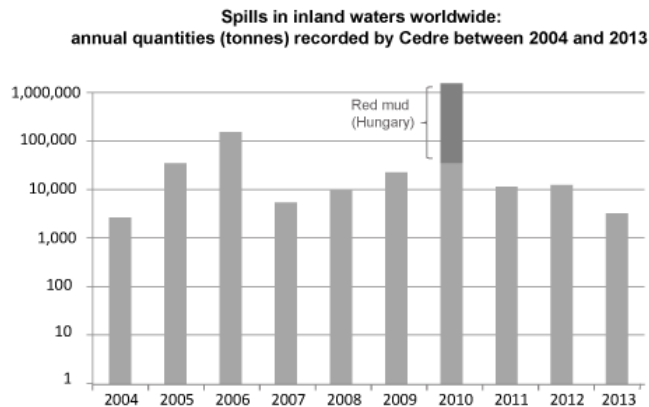
**Figure 1**

In 2013, 34 incidents followed by significant spills were identified in inland waters.

Compared with estimated data for the years 2004 to 2012 (median = 41), this places 2013 among years with a lower number of spills. The total quantity of oil and other hazardous substances spilt was approximately 3,200 tonnes. This estimation<sup>13</sup>, one of the lowest recorded since 2004 (Fig. 1), is far lower than the annual medians expressed for the periods 2004-2007 (19,900 tonnes) and 2008-2012 (12,300 tonnes).

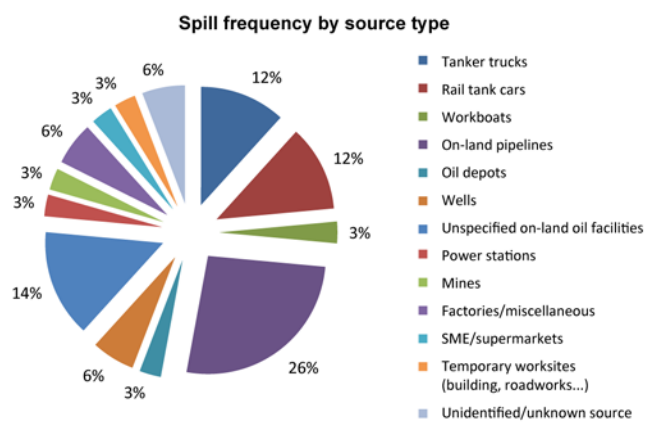
**Figure 2**

**Pipelines** were the most frequent spill source (26 %) in 2013, closely followed by tanks (Fig. 2), involved in 24 % of cases, equally divided between **tanker trucks** (12 %) and **rail tank cars** (12 %).

On-land oil facilities were the source of around 23 % of spills, 14 % of which were from **unspecified oil facilities** (and respectively 6 % and 3 % from wells and storage facilities).

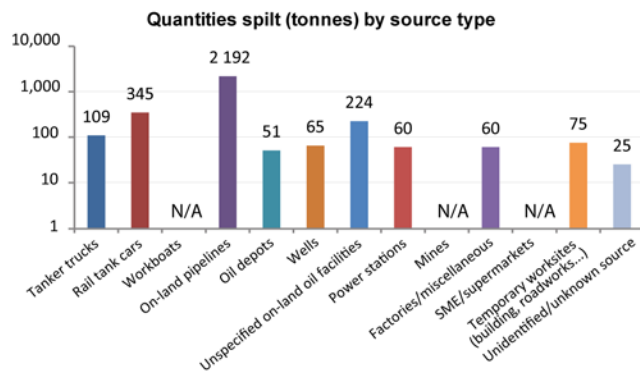
**Figure 3**

In terms of quantities, and in line with the observations in previous years, we note the major share (around 70 %) of **pipelines** in the 2013 total (Figure 3). The largest spills from such facilities occurred in the US in March<sup>14</sup>, in Russia in May<sup>15</sup>, and in Canada in June<sup>16</sup>. Due to the lack of detailed information on the quantities involved in several other cases<sup>17</sup>, the share of the total quantity spilt due to pipelines is no doubt underestimated.

Other notable contributors to the total quantity spilt are **tank cars** (with around 10 %, i.e. around 350 tonnes; Fig. 3), followed by **on-land oil facilities** and **tanker trucks**, the only sources to exceed 100 tonnes.

The other structures involved each contributed to less than 3 % of the total quantity spilt (Fig. 3).

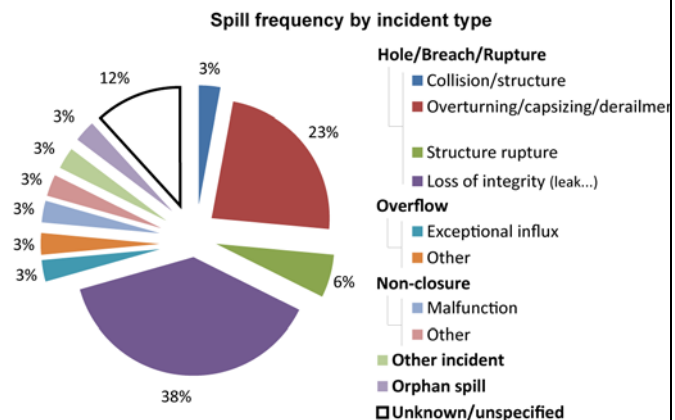
Figure 5

The most frequently reported incidents in 2013 were **structural breaches or ruptures** (70%; Fig. 5):

With the exception of **unspecified events**, involved in 12 % of cases reported, the other categories involved low frequencies (Fig. 5) and none of them represented more than 2 % of the total volume (Fig. 6).

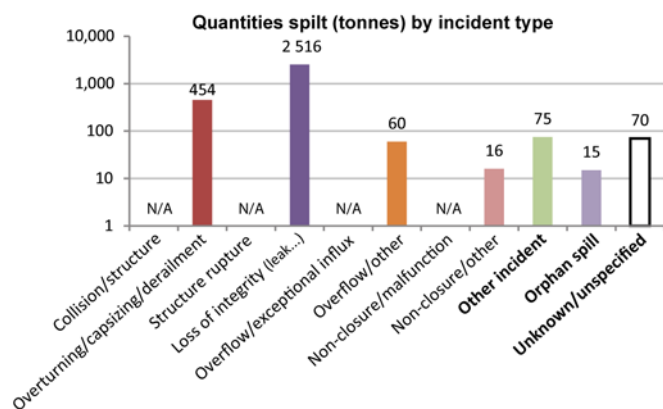
Figure 6

- Most were due to a **loss of integrity** (38 % of events) of various structures, mostly pipelines, or internal pipes within on-land industrial oil facilities. This category also represents the main proportion (80 %) of the quantity spilt in 2013 (Fig. 6), a third of which was caused by a breach in the Pegasus Pipeline in the US (see LTEI n°20).
- **Overturning incidents (capsizing/derailment)**, involving road or rail tanks, represented 23 % of events. Such incidents also ranked second in terms of their share (14 %) of the total volume of pollutants spilt during the year (Fig. 6).

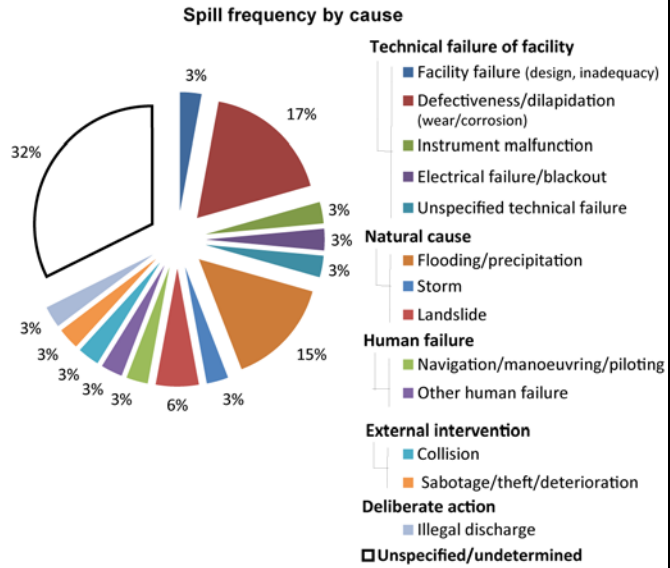
Figure 7

Analysis of the frequencies of each cause shows that the cause was **unknown or unspecified** in almost a third of cases listed (Fig. 7). These incidents also weighed heavily (25 %) in the total balance in terms of quantities spilt (Fig. 8).

- Over half of these failures were related to the **defectiveness/dilapidation** of facilities<sup>19</sup> (Fig. 7), a cause which represented a 26 % share of the total volume spilt (Fig. 8).
- Despite their relatively low occurrence (3 %), **facility failures (design/inadequacy)** were the number one cause (28 %) in terms of their share of the total volume spilt, mainly due to the spill from the Pegasus Pipeline, to which damage was believed to have been caused due to the transport of Wabasca Heavy Crude rather than a conventional crude oil (see LTEI n°20).

The other causes identified showed relatively low frequencies (3 % at the most) (Fig. 7) and did not weigh heavily in the 2013 balance in terms of quantities spilt (Fig. 8).

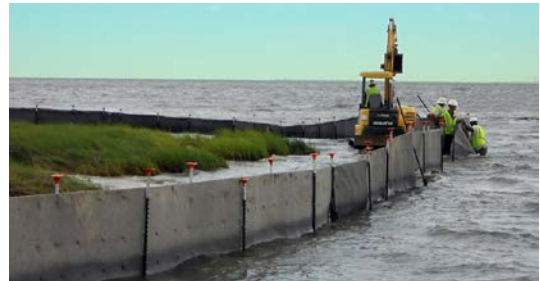
Ultra-Spill Fence<sup>®</sup> being used to protect a sensitive shoreline - here at the edge of a marsh in Louisiana, during the Macondo spill, US 2010 (Source: <http://www.spillcontainment.com>)

In addition to its use for industrial applications (effluent filtration), various forms exist for oil spill response: booms with or without a ballasted skirt (90 to 150 cm high according to models), mats, filter fence reinforced with steel wire (to protect streams for instance) and loose fibres (e.g. for use in filter cartridges to filter waste water after settling).

According to the manufacturer, Ultra-X-Tex can absorb up to 20 times its weight in oil and can be reused after extracting the absorbed oil.
