**CENTRE OF DOCUMENTATION, RESEARCH AND EXPERIMENTATION ON  
ACCIDENTAL WATER POLLUTION**

**Inland Waters Technical Newsletter n°23**

**LTEI 2014 - 2**

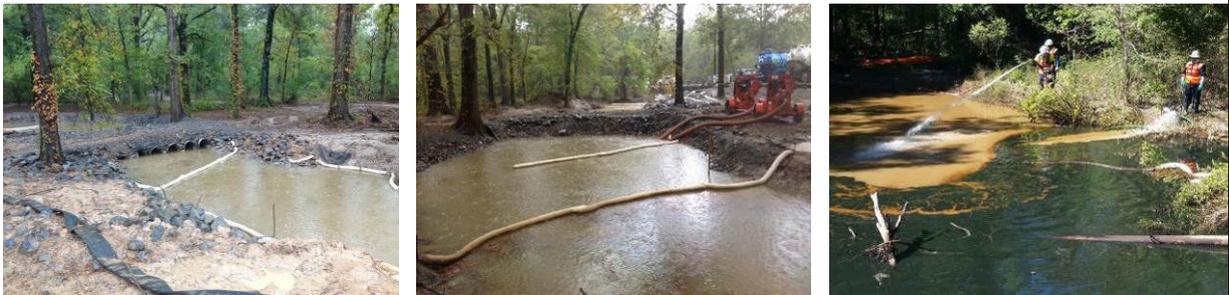
Containment by filter dams: bunds with pipes (left); Vacuum trucks for pumping floating accumulations between dams (centre); Concentrating the floating oil and directing it towards containment areas using hoses (right) (Source: US EPA)

- filter dams (bunds with pipes functioning by underflow) were built to optimise operations.
- the liquid waste recovered was transferred in mobile containers to a temporary storage area.
- in addition, the operator made an arrangement with a local landowner to use a private lake as a water reservoir to implement flooding operations in the watercourse upstream of the spill point, to help to rinse the banks and recover the oil via the filter dams.

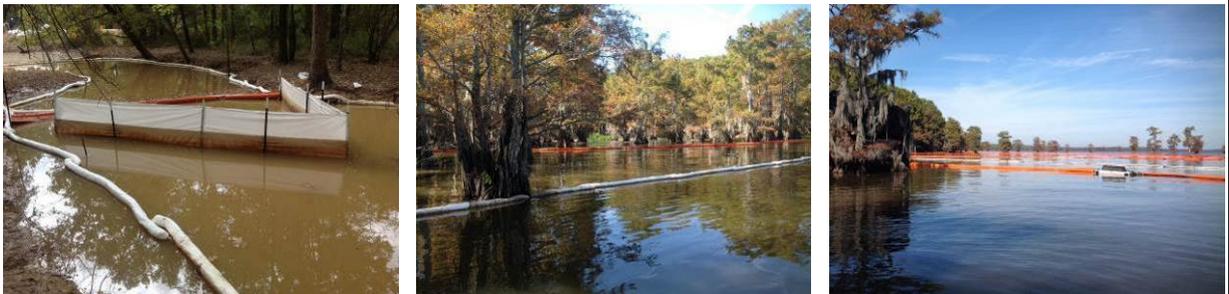
Containment/protection: in the creek, by floating booms, sorbent booms and oleophilic textiles on stakes (left); in the flooded area, by floating and sorbent booms (centre); at the mouth of Tete Bayou where it meets Caddo Lake, by rows of floating boom (with a drum skimmer between 2 sections of the 1st row) (right) (Source: US EPA)

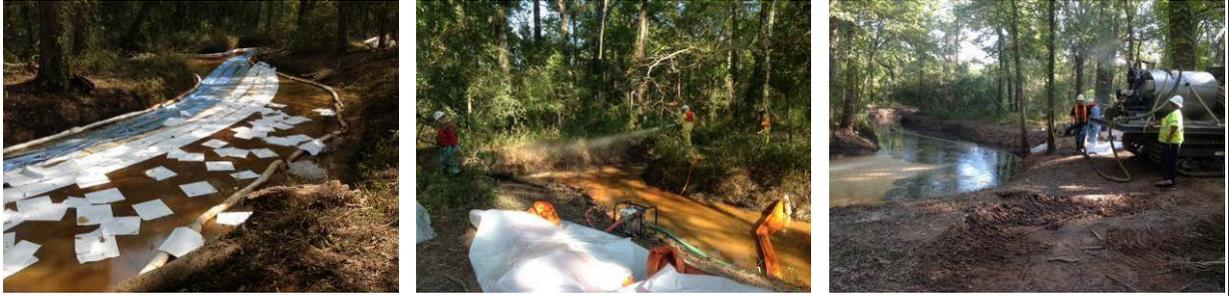
Collection using various types of sorbent (rolls, mats, pads) (left); localised rinsing of the banks using low pressure hoses (centre); pumping equipment deployed from small caterpillar track vehicles (right) (source: US EPA)

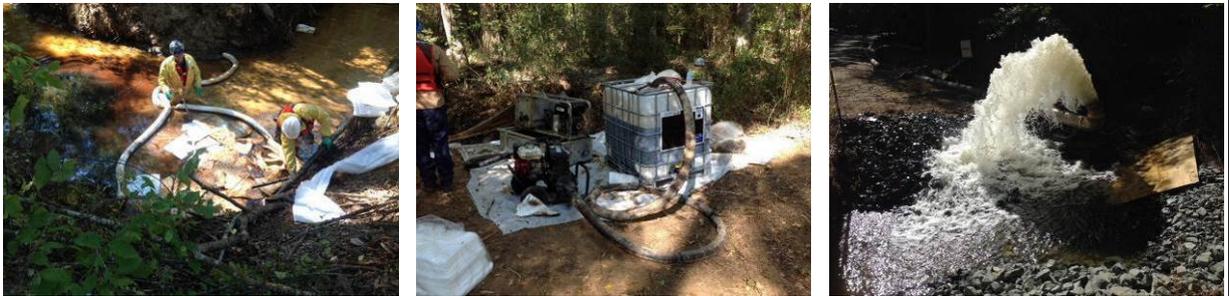
Manually collecting oiled sorbents (left); rope skimmer, pumping equipment and primary storage in IBC containers (+ ground protection using textiles) (centre); 29/10/14: pipe for flooding/rinsing upstream in the watercourse (right) (Source: US EPA)

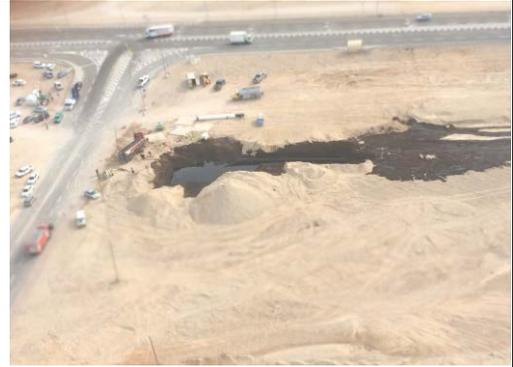
View of the breach in the Eilat-Ashkelon pipeline  
(Source: MCED)

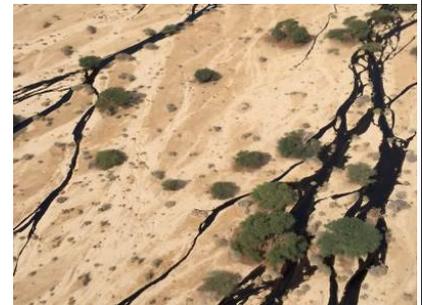
Aerial view of the spill in the Arava desert  
(Evrona Reserve), following accidental damage to the Eilat-Ashkelon pipeline on 04/12/14 (Source: MoEP)

However to prevent the rain expected from causing the oil to spread further, containment and recovery operations were implemented by building dams downstream of the spill point, mobilising absorbing materials and pumping the oil from the pools and puddles formed on land or floating on the water flowing through the wadi.

Major contaminated soil excavation operations (where the oil had infiltrated into on average a 6 to 7 cm deep layer within the Evrona Nature Reserve) were also carried out. They began the day after the incident and were completed in early January 2015 with the removal of 30,000 m<sup>3</sup> of contaminated soil, transferred to a specially prepared site (Nimra landfill) to be treated by bioremediation.

Approximately 2,000 m<sup>3</sup> of oil was recovered by pumping from the 210 identified pools of crude oil formed in natural depressions in the land<sup>5</sup>.

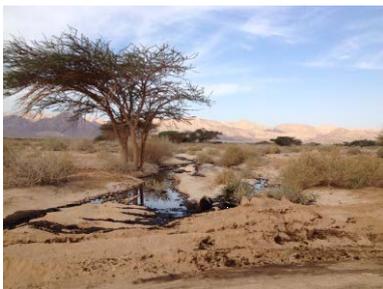
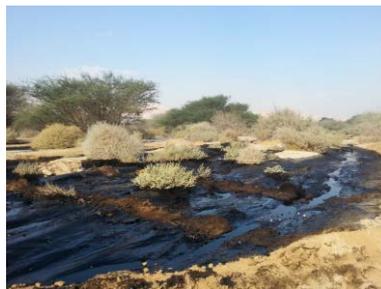
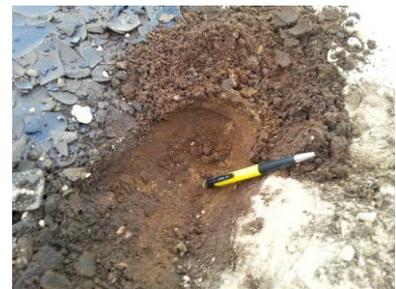
Floating oil (left); Oil spill in the wadi (centre); Fresh crude oil infiltrated into surface sediment (right) (Source: MoEP)

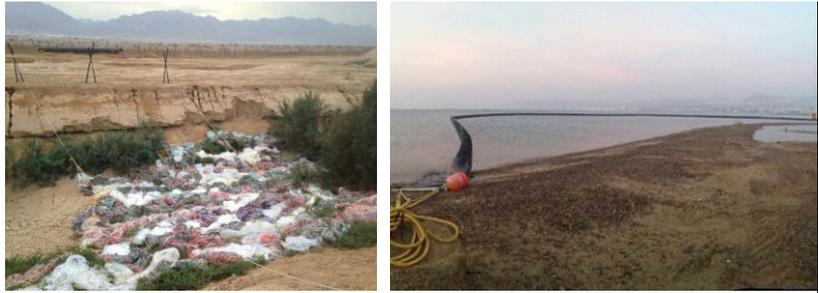
Laying mop sorbents in the Kinet Canal (left); boom set up on 9/12/14, in the port of Eilat (Gulf of Aqaba) (right) (source: MoEP)

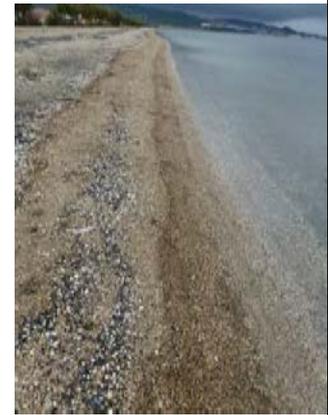
11/11/14: oily band along the western section of Jai beach  
(Source: Cedre)

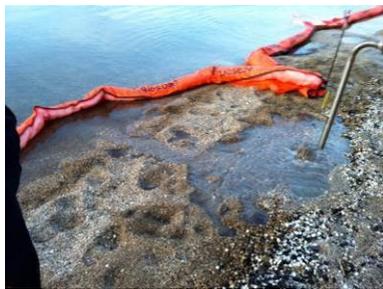
Western section of Jai beach: preliminary mixing test (low pressure lances) on oiled sediment: recovery, using sorbent booms, of the oil trapped in the sediment and remobilised by water jets (Source: Cedre)

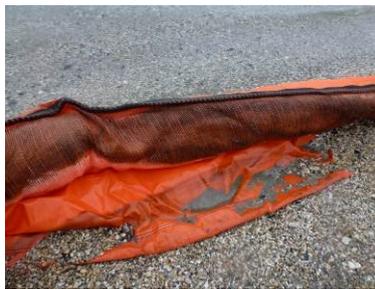
Sheen could also be seen in places along the water's edge, as well as oil sporadically released from the contaminated debris along the high tide mark. Some small, thin deposits were sporadically trapped between the rocky boulders on the upper beach (which were otherwise unoiled).

The technical recommendations for this section of beach focused on the manual recovery of oiled debris along the high tide mark (shells, litter, driftwood, etc.), as it was liable to release the oil, and the recovery of the floating accumulations between the boulders using sorbents.

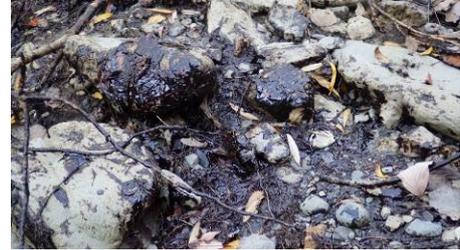
*Oiled stones on the banks of the Arc River  
(Source: Cedre)*

Highly viscous deposits were mainly observed on the banks of the Arc River, between the leak point and the first EDF dam (oiling of overhanging rocks, stones and vegetation). Downstream, lighter contamination (50 to 80 cm high band) was observed on the concrete walls and the plastic lining on the banks of the bypass channel. Along the rest of the route, bank contamination was minimal (oily marks), and even absent from the Cheylas reservoir. With a similar decreasing intensity from upstream to downstream, flap gates, valves and spillways were also oiled.

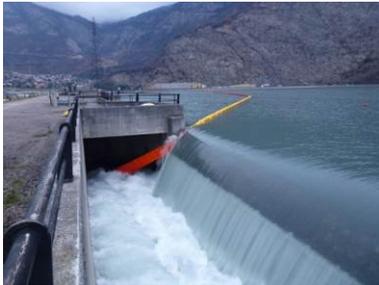
*Testing the resistance of a boom to optimise the flow rate: the boom is drawn into the spillway at a flow rate of 80 m<sup>3</sup>/s  
(Source: Cedre)*

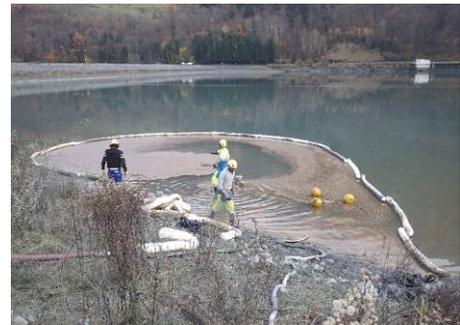
*Skimming and pumping contained oil from the banks, following collection by trawling (Source: Cedre)*

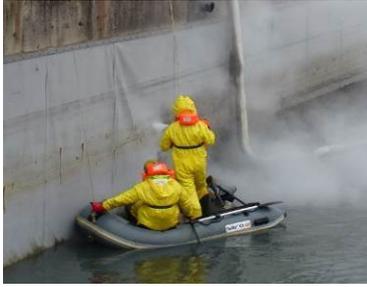
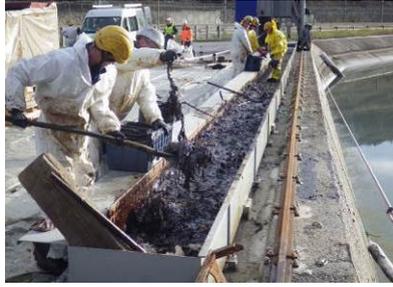
Low pressure rinsing of plastic liners with hot water (left); debris and fuel oil trapped in the screen of the Saint-Martin-de-la-Porte dam (right) (Source: Cedre)

Final clean-up of the walls was carried out manually, either using sorbent dipped in a washing agent, by rinsing or by pressure washing. Certain banks covered with a plastic liner were cleaned by low pressure washing with hot water.

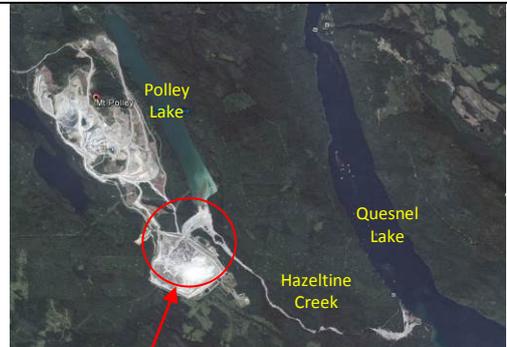
05/08/2014:  
Views of the tailings storage facility and of the plume of contaminated sediment (Google Earth satellite images):

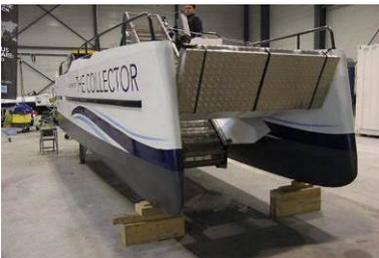
The Collector at the NIL shipyard in Lorient  
(Source: [www.entreprises.ouest-france.fr](http://www.entreprises.ouest-france.fr))

The prototype was developed by the recent Breton shipyard *Naval Industrie Lorientaise (NIL)*. It is a catamaran with an aluminium hull, is 7.30 m long and 2.55 m wide, with a draught of only 50 cm.

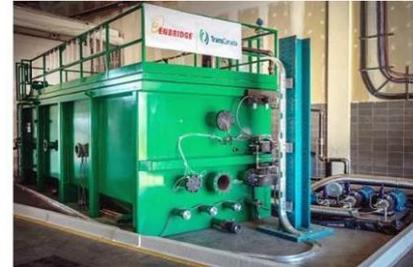
The resulting External Leak Detection Experimental Research (ELDER) test apparatus is a simulator within which pedological conditions close to those found at a given site (soil composition, temperature, etc.) can be recreated at meso-scale.

The ELDER test apparatus  
(Source: C-FER Technologies)

The aim is to be able to test various oil pipeline leak detection technologies, based on the parameters set by the researcher: distributed temperature sensing systems (DTS), distributed acoustic sensing systems (DAS), oil sensor cables, oil or gas detectors...

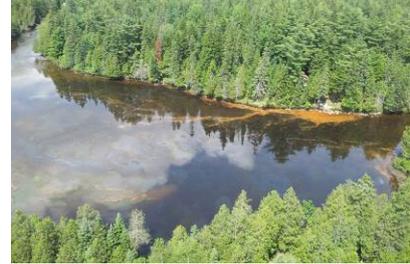
July 2013: aerial view of the pollution in the Chaudière River by Bakken Crude oil (Source: MDDELCC)

As a reminder, in 2013, an estimated 100 m<sup>3</sup> of light crude oil (Bakken Crude) reached the Chaudière River, where around 43 m<sup>3</sup> of a water/oil mixture was contained using booms and recovered by pumping in various parts of the river.

While the extent and level of residual pollution have diminished on the whole compared to the immediate post-spill situation, the Ministry indicates that "concerning" levels of contamination remain at a few sites 2 years on, within the first 15 km of the affected stretch of river and in Lake Mégantic.
