**CENTRE OF DOCUMENTATION, RESEARCH AND EXPERIMENTATION ON  
ACCIDENTAL WATER POLLUTION**

**Sea & Shore Technical Newsletter n°40**

**2014-2**

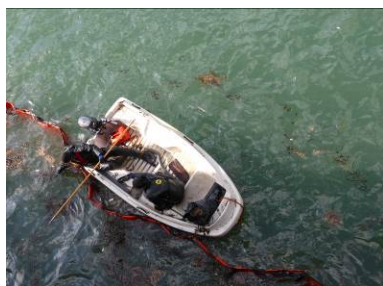
*Manual recovery of oiled sorbents within the containment area (Source: Cedre)*

A few brownish accumulations, mixed with seaweed and litter, were visible at the foot of riprap. In addition to monitoring the containment system, Cedre's recommendations included recovering the fuel from the water surface using sorbents (pads, booms) and collecting floating debris, possibly contaminated, using scoop nets.

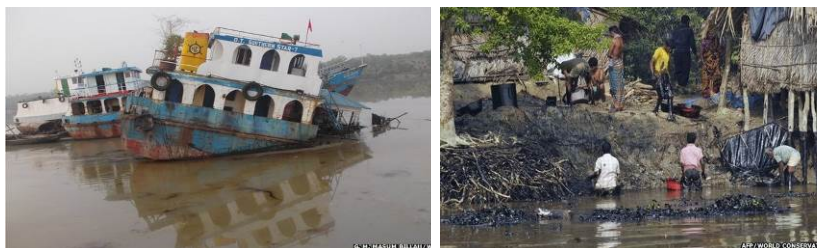
*The OT Southern Star 7 (left); Collecting fuel oil and oiled floating vegetation (directly by hand or using fishing nets) (right) (Source: Wildlife Conservation Society)*

In the first few hours following the incident, the Forest Department (FD) under the Ministry of Environment and Forests (MoEF) organised response operations with support from the Indian Navy<sup>1</sup>, then the following day, shoreline clean-up, with help from the local communities.

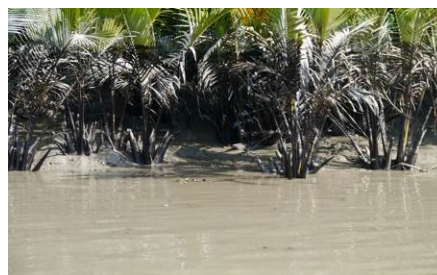
*Maximum level of contamination on the banks and vegetation, observed along 10% of the stretch surveyed by the UNDAC team (Source: Cedre)*

- the favourable tidal range and cycle at the time of the spill (no flooding of the mangrove), together with the almost continuous presence of cliffs along the shores, stopping the pollution from spreading into the mangrove
- the suspension of the movement of all vessels on the Shela River, following a decision made by the authorities very soon after the incident. This measure prevented the horizontal spread of the oil in the mangrove, which would have inevitably been caused by an overflow effect due to bow waves.

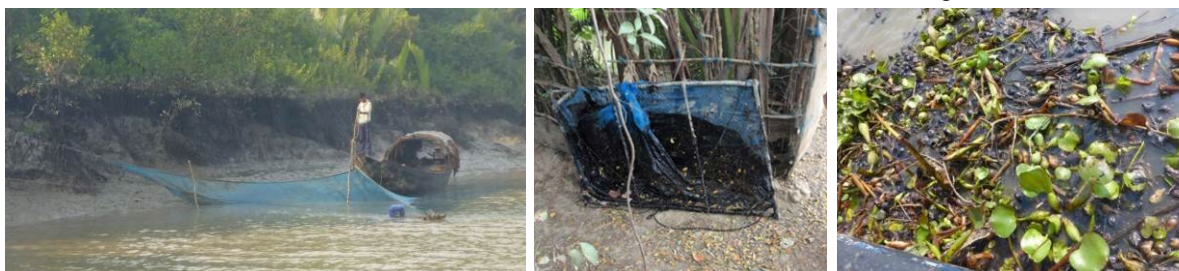
*Fishing net at the edge of the bank (left); Net attached to a frame (centre); Trapping oil using water hyacinths (right) (Source: Cedre)*

- Original collection methods were implemented, mainly on the water:
  - Protection across entrances to channels and small rivers using nets.
  - The collection of oil using stationary nets, based on a technique used to capture fry or larvae (fish/shrimps), at the edge of the banks.

- The most original (and apparently most efficient): use of floating vegetation (water hyacinths) to "soak up" the oil then recover it by draining.
  - The setting up of a line pirogues, positioned diagonally along the bank, to block the pollution and drifting water hyacinths, with storage directly in some of the pirogues – in various containers – which, when full, were taken to the village to be unloaded.

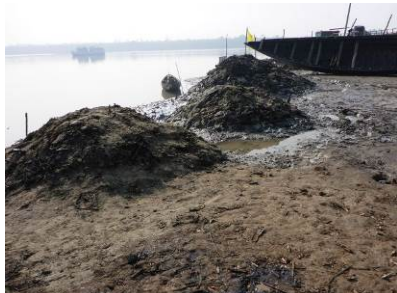
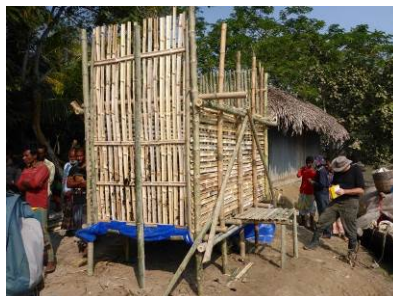
*Piles of waste covered in mud (at the top of a bank subject to flooding) (left); Waste storage/draining cage (right) (Source: Cedre)*

- Given the lack of an oiled waste management and tracking system (oiled nets, vegetation, etc.), it is difficult to draw conclusions about what became of this waste – although various observations in the field indicated a few theories on this point (burial within the vicinity of homes, often on the foreshore):
  - We note an original, and effective, action implemented by a local NGO which encouraged local residents to recover "hidden" oiled vegetation, to drain it in bamboo cages (pending subsequent treatment: incineration, etc.).
  - Uncertainty remains over what happened to the oiled nets (some were washed with diesel, others appear to have been abandoned on site).
  - The mission team assessed the local storage and treatment options, and made recommendations on these aspects.

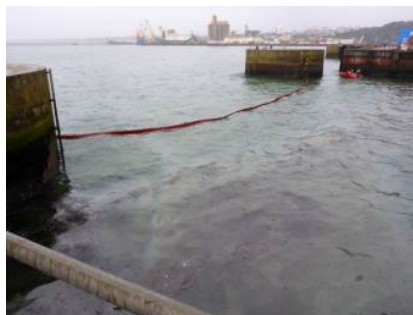
*Fire brigade boom at the end of the wharf QR5 (left); pumping of trapped slicks by a vacuum truck (right) (Source: Cedre)*

Under the effect of the ebb tide, the fuel oil was drawn under the wharf piles and out of the harbour basin. Two lengths of boom belonging to the Brest Chamber of Commerce and Industry (the port manager) were laid as an initial emergency measure. This containment system was rapidly supplemented with resources from the Finistère fire brigade and the French Navy.

A vacuum truck was stationed on the quayside to pump the contained oil and oiled seaweed.

Although this pumping operation was carried out without a skimmer head, a large share of the oil which had accumulated against the port infrastructures was recovered.

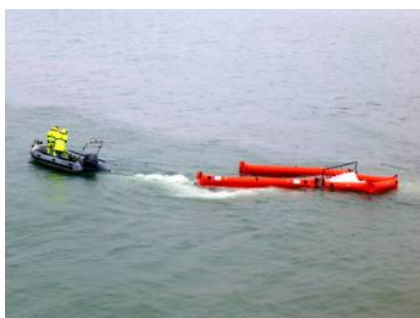
*Dynamic recovery by trawling in the Brest roadstead (Source: Cedre)*

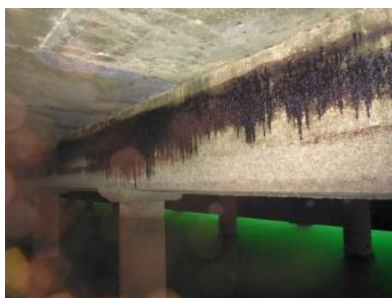
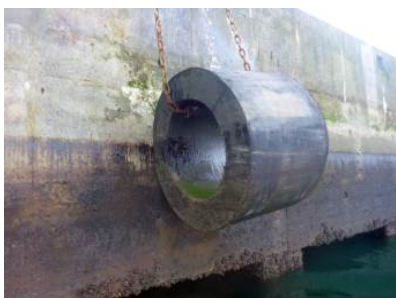
*Oiling of the porous surface of concrete beams under the deck of the wharf (left); Horizontal band on the outside of the wharf and fenders (centre); Deposits and splashes of fuel oil on the upper section of riprap (right) (Source: Cedre)*

On land, Cedre conducted an on-foot survey of the oiled infrastructures, which was completed 4 days later with an inspection from a boat in the presence of representatives of the P&I club and its technical expert (International Tanker Owners Pollution Federation, ITOPF). Four areas called for clean-up operations, including outer walls (horizontal band of fuel oil, a few centimetres high), the underside of piled wharfs (horizontal concrete beams contaminated with bands and drips of fuel oil ranging from a few centimetres to up to 1 m high), as well as scattered oilings at the top of riprap at the end of the harbour basin.

Recommendations relating to the clean-up of the outside and underneath of the wharf included: (i) spraying with a washing agent followed by low pressure rinsing, (ii) hot water high pressure washing. As for the riprap, the technical recommendations included collecting oiled debris, manually scraping off the layers of oil and high pressure washing with hot water to complete clean-up. In all cases, the containment (by sorbent booms) and recovery (by pumping or using sorbent) of effluents were recommended.

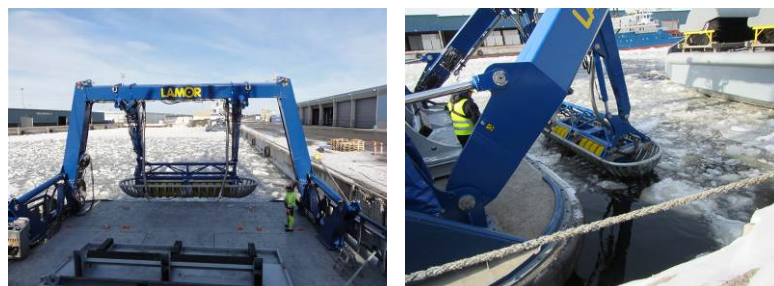
The Sternmax fitted to the stern of a spill response vessel (Source: Lamor)

The large isolation grate (l x w x h (m) = 9 x 2.4 x 1.1) is supported by an A-frame attached to an articulated arm with an operational reach of 7 m. Partially submerged, the isolation grate separates the oil and water from the ice broken by the bow of the vessel: it is regularly lifted and tilted to remove any ice obstructing it.

The skimmer is equipped with a hot water injection system to constantly keep the brushes, scrapers, hopper and pumps warm. The isolation grate is pre-heated prior to deployment by an internal steam heating system.

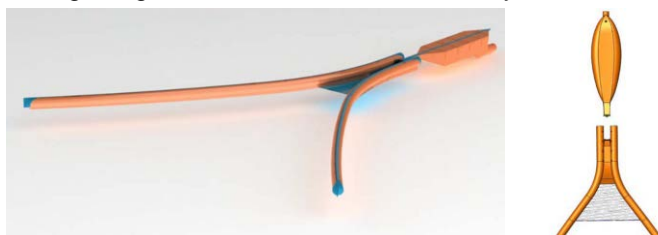
Diagram of the Oil Trawl system (Source: [www.norlense.no](http://www.norlense.no))

The Norwegian firm NorLense has designed and developed a system to recover oil at speeds of 1 to 4 knots. This system can be used either in dynamic mode, for trawling on open water bodies (open sea, coastal waters, large estuaries and wide rivers), or in stationary mode (moored to a bank) facing into potentially quite strong currents (estuaries, rivers, etc.). It has a high encounter rate (swath width x speed) to respond to very widely spread spills, which it can concentrate, thicken and collect directly, without requiring a skimmer or pumping unit, by channeling the oil into a floating storage bag connected to the rear of the system.

The Oil Trawl is composed of three parts: a deflection boom, a concentrator-oil/water separator and a storage bag for the recovered oil.

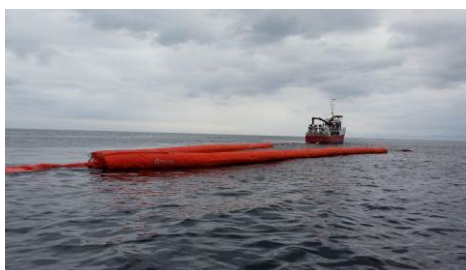
Rear view  
(Source: Norlense)

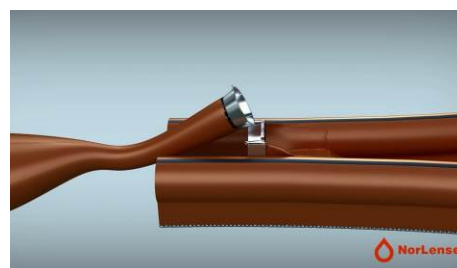
Connecting the collection bag (Source: Norlense)

Downstream of the concentrator-separator, a quick connection system is used to connect the collection bag to the system. The connectors are designed to allow the bag to be easily changed during operations at sea. Inside the storage bag, a valve prevents the oil from leaking out. A pump can optionally be incorporated in the storage bag to continuously transfer the recovered oil to the tanks of a support boat.

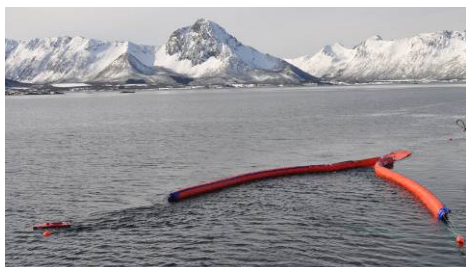
The NO-T-600-S (left) and a diagram showing trawling with a paravane (right) (Source: Norlense)

Since 2014, two models of the Oil Trawl have been marketed by NorLense:

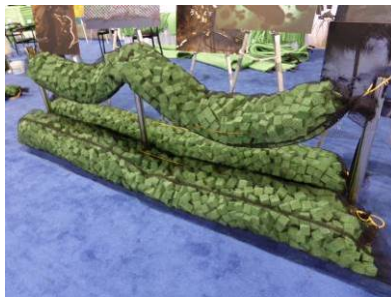
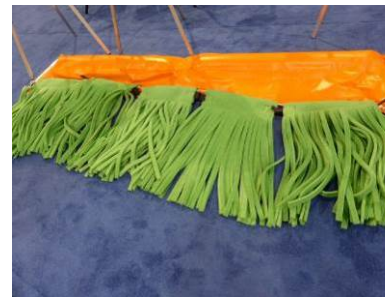
IOSC 2014: OPFLEX sorbent Cube Boom (left) and Eelgrass (right, here used with sections of fence boom) (Source: Cedre)

We note in particular the existence of forms providing a large surface area for contact between the sorbent and the environment: the Cube Boom, composed of cubes (5 cm edge) contained within a coarse mesh tube and the Eelgrass form, designed to collect oil at the surface or ballasted in the water column.

According to the manufacturer, this material's tensile strength and elasticity mean that it can be used in currents and rough water: rivers, estuaries or even inshore and coastal waters.

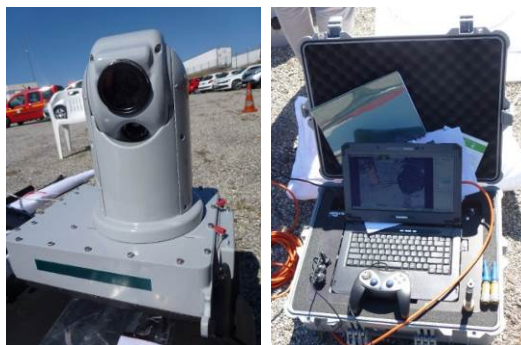
View of the turret with IR and video cameras (left) and of the compact command panel (right) (Source: Cedre)

The turret, designed by Survey Copter, attached to the underside of the balloon, is motor-driven in 2 directions, thus enabling 360° panoramic rotation as well as inclination of up to 90°. The images obtained by the cameras are georeferenced and transmitted in real time by VHF to the receiver on the vessel's deck.

The cameras are operated from the vessel relatively intuitively using a multifunction controller.
