**CENTRE OF DOCUMENTATION, RESEARCH AND EXPERIMENTATION ON
ACCIDENTAL WATER POLLUTION**

Inland Waters Technical Newsletter n°24

LTEI 2015 - 1

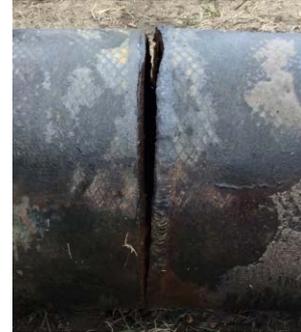
Close-up of the breach in the Poplar Pipeline, after the section had been excavated in April 2015 (source: Bridger Pipeline LLC)

The damaged section, 30 cm in diameter, was carrying over 140 m³ of light crude oil (Bakken crude), which was immediately suspected to have leaked into the frozen river.

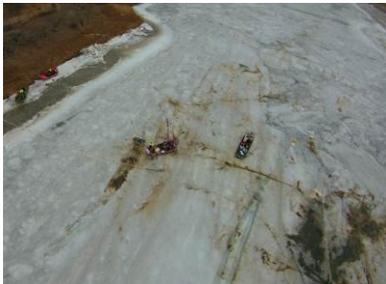
Left: Manual collection of crude oil surfacing through cracks in the ice (Source: MT-DEQ);

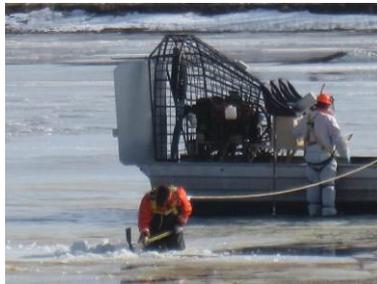
Right: Surveys, by cutting holes in the ice (note the use of safety harnesses by responders) (Source: US EPA)

In addition, holes were made to attempt to locate any pockets of oil trapped under the ice. In addition to direct observations, aerial surveys were carried out throughout the response.

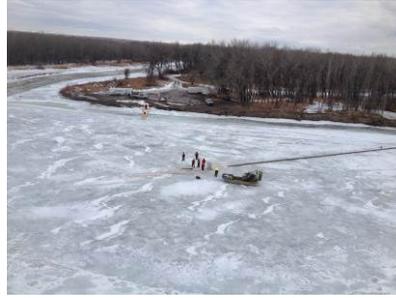
Containment and recovery on the frozen river: cutting slots in the ice to deflect the oil
(Source: US EPA)

Then, immediately upstream of sensitive facilities, as well as at a few points downstream of the spill (from 5 km to approximately 50 km), the responders attempted to contain the oil, sometimes drifting below the ice, by cutting slots – where the oil was thick enough to operate safely – designed to channel the floating oil, somewhat like deflection booms, towards a calm area where it could be recovered by pumping or with sorbents.

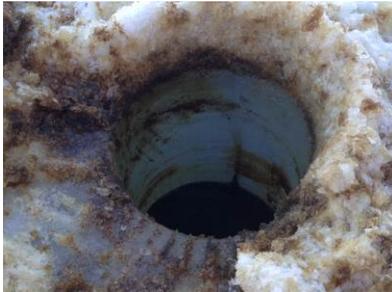
Visible presence of oil: hole drilled in the ice (left); oil surfacing through cracks in the ice (5 km downstream of the slots) (right) (source: US EPA)

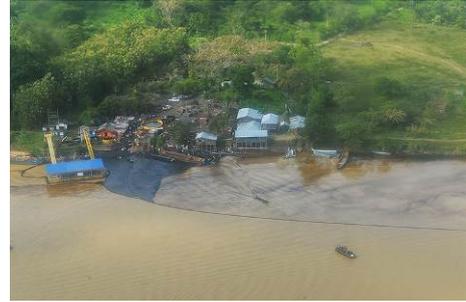
Containment area for the floating crude oil set up using containment booms on the River Mira (Source: Gobernador de Nariño / Ecopetrol)

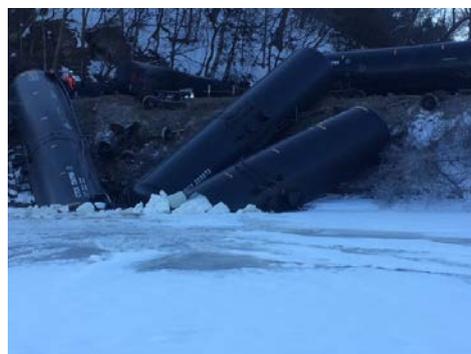
05/2/2015: railcars partially submerged in the Mississippi (Source: US EPA)

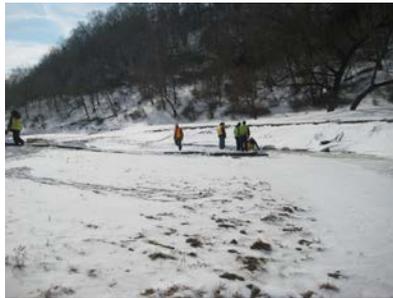
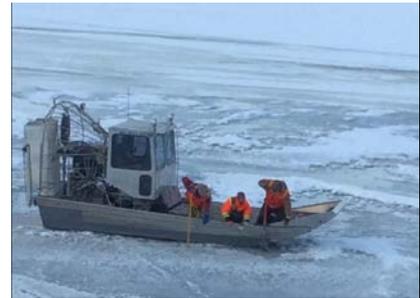
Left: 07/2/2015, IDNR teams supervising semi-solid ethanol pumping operations at the surface of the ice (Source: US EPA); Right: 06/2/2015, sampling from an airboat (Source: US EPA)

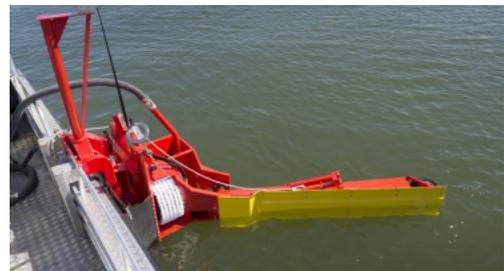
Within this range is the MiniBagger aluminium sweeping arm which offers a sweeping width of 2.5 metres and is fitted with a polyethylene rotating brush skimmer.

This comparatively light device (weighing 106 kg in total) can be mounted on the side of a workboat (minimum of about 5 metres long) without requiring lifting equipment or specialised tools, for use in ports, watercourses, etc.

The MiniBagger sweeping arm (Source: SeaHow)

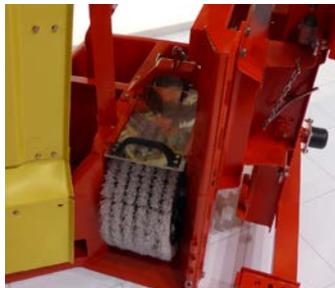
The rotating oleophilic brush skimmer at the base of the sweeping arm (Source: Cedre)

The nameplate capacity specified by the manufacturer is 10 m³/hour on heavy oil, on which brush skimmers are generally efficient, and 6 to 8 m³/hour on light oil, with up to 90% oil in the recovered mixture. According to SeaHow, the system's efficiency with light oil results from its patented brush-comb design.

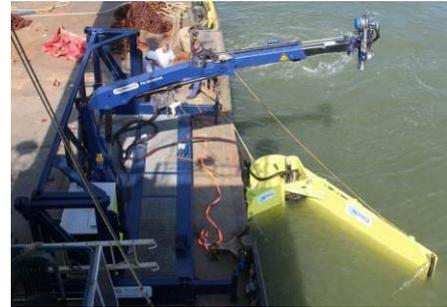
It is based on the same sweeping arm principle but in smaller dimensions with a 5 m-long arm, with a weir skimmer at the base, coupled with a submersible pump (Marflex MSP 100) with a nameplate capacity of 150 m³/hour. The skimmer can be an oleophilic brush (like the larger models), disc or drum skimmer.

Deploying the Koseq Compact 502 (Source: Koseq)

With its auxiliary equipment, including an independent hydraulic power pack (driven by a diesel engine), a lifting device (telescopic crane) and the control box, the whole system (weighing around 10 tonnes) is stored in a standard 20-foot container which can be easily transported by road, rail, etc.

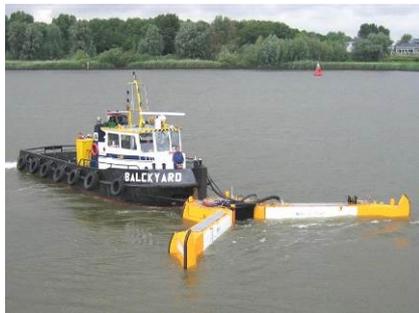
The Victory Oil Sweeper operated by a push-tug (Source: Koseq)

This system is composed of 2 sweeping arms positioned in a V shape designed to be pushed by (or attached alongside) a workboat. By adjusting the angle between these arms, the sweeping width can be adapted according to the speed of travel.

At the apex of the system, the collection chamber is equipped with 2 Marflex MSP 150 pumps (with a nameplate capacity of 2x360 m³/hour), bearing in mind that the weir can be replaced by oleophilic modules (belt or brushes), or even a conveyor belt for collecting floating debris.

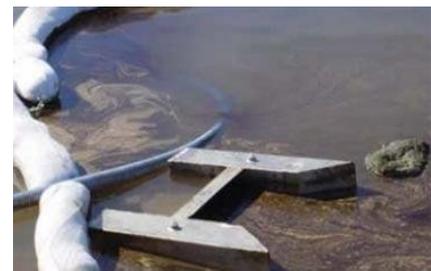
The SKSkim (manufactured by Le Floch Dépollution -LFD) comprises two lateral floats (aluminium or stainless steel) on either side of an adjustable weir. This device can operate in very shallow waters (6 to 3 cm according to the model).

SKSkim device (Source: LFD)

The skimmer is connected via a semi-rigid suction hose to a pumping system (pump, vacuum truck, etc.) whose pump rate (25 to 90 m³/hour according to the manufacturer) should be adapted according to the model (SKSkim40, 80 or 120: opening/sweeping width of 40, 80 or 120 cm respectively) and the operating conditions (oil thickness, quality, etc.).

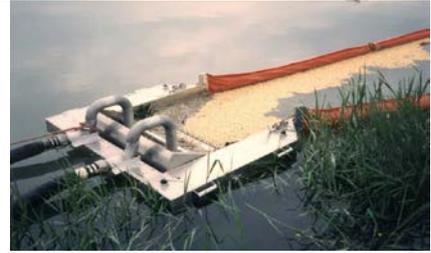
The Pedco 2 Skimmer (Source: Canadyne)

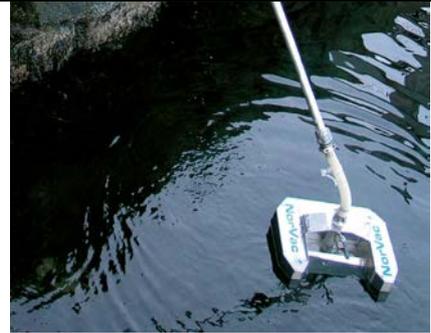
NorVac Skimmer (Source: Noren)

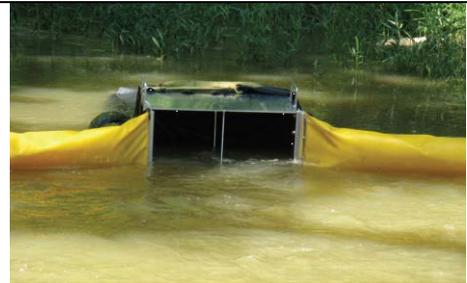
This system is composed of an aluminium collection unit (the "Sheen Machine" itself: 60 x 30 cm opening and 40 cm deep) fitted with floats and attached to 2 sections of containment boom (foam-filled) equipped with a skirt (total height of around 30 cm).

Front view of the Sheen Machine (Source: C.I.Agent Solutions)

When deploying the system (in static or dynamic mode), the sheen is concentrated and funnelled towards the collection system, which feeds into a detachable bag made of Agent Q, i.e. 2 layers of a non-woven fabric embedded with a layer of the solidifying agent manufactured by the brand. Once the bag is filled with oil, it can be replaced by another one using the plastic connectors, with no specific tools required.

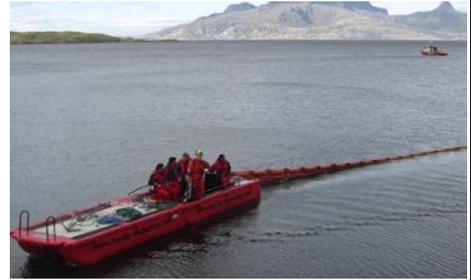
The main unit is 5.6 m long and 2.4 m wide, and is equipped with a 9.9-hp outboard engine (or 25 to 30-hp with a steering console). The connectible modules have the same dimensions and can be transported on a road trailer. According to the specifications, each module has a carrying capacity of 1.5 tonnes.

*Deploying booms from the double hulled Seahunter with a 25-hp engine (LSH 25 SC)
(Source: Lamor)*

Among the advantages of this platform, we note the hull's stability and durability. It has a catamaran-shaped design, a low draught (35 cm), and is made of rotomolded thermo plastic (polyethylene), which, with no seals or joins, improves its solidity. The Seahunter can therefore be used as a landing craft on banks and even rocky shores (its propeller is protected to prevent damage). The flooring (including top and front) is covered with an anti-skid material to reinforce operator safety when working with oil.

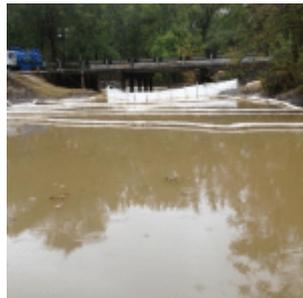
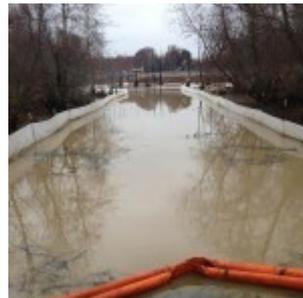
The US firm CEREX Advanced Fabrics, Inc. has developed a fabric capable of filtering a polluted watercourse, by letting the water through while capturing the contaminant. The OilShark® Fence is a non-woven nylon spunbond fabric which, when installed vertically using stakes or stretched between two trees, is said to withstand currents, tides and high rainfall.

*Various examples of configurations using the OilShark® Fence in inland waters in the US
(Source: US EPA)*

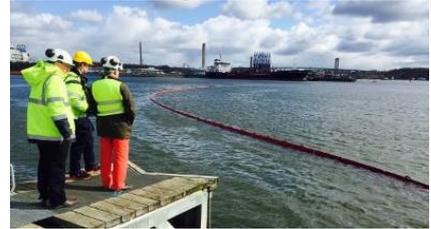
Trials involving the SP Marine Technologies system (Source: Port of Gothenburg)

A catamaran-shaped Autonomous Tug Vessel (equipped with a GPS positioning system), secured to a frame and driven by a turbine, tows a 400 m section of lightweight containment boom (50 cm draught and 20 cm freeboard, on a pre-positioned reel) between two wharfs, in just 10 minutes. Tests carried out in 2015 highlighted the system's efficiency, in terms of deployment time. It took 5 years to adapt the system to the conditions in the estuary of the Göta älv river (where the Port of Gothenburg is located).

In order to improve its spill response preparedness, the structure responsible for the Energy Port decided to equip the port with an automated containment boom deployment system. The boom is towed by a robot, developed by the Swedish firm SP Marine Technologies, in order to reduce response times and to improve safety (no operators or boats required on the water near the pollutant during the emergency response phase).
