**CENTRE OF DOCUMENTATION, RESEARCH AND EXPERIMENTATION ON
ACCIDENTAL WATER POLLUTION**

Inland Waters Technical Newsletter n°27
LTEI 2017

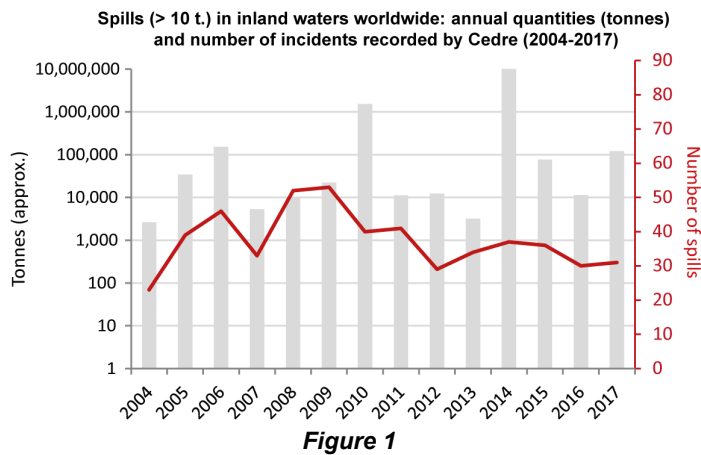
These incidents represented a total quantity of just over 120,000 tonnes of oil and other hazardous substances spilled (Fig. 1), an estimation well above the annual median expressed for the period 2004-2016 (around 12,000 tonnes).

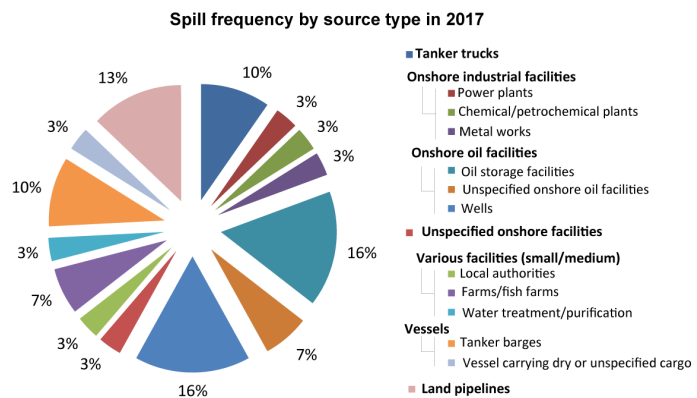
Figure 2

In 2017, **onshore oil facilities** were the most frequent source of significant spills in inland waters known to us, accounting for almost 40% (with 16% from oil storage sites and the same proportion from wells; Fig. 2). The next frequent sources were **land pipelines**, **vessels** (especially tank barges), and **various onshore facilities** (with agricultural facilities at the top of the list), each of these categories responsible for 13% of the events (Fig. 2).

Onshore industrial facilities were the cause of around 10% of the events (related to spills at **power plants** and various industrial sites – in this case both chemical/petrochemical plants and metal works), a frequency equivalent to that of **tanker trucks** (Fig. 2).

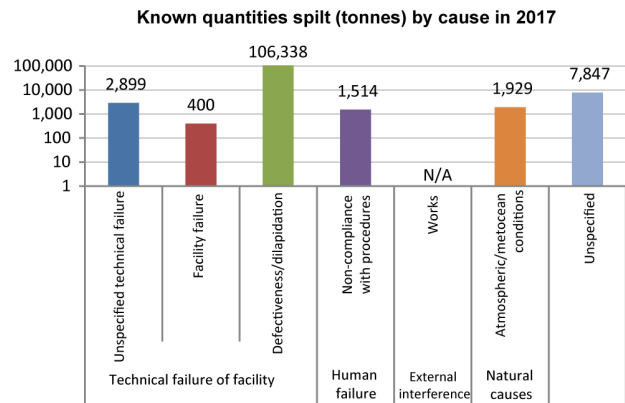
Figure 8

cases brought to our attention, with a no doubt underestimated share in the total quantity spilt (estimated here at nearly 2,000 tonnes; Fig. 8).

Human error accounted for only about 3% of the events recorded (Fig. 7), but nevertheless contributed more than 1,500 tonnes to the total volume spilt (Fig. 8), mainly in connection with the structural failure of a tank barge in the United States caused by an inappropriate unloading procedure.

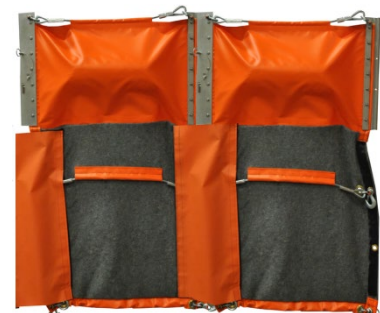
From a structural perspective, the MarkMaster V is similar to a silt curtain. It comprises a permanent float, which is available in different diameters (from 15 to 30 cm), supporting a detachable skirt made of oleophilic *X-Text* filter fabric (from Ultratech International),⁴ with dimensions ranging from 0.12 m to 0.37 m.

The MarkMaster V boom with detachable oleophilic filter skirt (source: www.parkersystemsinc.com)

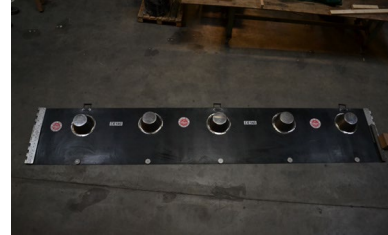
This permanent flat boom has a fence of a height of 60 cm made of a chemically resistant fluoroelastomer, the Viton® fluorocarbon rubber from DuPont/Chemours Company, and a synthetic MPD-I fibre,⁵ here Nomex® (a registered trademark of the same manufacturer), ensuring low combustibility and improving the tensile strength of the boom.

The boom's buoyancy is ensured by stainless steel floats. The weights and connectors of the ChemBoom sections (available in lengths of 10 or 25 m) also made of stainless steel.

View of a section of the DESMI ChemBoom
(source: DESMI)

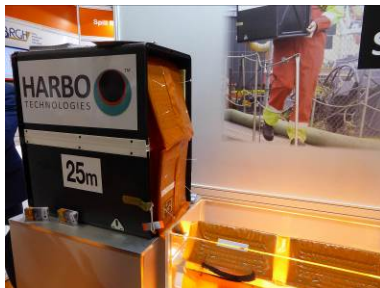
View of a "cartridge" containing 25 m of lightweight HARBO T-Fence boom
(source: Cedre)

According to the manufacturer, this deployment chute for cartridges (with dimensions of 40 x 75 x 65 cm), each containing 25 m of lightweight boom (draught of 20 cm and freeboard of 12 cm), works in a similar way to launch systems for inflatable life rafts. The removable cartridge carrier is relatively small (1 x 1.3 x 0.2 m).

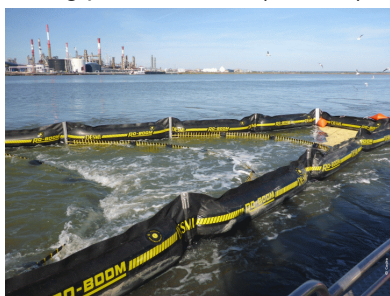
Attenuation of the surface current by successive Kevlar screens integrated in the DESMI Speed Sweep (source: Cedre)

The results were satisfactory for both systems in terms of current attenuation in the collector pool, with containment of the simulated slicks at currents of up to 3 knots at the inlet of the systems, the different tests showing a decrease in effectiveness beyond this value. When deployed by a single vessel, the systems were opened sufficiently by the paravanes in currents of between 0.7 knots (DESMI Ro-Kite 1500) and 1 knot (Egersund Seafoil 15). It is worth noting, however, that the deployment of the DESMI system requires the use of appropriate nautical assets (e.g. with sufficient power).

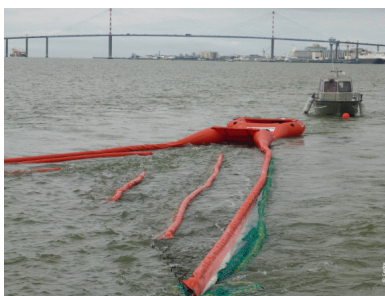
View of the Lamor MOS 15 with its deflectors concentrating the pollution towards the recovery channel and collector pool (source: Cedre)

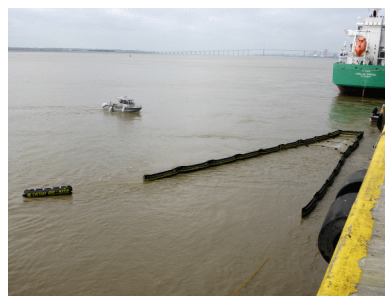
Positioning of the Speed Sweep in static configuration using the Ro-Kite (source: Cedre)

The static mode tests also validated the technical feasibility of continuous pumping from the dockside (maximum height tested of around 5 m), and identified the potential additional resources necessary for turning manoeuvres at slack water (e.g. lifting equipment).

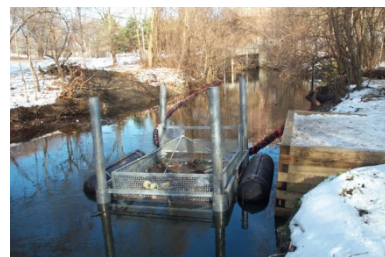
- The EnviroEnhancer (or Trash Trap) consists of a removable recovery basket (made of galvanised steel mesh) housed in a steel frame, which floats thanks to either permanent fenders (heavy-duty HDPE pipes with foam filling) or inflatable fenders. This filtering “trap” is secured on pilings via a tide/flood compensating system, with the opening facing into the current. In addition, deflector booms are anchored upstream of the system.

- The lighter, smaller capacity EnviroTube (or Trash Tube) is designed to be framed by two sections of deflector/funnel booms using standard (ASTM) connections. Located at the apex of the collector pool, this metal plate is equipped with a rear hole to which a storage bag is connected for the recovered debris. This bag is removable, potentially reusable, and its dimensions (volume, mesh size, etc.) can be adapted according to the customer's requirements.

Above: The Trash Trap (top) and Trash Tube, here coupled with GlobeBoom
