**CENTRE OF DOCUMENTATION, RESEARCH AND EXPERIMENTATION ON
ACCIDENTAL WATER POLLUTION**

Sea & Shore Technical Newsletter n°35

2012-1

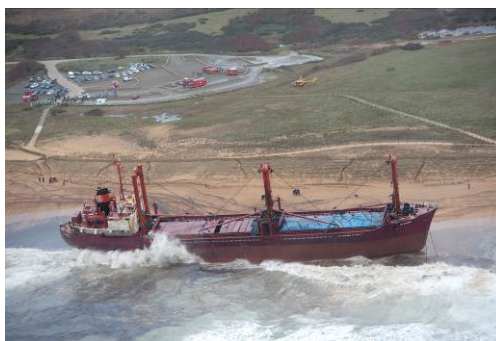
16th December 2011: Oil spill from the TK Bremen, grounded on Kerminihy Beach (Source: Marine Nationale)

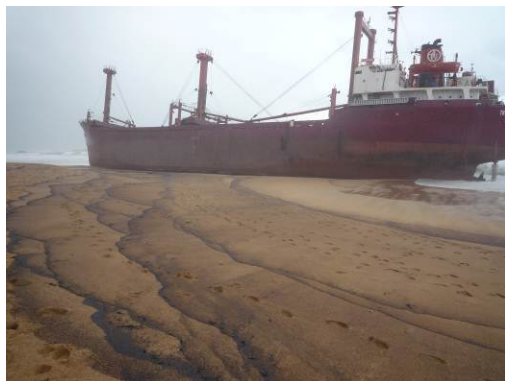
16th December 2011: ribbons of fuel on the sand in the immediate vicinity of the wreck (Source: Cedre)

The initial surveys confirmed (i) the oiling of the sandy foreshores of the incident site and (ii) the incursion of floating oil into the Etel Ria (situated 2 km north and well-known for oyster production), contaminating a small number of oyster farms and threatening others farther upstream (Etel, Belz and Locoal-Mendon sectors).

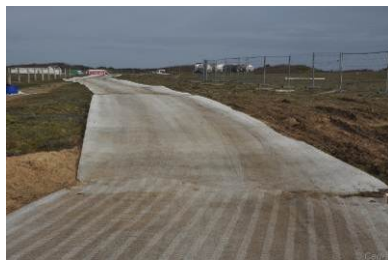
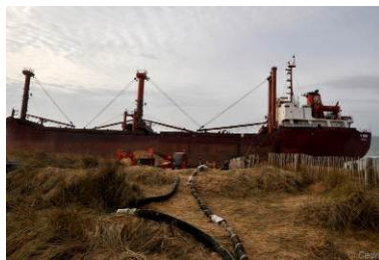
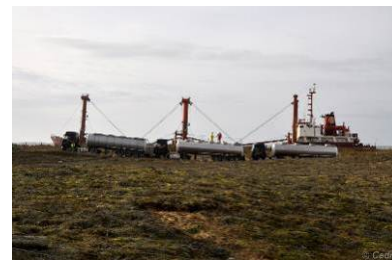
20th December 2011: defining access through the dune to set up the site for the bunker tank pumping operations by Smit Salvage and the evacuation of pumped fluids (Source: Cedre)

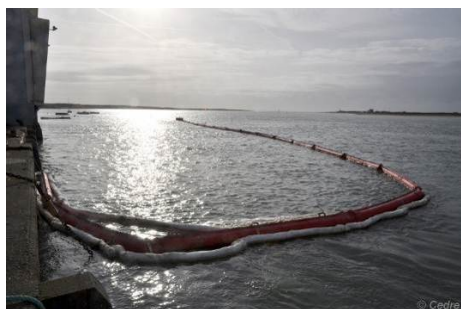
Protective measures in Etel port: floating boom in "J" formation with sorbent booms (Source: Cedre)

Bolstered by these tests, CETMEF, the *Phare & Balises* Service (lighthouses and beacons), oyster farmers and Cedre agreed on the location, length (200 m) and formation of the set-up ("J", moored to the quay and tied to a 6-tonne sinker in the water). Laid in tenuous safety conditions, using an oyster-farming barge, by the Lorient *Phares & Balises* Service, with help from oyster farmers and Cedre, the boom was the principle element of protective measures in the event of a sudden leak from the wreck or remobilisation from heavily oiled beaches downstream.

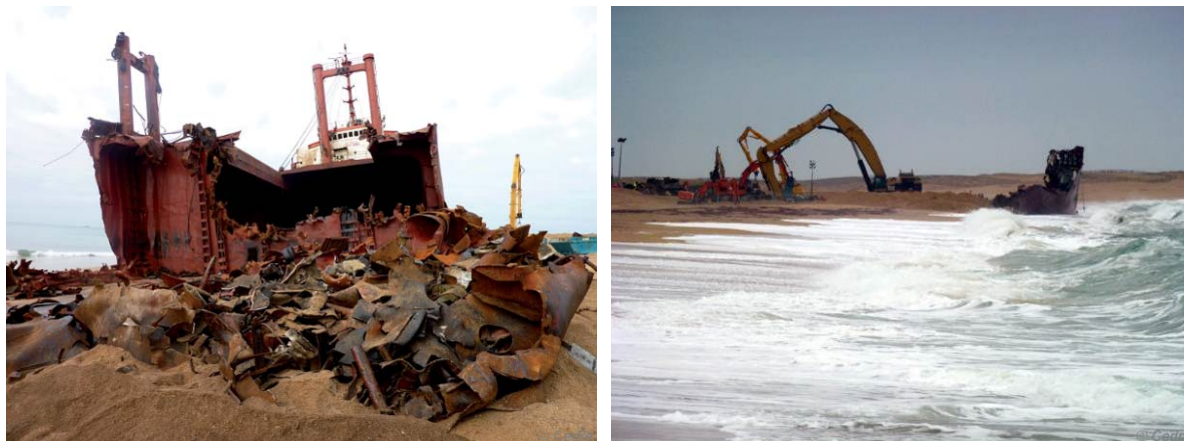
January 2012: cutting and removal of the TK Bremen wreck (Source: Cedre)

- The specialist Dutch company Euro Demolition was contracted to cut up the wreck, which it carried out between the 6th and 25th January 2012 using a giant, 280-tonne track excavator, fitted with an articulated boom and shears. This operation resulted in the removal of 2,000 tonnes of metal;
- The internal deconstruction of the vessel as well as the prior clean-up and pumping of the tanks were entrusted to *Recycleurs Bretons* and its subsidiary *Alzeo Environnement* respectively;
- The scrap metal was taken to Lorient to be recycled by the company *GDE Atlantique*, while the polluted effluents were treated in Saint-Malo by ETVV (*Entreprise de Vidange des Trois Villes*).

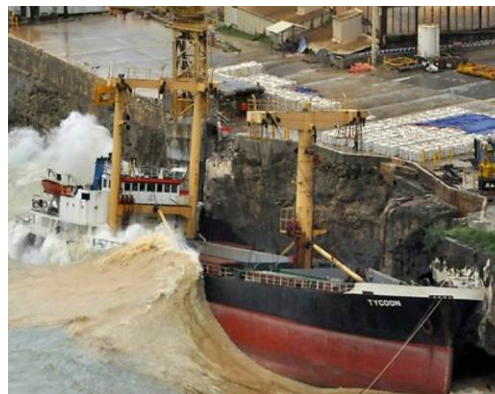
8th January 2012: The *Tycoon* grounded on the cliffs of Flying Fish Cove, Christmas Island
(Source: AMSA)

During the night, wave action (4 to 5 m-high waves) cracked the vessel's structure and it foundered at the base of the cliffs where it broke in two early in the morning of the 9th, releasing the main bulk of its cargo and the contents of its bunker tanks.

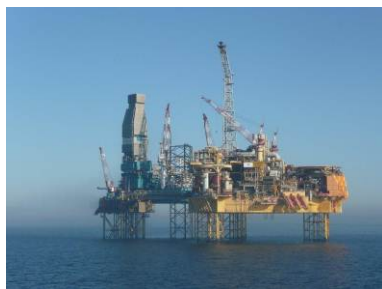
The Elgin rig, on the 27th March 2012 (2 days after the leak was reported) (Source: Total)

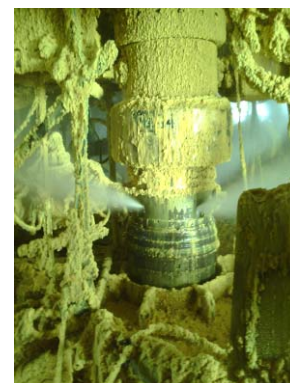
The Elgin G4 wellhead: view of the source of the leak (Source: Total)

The incident was the result of the unforeseen rise in gas pressure in the well, which is speculated to have been caused by the sudden influx from another reservoir²¹. Whatever the reason, this influx of gas led to the rupture of a tube, despite being intended to withstand high pressure, whose seals, on further analysis, appeared to have been weakened by unexpected corrosion. Their rupture allowed the gas and condensates to rise up to the platform.

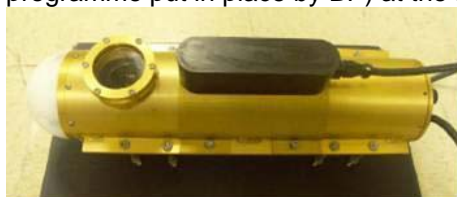
The Oscar prototype, sensor for submerged or sunken oil (Source: EIC Laboratories)

EIC Laboratories has developed a detection system for oils with a density of over 1, submerged in the water mass or even deposited on the seabed. The instrument, called Oscar, is a front scanning sensor, whose technology is based on fluorescence polarisation (laser excitation) and can discriminate viscous oil from other naturally fluorescent material present in the near environment (e.g. vegetation).

Controlled remotely, the Oscar prototype can be deployed at depths of up to 1,500 m with a range of 1 to 10 m. It was tested in 2009 in the OHMSETT (USA) tanks, then following the *Deepwater Horizon* disaster (and at its selection for the Alternative Response Technologies (ART)²⁶ evaluation programme put in place by BP) at the request of the Unified Area Command.

In 2012, EIC Laboratories announced the satisfactory performance of the device during testing in various United States Coast Guards (USCG) installations in depths of up to 10 m. Moreover, on the issue of response in a cold/Arctic environment, the company has announced that it has also tested the potential of the device in detecting oil accumulations trapped under a layer of ice when deployed pointing towards the surface.

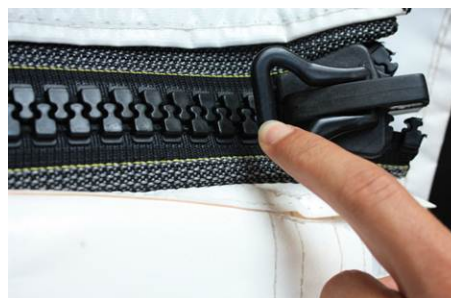
"S14" connection system (industrial marine zip)
 (Source: www.eurofilet.fr/)

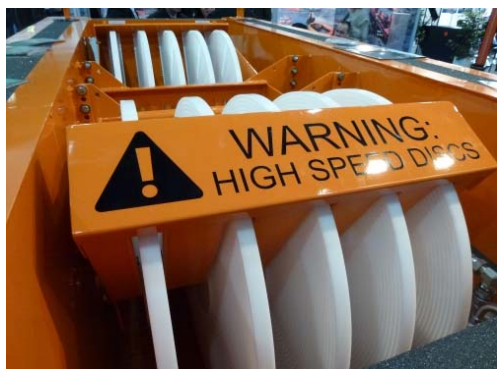
Two series of discs on the X150 skimmer (Source: Cedre)

Smaller than the prototype, the X150 features 2 axles each fitted with 5 grooved polyethylene discs housed in a steel structure measuring 2 m x 3 m. According to the manufacturer, the skimmer has a recovery rate of 150 m³/hour (hence the commercial name of the model).

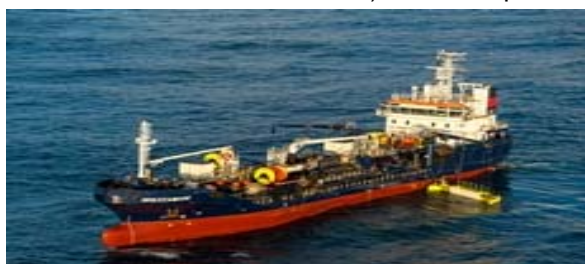
The oil tanker *Brezzamare*, equipped to enter into service with the EMSA network of stand-by oil spill response vessels (Source: EMSA)

Engaged mainly in bunkering operations in the port of Genoa and its vicinity, *Brezzamare* will join the EMSA network in late 2013 after being adapted and equipped with the necessary means to carry out its future oil recovery missions at sea (including 12 m Koseq sweeping arms, 2 x 250 m sections of single point inflation Markleen Uniboom X-1 900 boom, 1 Tarantula DESMI offshore skimmer and 1 Consilium detection system).

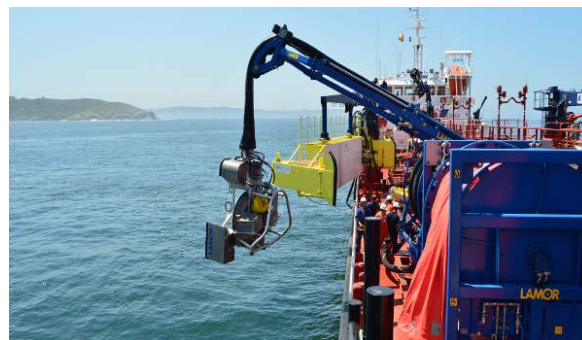
Testing the Lamor LWS 1300 system at sea, now fitted on the oil tanker *Monte Arucas* (Source: EMSA)

The *Monte Arucas*, on stand-by and assigned to the Bay of Biscay, is equipped with 15 m sweeping arms, ocean oil booms (2 x 250 m), an offshore weir skimmer (self-adjusting Lamor LWS 1300) operated by an umbilical hose reel, and a Miros oil spill detection system.
