CENTRE OF DOCUMENTATION, RESEARCH AND EXPERIMENTATION ON ACCIDENTAL WATER POLLUTION

Sea & Shore Technical Newsletter n°47

2018-1

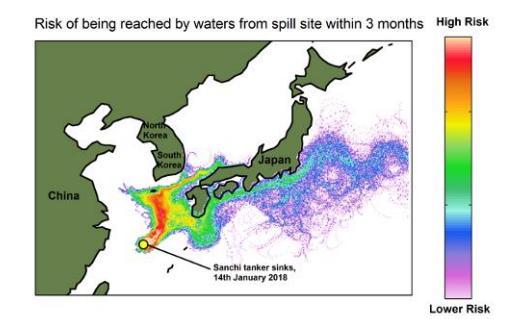
Calculation of the probability of pollution over the three months following the sinking of the Sanchi based on the NEMO model (source: National Oceanography Centre)

Furthermore, the National Oceanography Centre (NOC) and the University of Southampton (United Kingdom) performed numerical drift simulations³ to determine the probabilities, calculated at dates before and after the sinking (12th and 16th January), of condensates or bunker fuel washing up along the coasts. The probability was considered: (i) low at 1 to 3 months (the model did not take into account the fate of the condensates, whether combustion or dissipation); (ii) affecting more specifically Japan to the east and the Republic of Korea to the north; and (iii) with most of the particulate matter carried by the Kuroshio current (thus drifting towards the north-east of Japan).

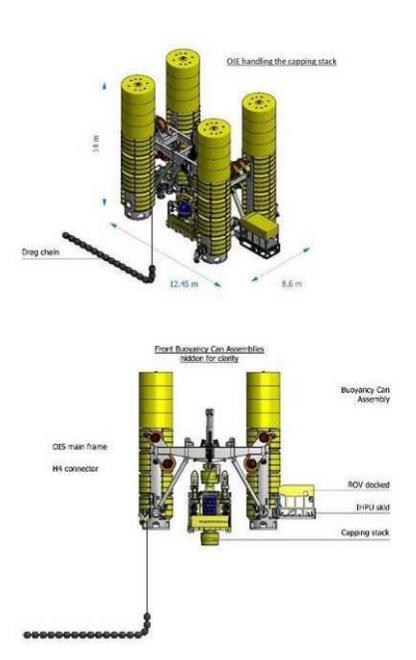
Diagram of the OIE, with adjustable flotation components for the remote positioning of a capping stack (source: OSRL)

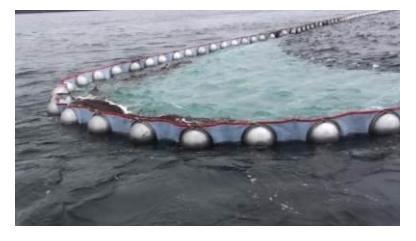
Opposite: collection net for burn residues, attached to a section of DESMI PyroBoom® (submerged skirt, with front line of ballasts) (source: DESMI)

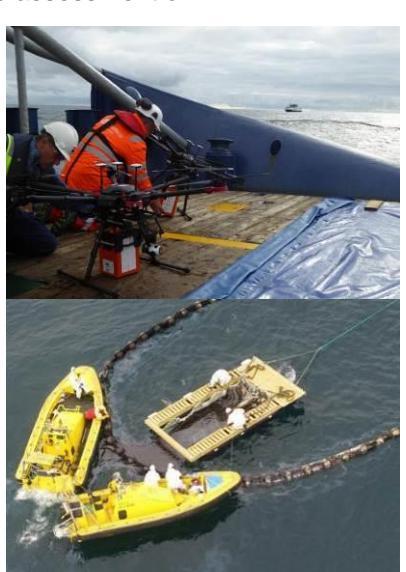
Preparation of the DESMI PyroDrone (top) and disconnection of the ISB residue collection net (bottom) (source: NOFO)

While the performance of the PyroDrone was considered satisfactory, a single igniter being sufficient for both the Oseberg crude and ULSFO (for areas of 100 m² and 50 m², respectively, in the boom), the ignition of the ULSFO took a little more time. The atmospheric measurements indicated very high concentrations of particulate matter in the smoke plume, with a very significant proportion of fine particles (< $2.5 \,\mu$ m), decreasing rapidly at its periphery. According to NOFO, the extensive data acquired during these trials, from both the sensors (on drones and ships) and the sampling of the residues, will be analysed for the purposes of assessing the health risks and environmental impact associated with ISB operations. With regard to the PyroBoom® fire booms, the following findings were noted: (i) leakage from the boom, prior to ignition, of the light Oseberg crude oil in greater quantities than for the ULSFO (more viscous); and (ii) significant damage to the emerged part of the boom at the end of the burns (between 43 and 48 minutes).

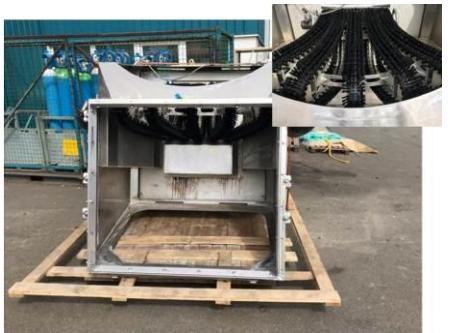
DESMI prototype (using one Octopus module) mounted on the apex of a LAMOR MOS 50 boom (source: NOFO)

In this configuration, the single Octopus brush belt module nevertheless proved selective, despite issues with the stability/position of the prototype,¹⁸ which could be improved according to NOFO. This also highlights the advantage of using aerostats to verify/control the deployment of the MOS 50 during operations.

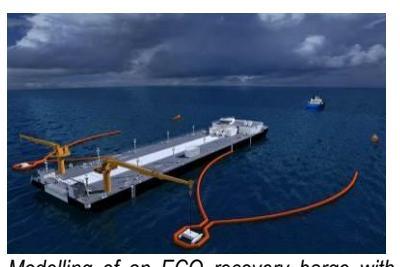
Modelling of an ECO recovery barge with deployment (via lifting arms) of two CRUCIAL oleophilic skimmers in the NOFI Current Buster 8 temporary storage unit (source: Alyeska Pipeline Service Company)

As regards the design of the barges themselves, it is worth noting that the lines and pumps required to transfer the recovered fluids are placed below deck to reduce congestion topside (along with the associated risks) and to provide the space necessary for the storage and preparation of the equipment (e.g. inflation of the booms prior to deployment).

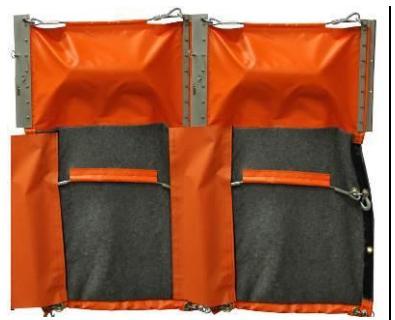
The MarkMaster V boom with detachable oleophilic filter skirt (source: <u>www.parkersystemsinc.com</u>)

Available in sections measuring 0.75 m, 1.50 m or 3 m in length, the system is designed for use as protection in rivers with weak to moderate currents (e.g. in front of sensitive sites or along riverbanks) in the event of sunken oil, a recurring problem in North America in particular and linked to the increasing use of non-conventional oils (oil shale, oil sands, etc.).

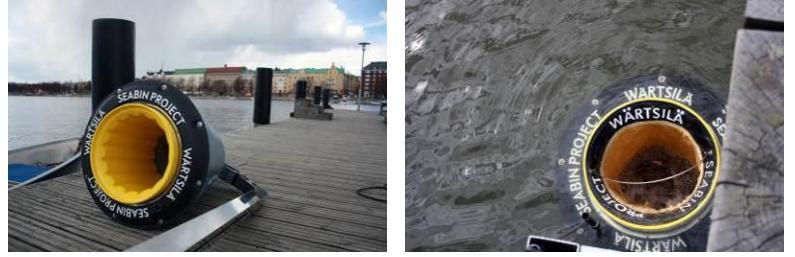
The model launched in 2017 is the V5 Hybrid version of the prototype. Resembling a floating dustbin (HDPE construction; $\emptyset \times$ H: 0.5 x 0.5 m), it is moored to a floating pontoon and equipped with a weir lip adjusted to the water surface via a submersible pump (electric, 12V; 25 m³/hour).

Views of the V5 Hybrid prototype of the Seabin floating waste collector (source: www.wartsila.com)

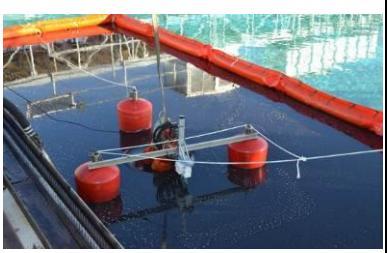
Capacitance sensor mounted on a weir skimmer (here a DESMI Termite), being tested in the Ohmsett test tanks (source: AUB)

Its principle is based on measuring capacitance values using a set of conductive electrodes immersed in the floating slick, the relative differences in these values reflecting the presence of interfaces between different layers of fluids and/or gases (e.g. air/oil, oil/water, etc.) and from which the thickness of the oil slick is determined (depending on the dimensions/positions of the electrodes). Based on capacity differences instead of absolute values, it would appear that this calculation does not require calibration. The prototype has been designed to operate in a range of thicknesses from 3 mm to 1 cm; a range that could be extended with the integration of certain design modifications.

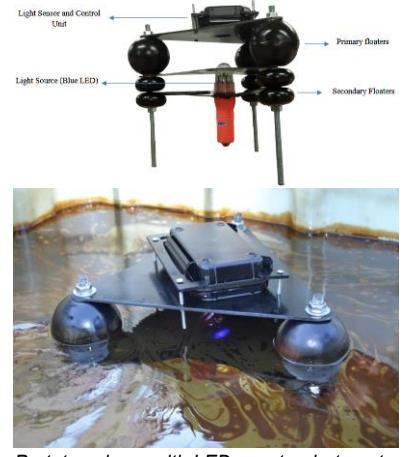
Prototype buoy with LED spectrophotometer (source: AUB)

A second concept was developed, namely a LED spectrophotometer (for measuring the absorbance of light rays) intended for use on thinner oil thicknesses of between 100 μm and 3 mm.

The performance of a prototype was assessed, also at Ohmsett, under variable conditions of agitation of the water body and on thin layers of two types of oils. While the detection (absence/presence of oil) proved effective, certain limitations were identified in the accuracy of the thickness measurements for reasons similar to those mentioned above (i.e. related to the intensity of agitation of the water and to the oiling of the cells). These limitations are currently the subject of research into possible enhancements to the system. It is worth noting, however, that the characteristics of the oils tested – and more precisely their "opacity" as a function of their thickness – could cause the range of thicknesses measurable using this technology to reach a ceiling below the 3 mm envisaged.

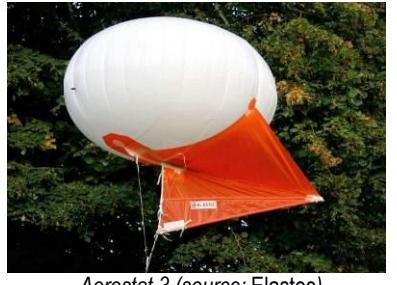
Aerostat 3 (source: Elastec)

Equipped with a signalling system (radar deflector and LED lighting), the Aerostat 3 is designed to be able to attain altitudes of up to 200 m, secured to an anchoring system via a rope made of UHMWPE²⁷ fibre (Dyneema, from Dutch company DSM) chosen for its resistance (torsion, abrasion, etc.), its light weight, and its low elongation/deformation properties.
