13th Cedre Information Day

Fire and Rescue Service for the Department of Moselle

The PROBO KOALA

The incident

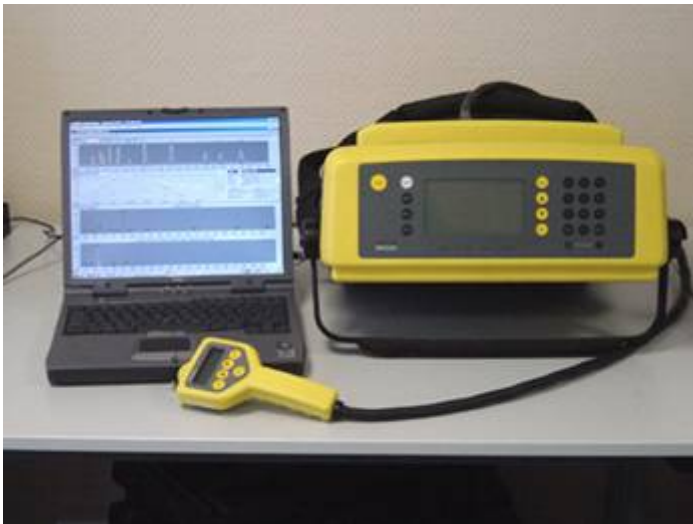
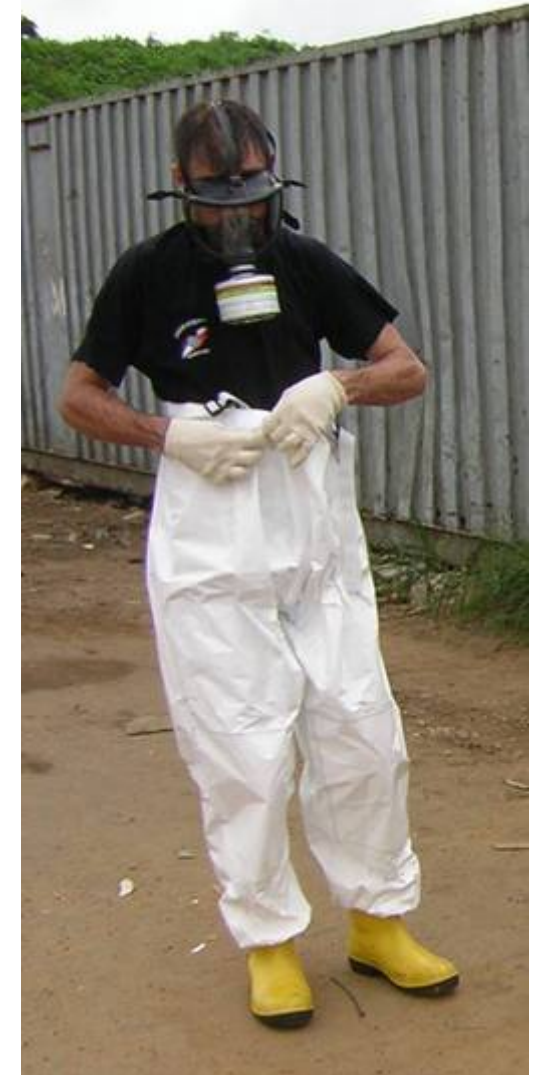
Detection equipment and personal protective equipment

- ⇒ 1 CMS kit + colour comparison tubes (H₂S, mercaptans,...)
- ⇒ 1 AP2C
- ⇒ 1 Tim's
- ⇒ 2 PID
- ⇒ 1 multigas detector (explo, O₂, H₂S)
- ⇒ 1 GC/MS HAPSITE

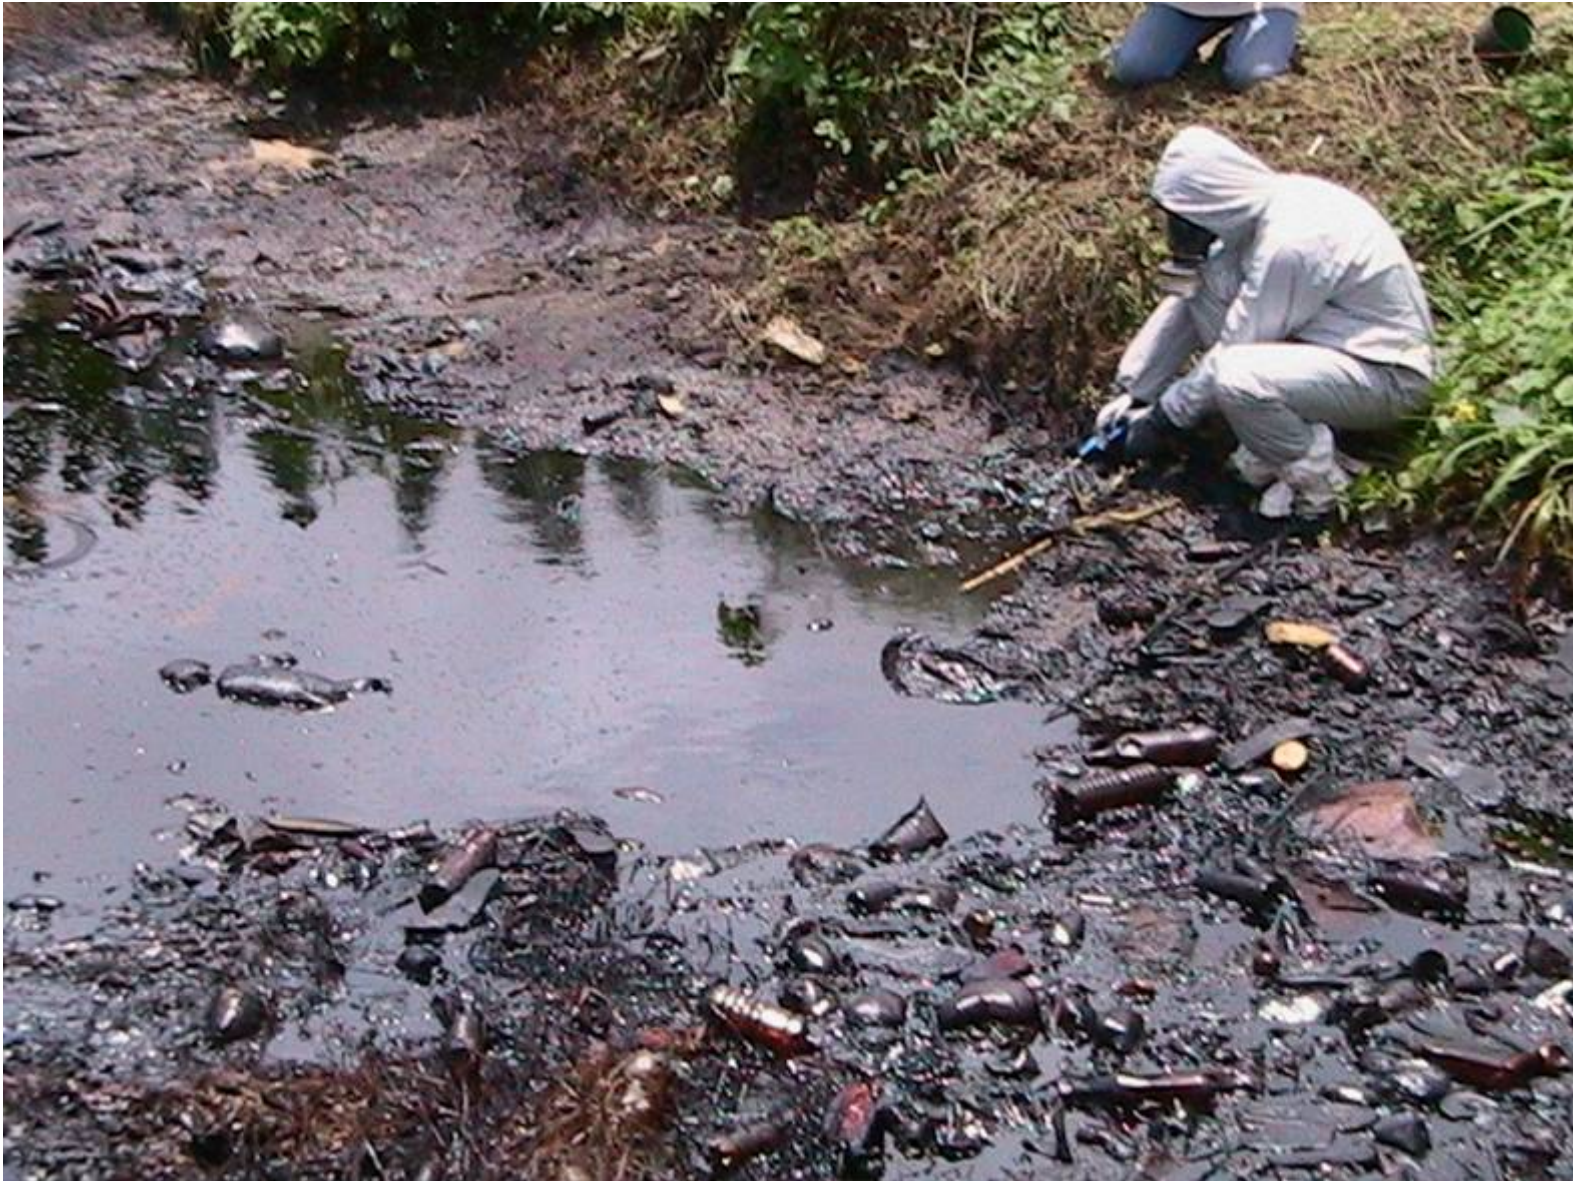
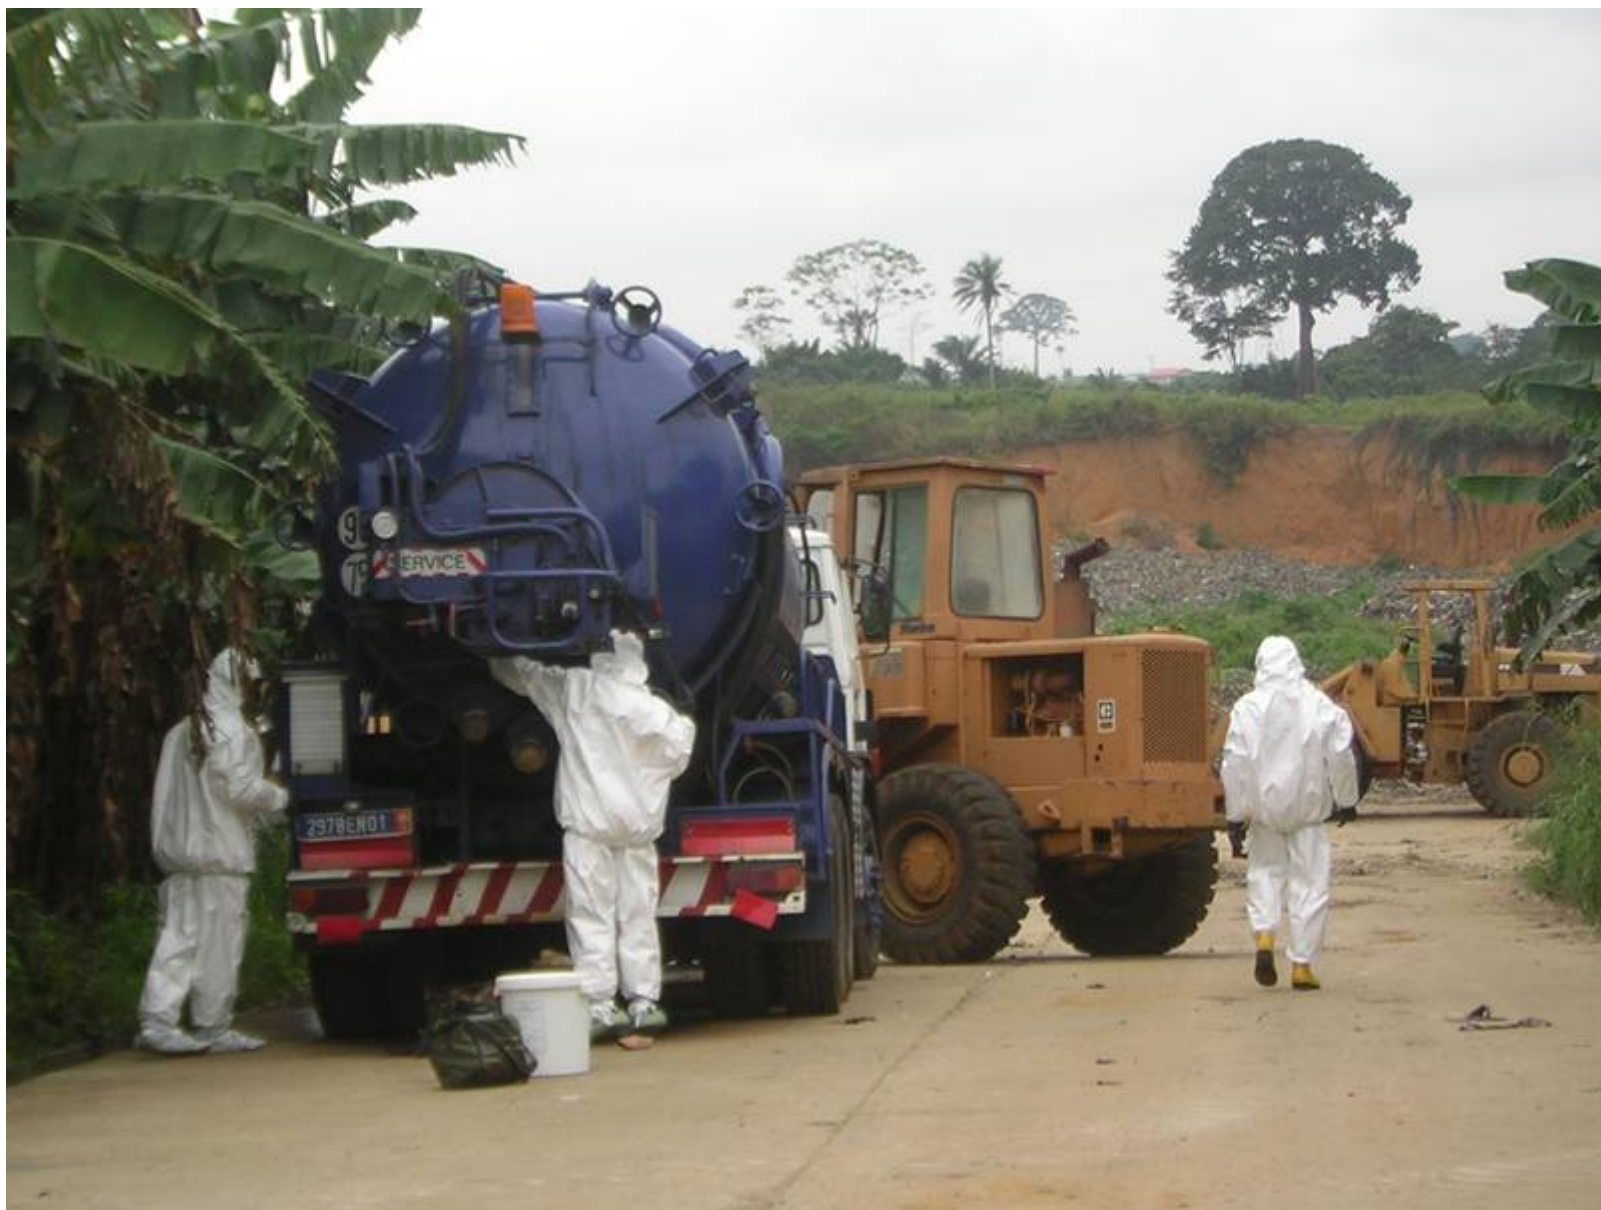
Physical appearance:

- ⇒ Blackish viscous liquid in pools
- ⇒ Fluid, clearer liquid in truck (similar appearance to petrol)

Odour:

- ⇒ Repulsive garlic-like odour

Colorimetric detection:

- ⇒ $H_2S < 1$ ppm
- ⇒ mercaptan: positive (saturation of tube at 5 ppm in pool)
- ⇒ hydrocarbons: positive (qualitative tube)
- ⇒ benzene < 5 ppm
- ⇒ methyl bromide < 5 ppm
- ⇒ thioether: positive (qualitative tube)

AP2C:

- ⇒ Positive detection of sulphur

Electrochemical H_2S cell:

- ⇒ 0 ppm in pool (4 ppm in truck)

pH:

- ⇒ 9 in pool with water

- ⇒ A majority of hydrocarbons characteristic of oil products (alkanes, aromatic hydrocarbons).
 - ⇒ Mercaptans present in the form of traces (ethanethiol, propanethiol).
 - ⇒ Sulphur present mainly in the form of disulphurs and thiophene
 - ⇒ Presence of phenol, in acute quantities in aqueous sample (soluble compound at 80 g/l).
 - ⇒ Presence of traces of dichlorobenzene.
-
- ⇒ **Measurements consistent with initial Dutch analyses (the product appears to have evolved in 1 month)**

The following precautionary measures were given:

- ⇒ set up an exclusion zone 200 m around the pools of chemicals
- ⇒ destroy cultures within a radius of 500 m

Advice was given on:

- ⇒ conducting an epidemiological study with analysis of biological parameters through blood or urine tests, coupled with an environmental study (land, water, vegetation)
- ⇒ having an independent laboratory carry out further tests.
